# Clocks Trust: An investigation of recent 500KV line operations

Galina S. Antonova and Tommy Jansson, Hitachi Energy  
Tom Roseburg and Steve Laslo, Bonneville Power Administration

## Abstract

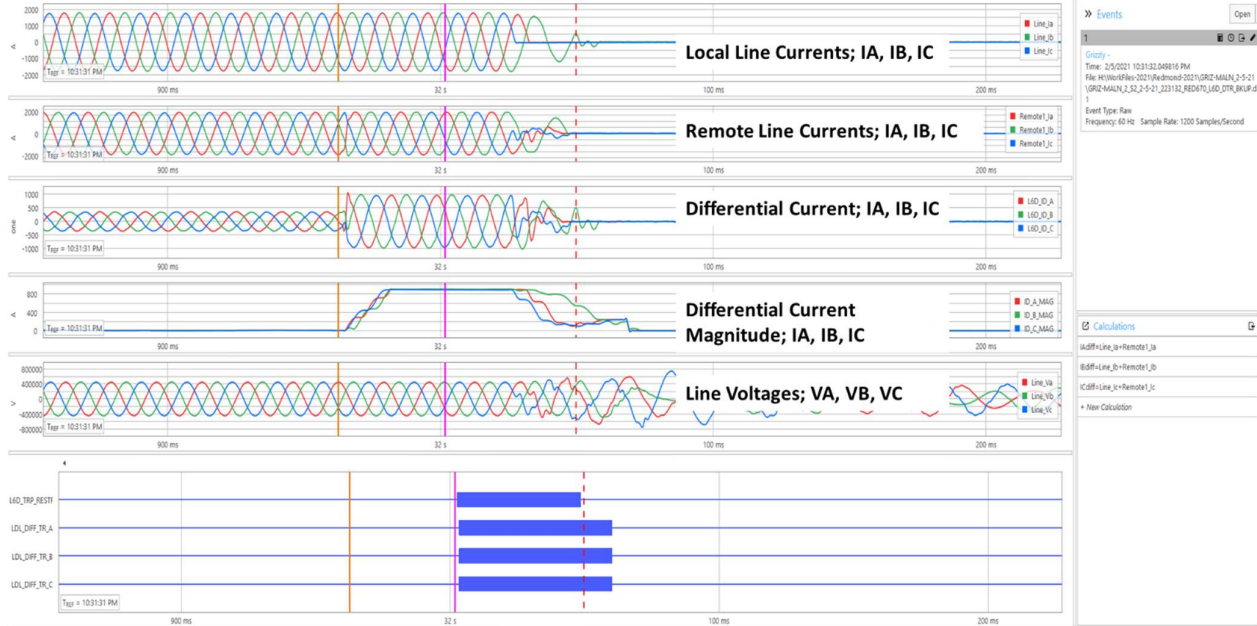
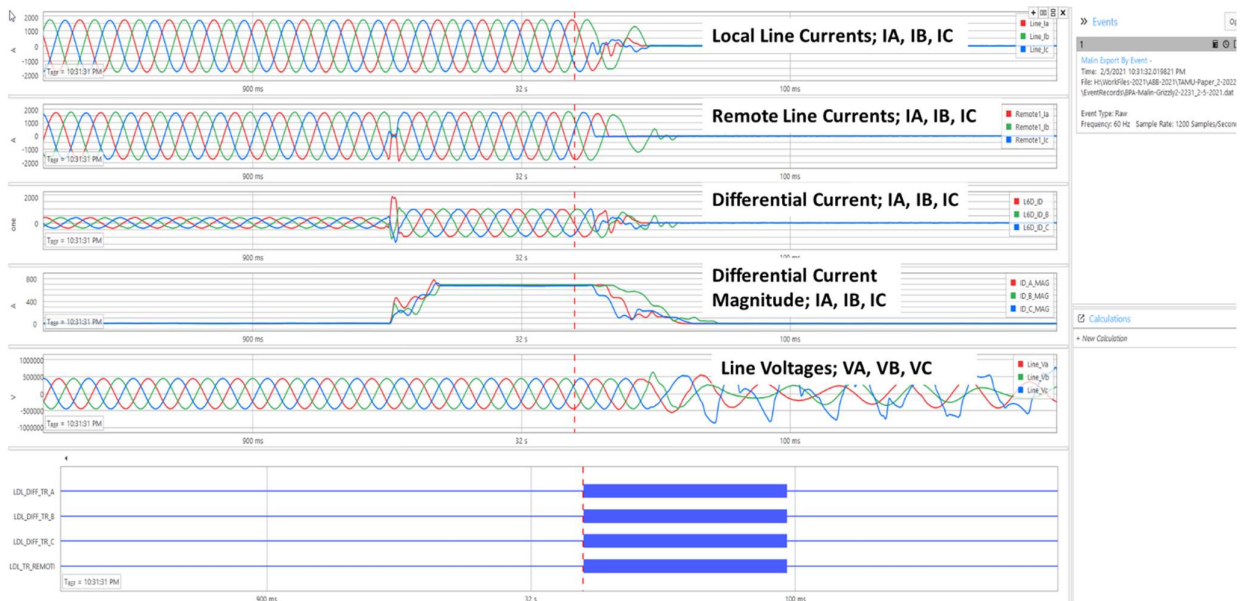
**Figure 2.** Event 1 records at Grizzly terminal (a) and Malin terminal (b)

The first event had a time glitch that caused a slight time shift in the remote currents. Instead of blocking the differential the relay locked in the time error and appeared to unblock the differential allowing it to trip. Event records below show that both Grizzly and Malin terminals tripped on 87L element (Figure 2a). One can observe AC waveforms distortions, these are further analyzed in this paper.

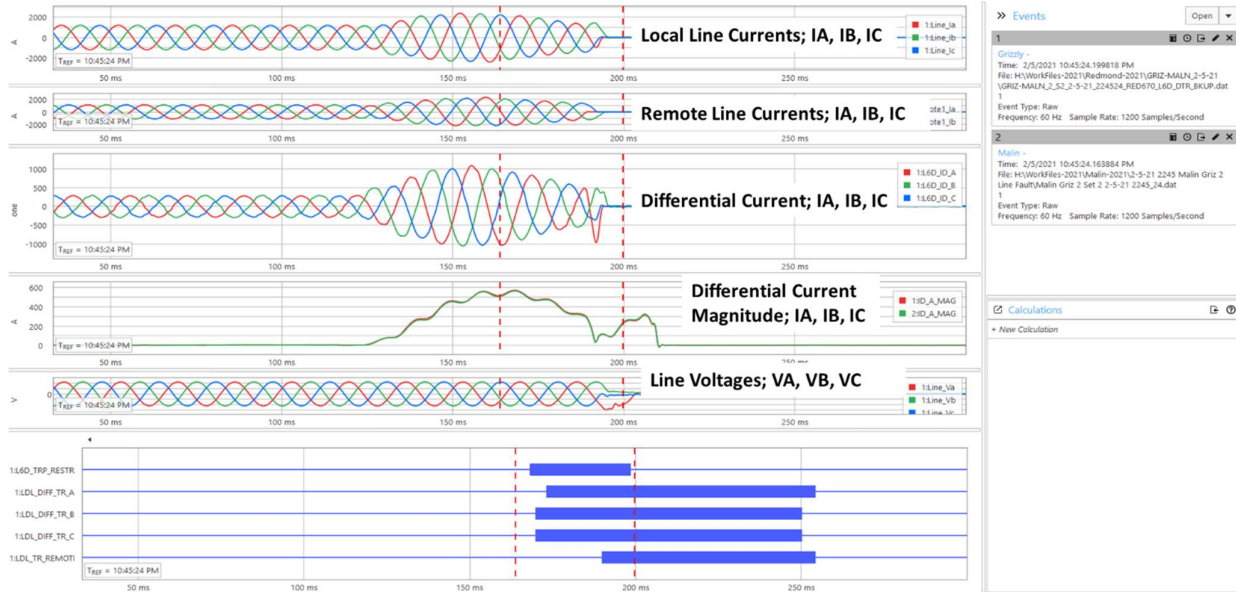
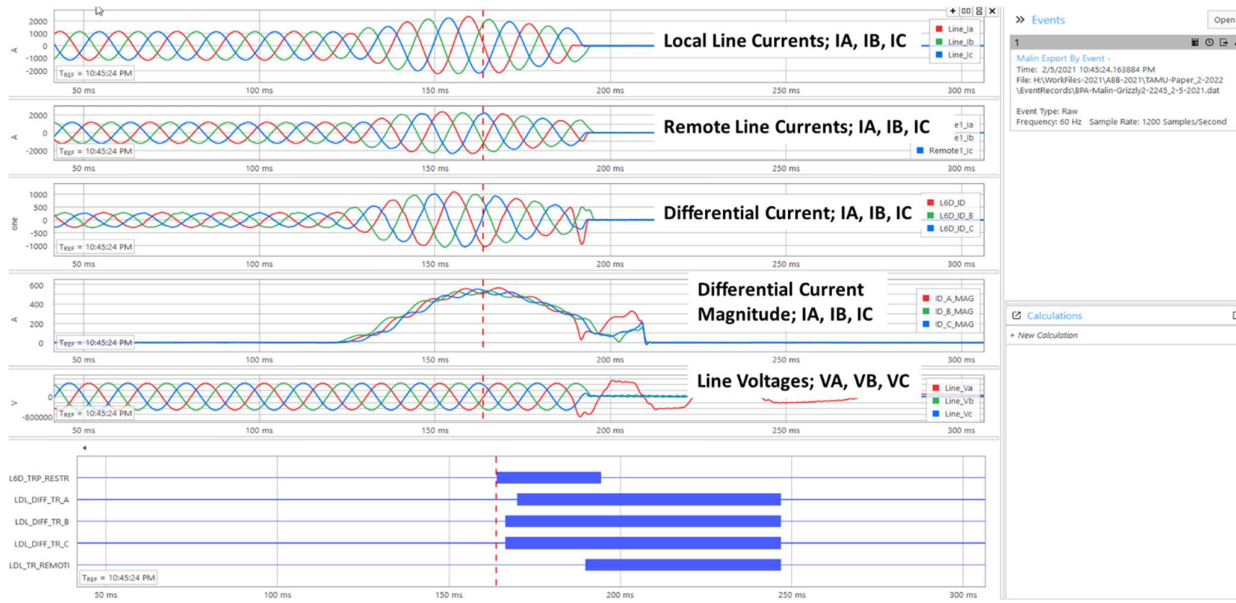
**Figure 3** Event 2 records at Grizzly terminal (a) and Malin terminal (b)

The second event occurred 15 minutes later when the line was returned to service and one of the series capacitors was re-inserted. In this case the trip was caused by the increase in current when the capacitors were inserted, and the clock time was still in error. The clock was apparently stable after the first event and the differential remained in service with the time error. Both terminals tripped on 87L elements, as shown below for Grizzly terminal (Figure 3a) and Malin terminal (Figure 3b).

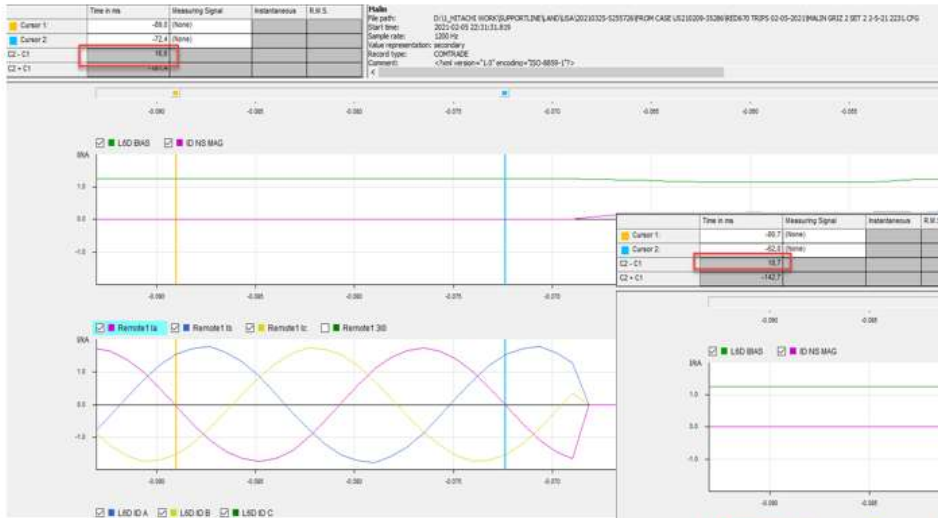
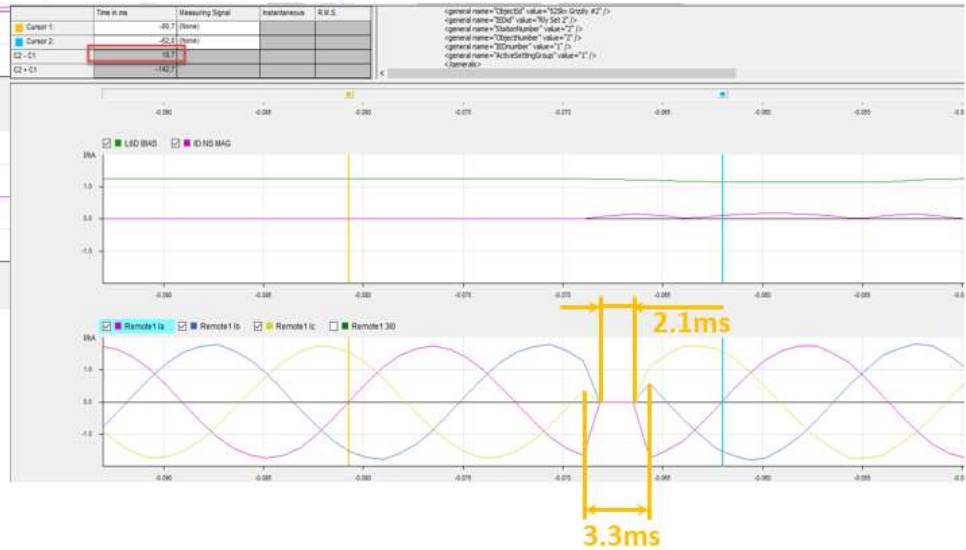
Figure 7a. Frequency/period checks for Malin relay for remote current from Grizzly

During: period extended to **18.7ms !**

AC waveform discontinued for **3.3ms**  
 0 data recorded for **2.1ms**

Per Figure 7a, the measured duration of the zeroed current is about 2.1ms, while the duration of the disturbed AC waveform is about 3.3ms.

Samples insertion with zero values explains period extension by about 2.1ms. These samples were inserted unnecessary, in addition to the correct AC data, because of the timestamps jump.

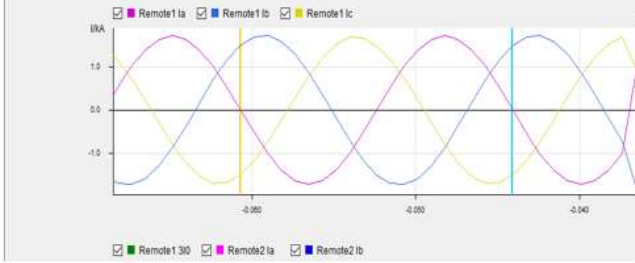
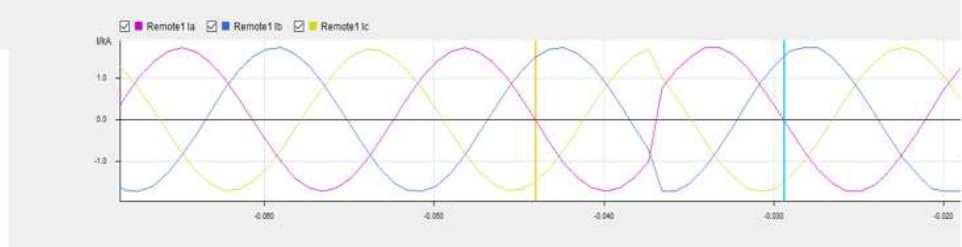
Figure 7b. Frequency/period checks for Grizzly relay for remote current from Malin

Delta: **15ms** com delay + processing

During: period shrunk to **14.6ms !**

Discarding two data samples with valid data with timestamps in the past explains the AC waveform period reduction by about 2.1ms in Grizzly record for the remote current.

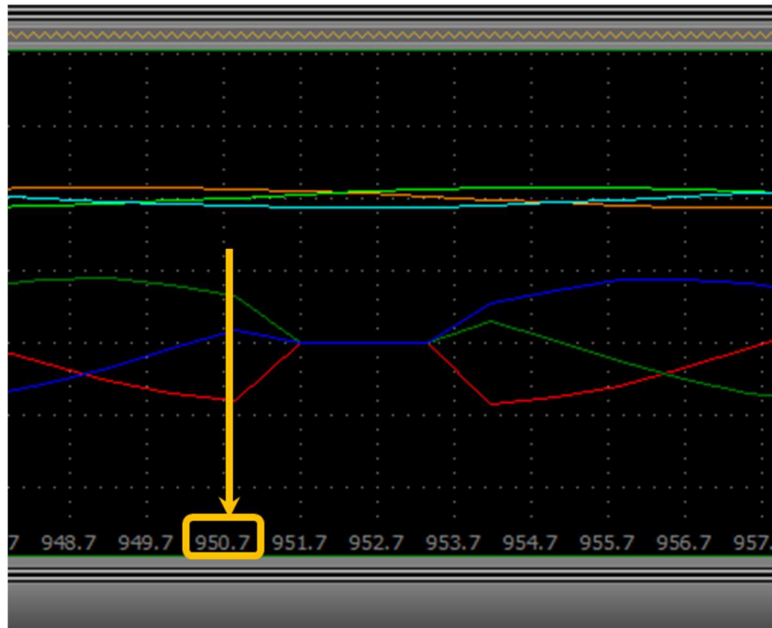
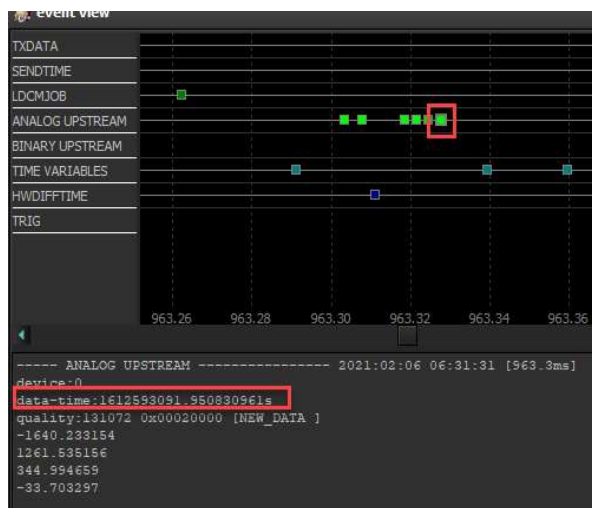
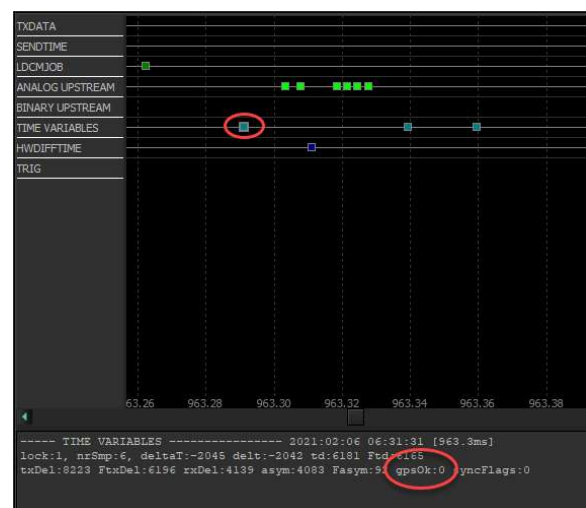
**Figure 8.** Details of relay-to-relay communication message received at Malin, 950.83ms

Examining the internal log in the Malin relay, it was concluded that at the start of the event its remote relay was operating in Echo mode. Figure 8 shows relay-to-relay communication message with 950.83ms time stamp received at Malin. Likewise, the associated message that arrived at Grizzly shown with 965.0ms timestamp also indicates that Malin relay sending it was in Echo mode. This is shown on Figure 9.

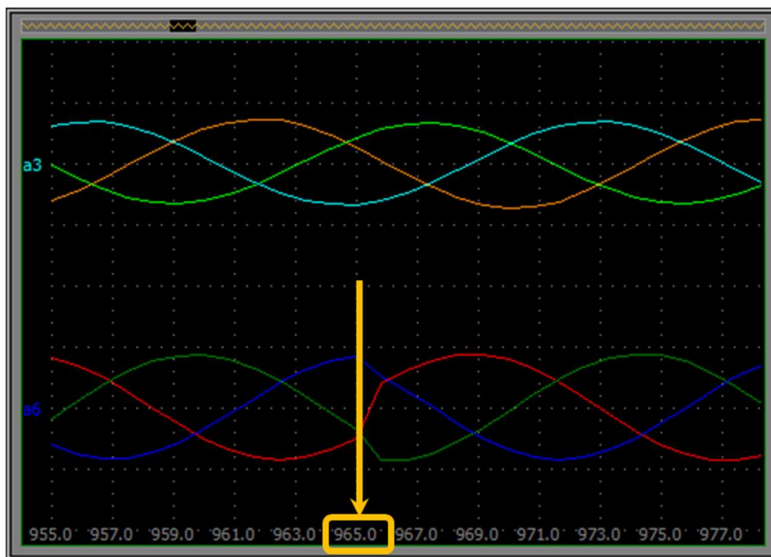
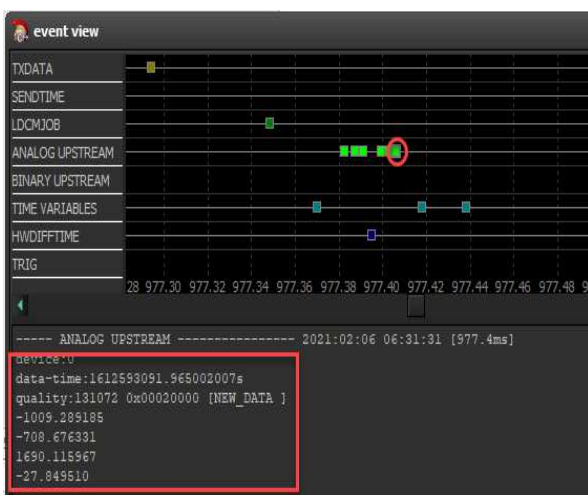
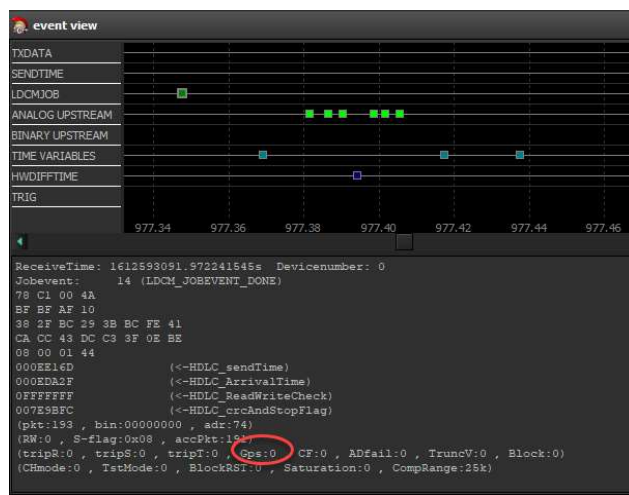
**Figure 9.** Details of relay-to-relay communication message received at Grizzly, 965.0ms

Thus, before Event 1 both relays were in Echo mode. An assumption was made that a clock issue experienced at Malin initiated a transition to Echo mode some time prior to the event. It should be noted that at the start of Echo mode operation a known good GPS time is frozen and used. Up until the times shown in Figure 8 and 9 regular and proper 16.667ms AC periods were observed.

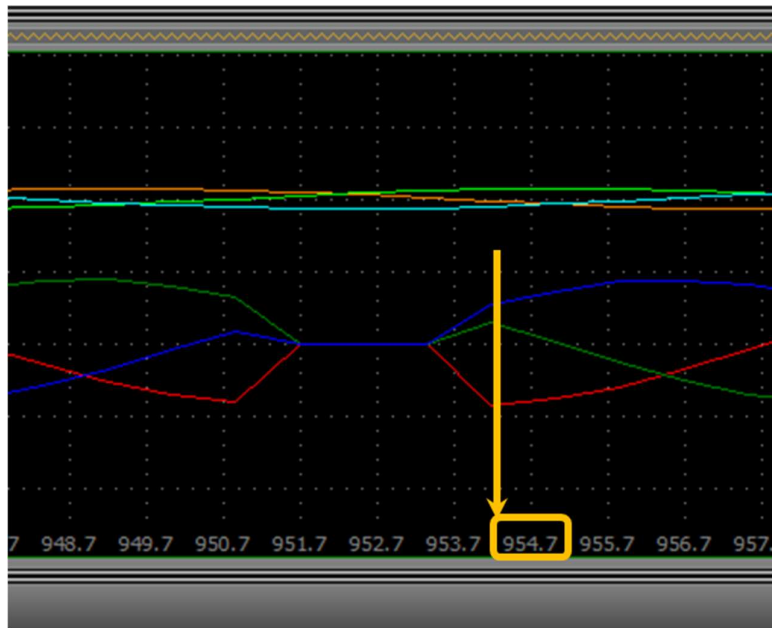
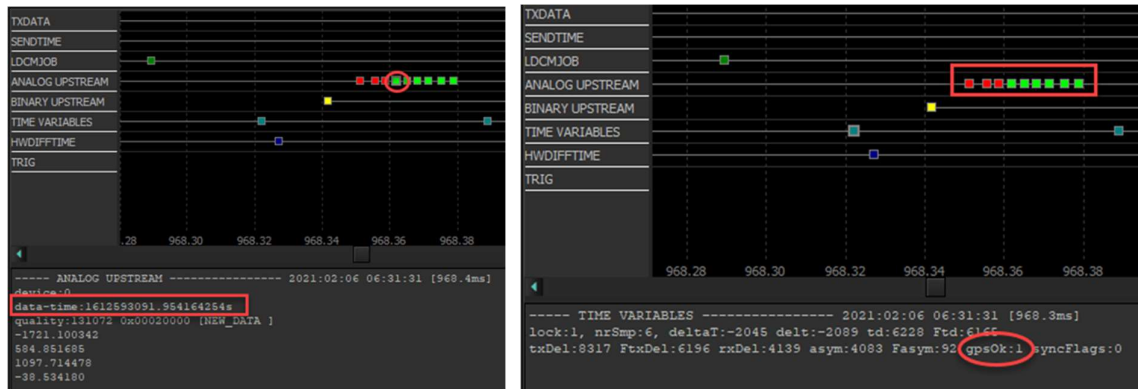
**Figure 10.** Details of next message received at Malin, 954.1ms

The next relay-to-relay communication message that arrived at Malin from Grizzly end carried GPS=Ok flag, indicating that a transition back to GPS mode has occurred. Figure 10 shows details of this message. Note a 3.3ms timestamp jump from 950.83ms to 954.1ms.

This jump indicates that time at the (properly functioning) GPS clock at Grizzly end is around 3.3ms ahead of time at Malin terminal

This first message in GPS mode received at Malin terminal, was interpreted as 3.3ms of data was missing, i.e., no data was provided for times at approximately 951ms, 952ms and 953ms. As relay CPU needs samples every 0.83ms, zero values were provided for these samples. These are seen as red dots on Figure 10.

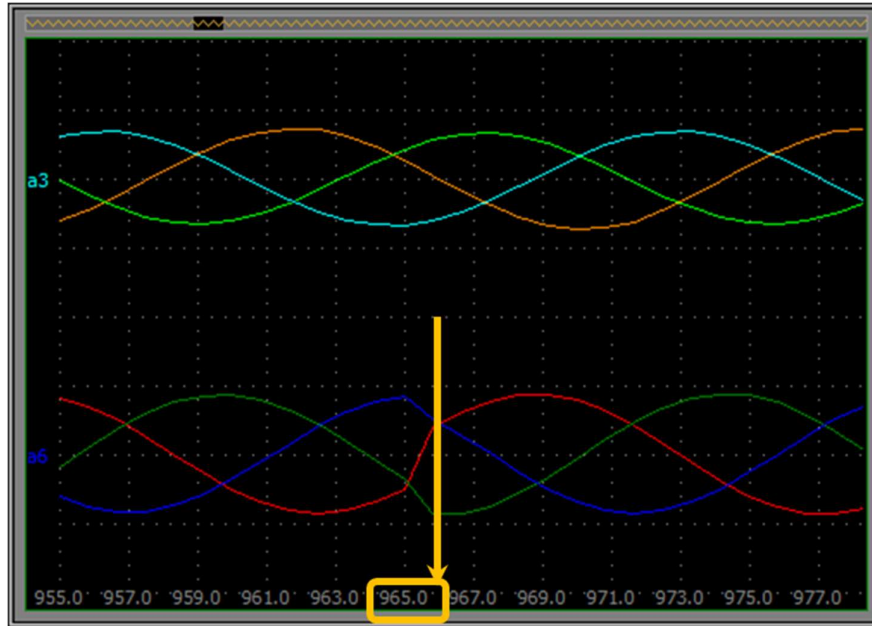
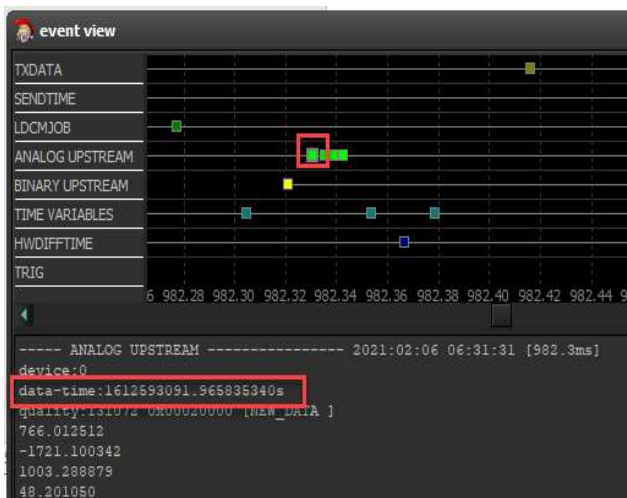
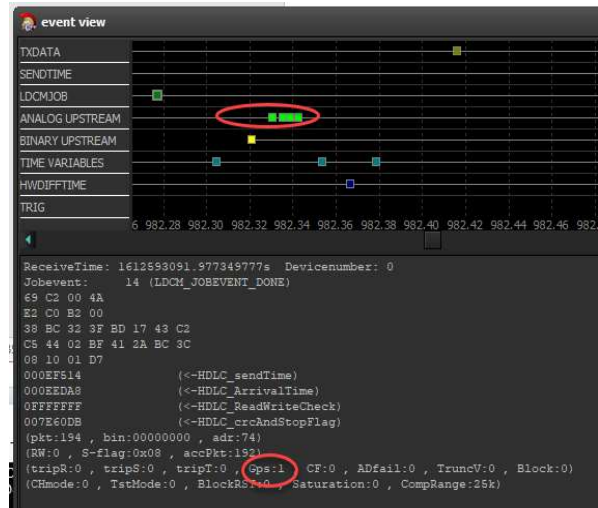
**Figure 11** Details of next message received at Grizzly, 965.83ms

At Grizzly end, the next received message as well had GPS flag set to OK. Details of this message are shown on Figure 11. Note that the timestamp used is exactly the expected next time stamp value: 965.83ms. However, as seen on Figure 11, only 4 samples out of 6 were passed to CPU for processing. 2 samples were discarded for having timestamps in the past.

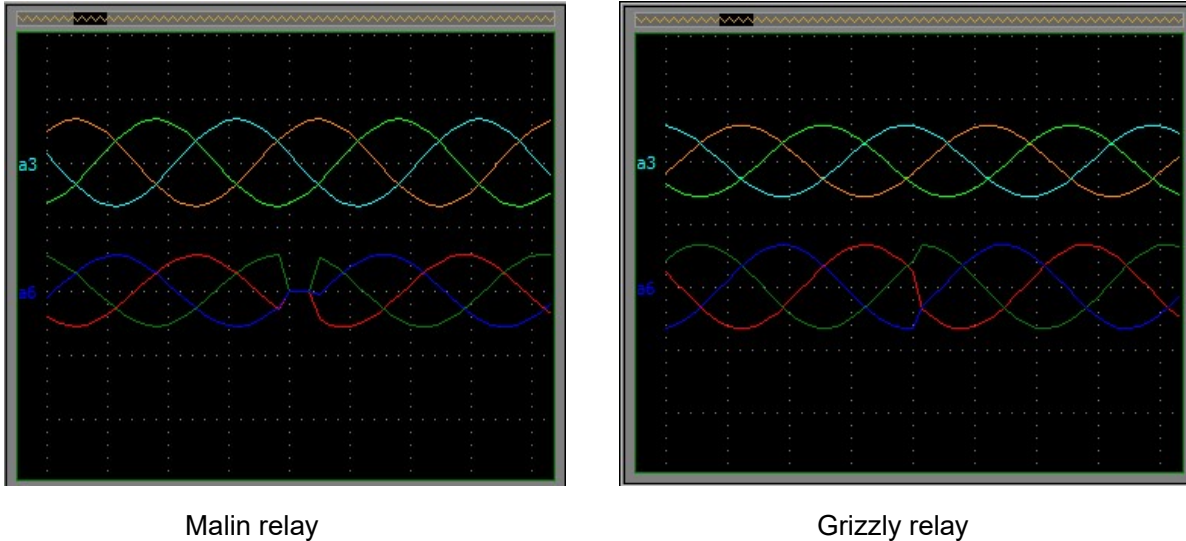
**Figure 13:** Relay vendor R&D test results, matching Event 1 data

Malin terminal locked to GPS time with the configured negative  $-2.1\text{ms}$  time offset, current samples timestamps were also offset by  $2.1\text{ms}$ . Calculated using such timestamps differential current exceeded  $I_{\text{dmin}}$  setting and an 87T trip occurred, with nominal current injections. Figure 13 shows analog data captures from R&D tests, which are very similar to the actual event captures shown on Figure 6.

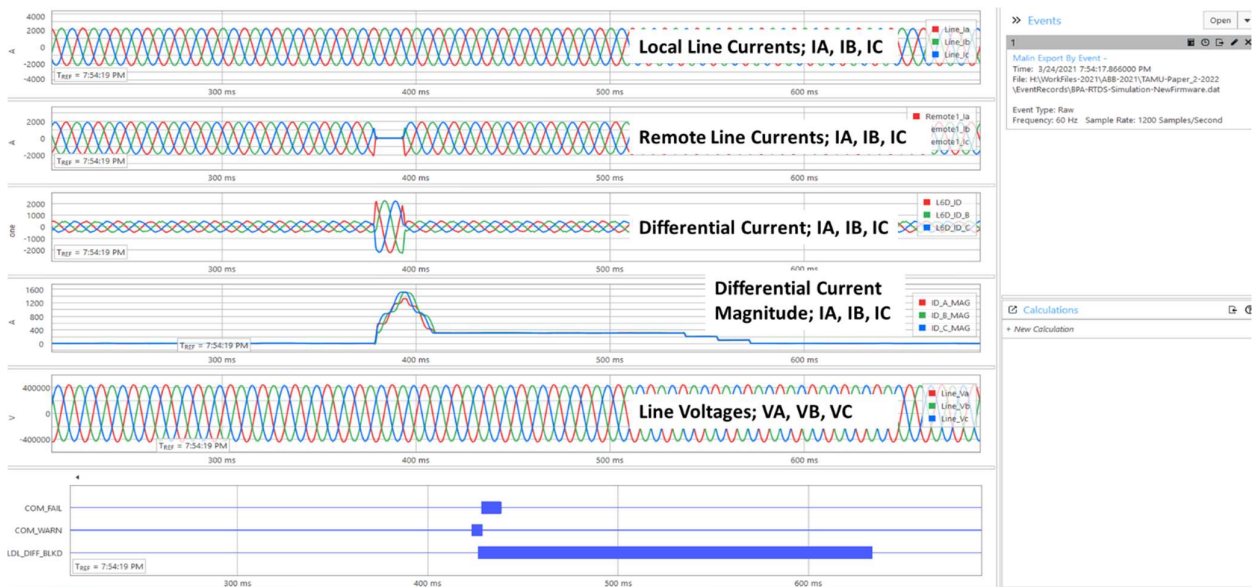
**Figure 14.** Record for series capacitor bypass test

It was noted that during series capacitor bypass test, a glitch in analog signals, similar to the one in Event 1 occurred. Its timing was also consistent and predictable: it happened about 1 second after capacitor bypass event. Figure 14 shows a record for such series capacitors bypass test. It should be noted that this test was performed with the latest approved by BPA firmware, which actually blocked differential in response to this glitch. More discussion on this is provided in Section 4.2. Relay vendor team analyzed this glitch in analog data as well.

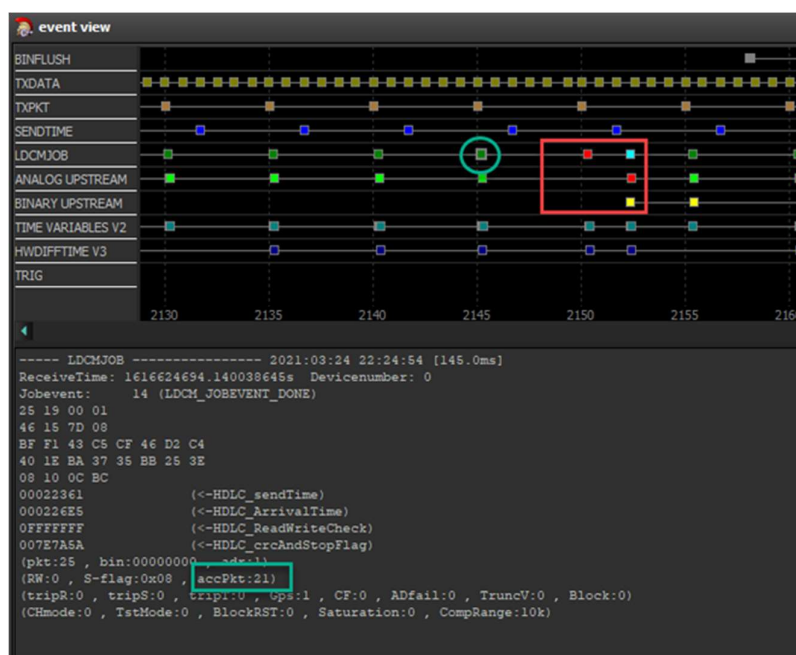
**Figure 15.** Message details for the glitch in analog data: Messages 21, 22 and 23

Message 21 arrived with healthy flags and was received correctly. Message 22, however, colored in red had multiple issues. As shown on Figure 16 below, a Cyclic Redundancy Check (CRC) error was reported, as well as a lost/discarded message. Message 23 again had valid flags and was received correctly.

Based on the above information it was concluded that the glitch in analog data was caused by lost data samples due to corrupted relay-to-relay communication message which had a CRC error. The source of the CRC error was concluded to be outside for the relays, inside BPA test setup which includes communication channel emulator and channel bank.

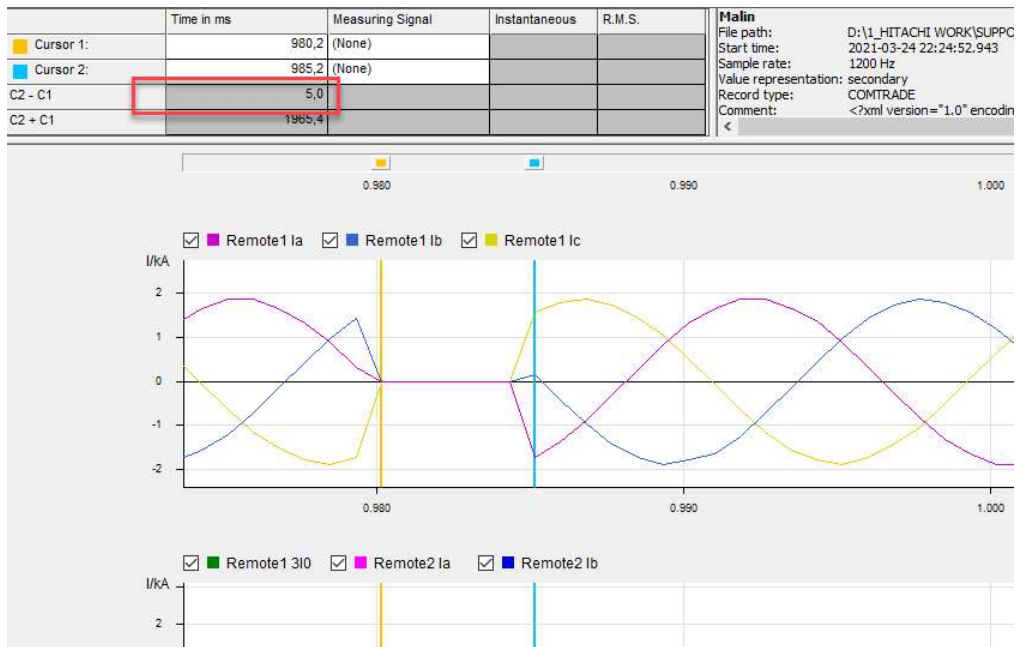
**Figure 18.** Data interruption for 5ms upon loss of a single message

Figure 18 as well show that analog samples are missing for exactly 5ms which corresponds to losing a single relay-to-relay communication message.

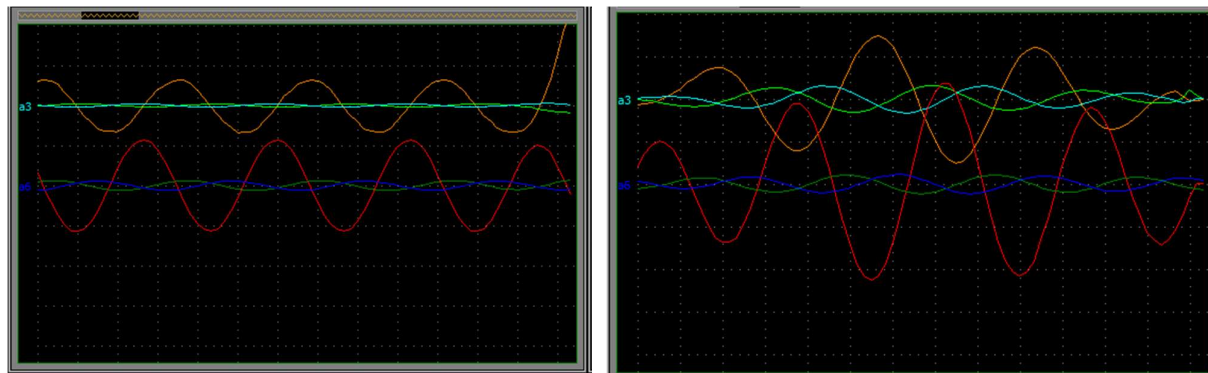
**Figure 19.** Phase difference observations before and during Event 2

Right away it was identified that a phase shift was present prior and during the event. Figure 19 shows that the same phase difference was observed.

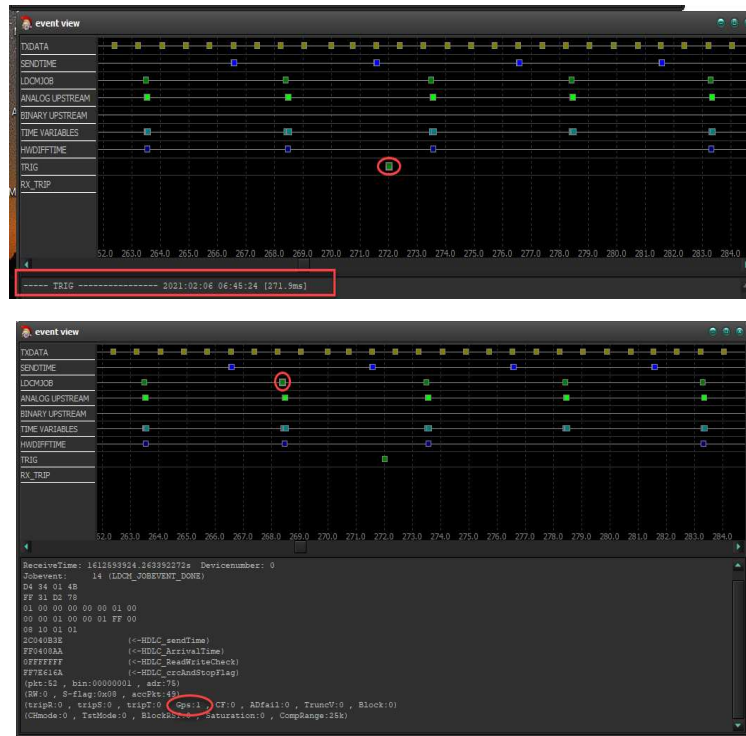
Figure 20. Malin relay log during Event 2

Analysis of internal log messages identified that both relays were in GPS mode prior and during the event, as shown on Figures 20 and 21. It was also known that clock issue at Malin was not resolved.

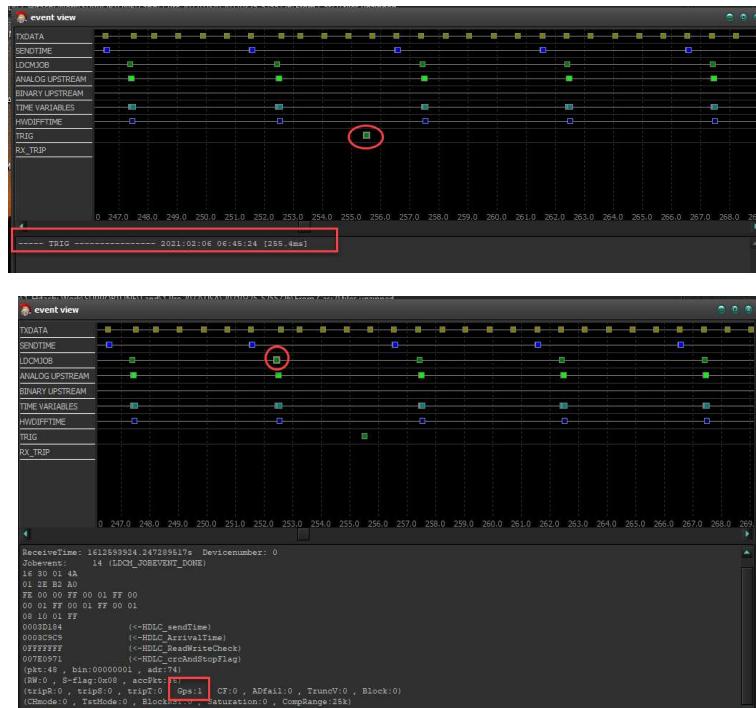
Figure 21. Grizzly relay log during Event 2

Per relay logic the  $16\mu\text{s}$  check tracks time change between internal relay clock and local GPS in sequential synchronization messages, and a constant and precise time offset of 2.1ms does not trigger a transition to Echo mode.

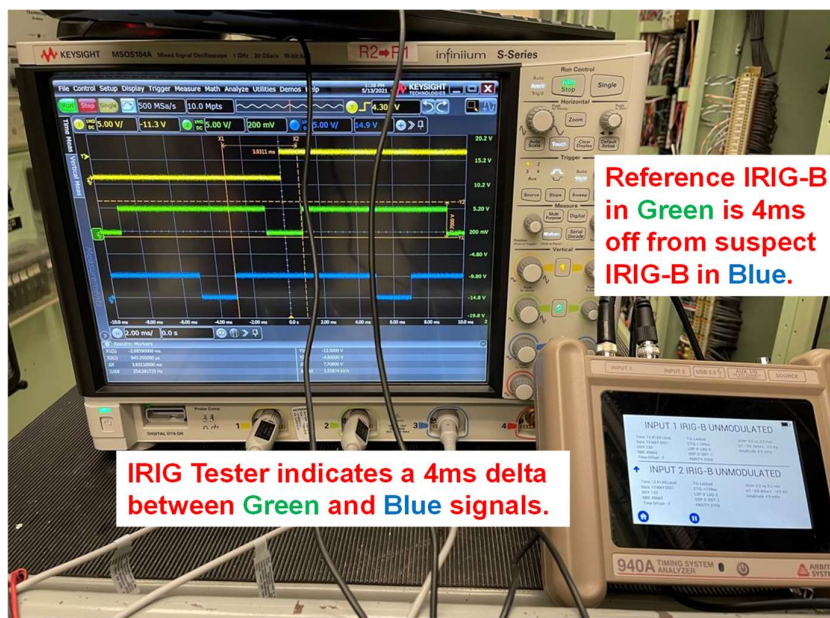
Figure 22. Oscilloscope and IRIG-B analyzer registration of 4ms clock jump

Similar behavior for a clock from the same vendor was observed after the described events. Figure 22 documents a clock jump to 4ms, as shown on an oscilloscope screen. Note that Time Quality (TQ) and

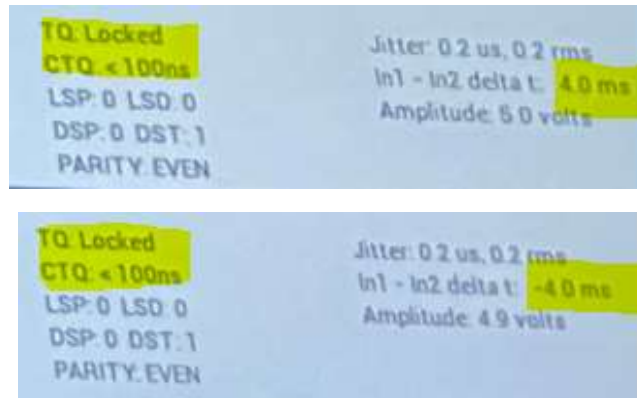
Continuous Time Quality (CTQ) fields in IRIG-B frame indicate that the clock is locked, and its accuracy is within 100ns, see Figure 23. At the same time a constant and precise time offset of 4ms is present.

**Figure 23.** IRIG-B analyzer data showing 4ms offset while TQ and CTQ fields show good quality. Another strange behavior was experienced with the same vendor clock manifested itself in on-going variations in  $\pm 2$ ms range. This was captured in a video; snapshots are provided on Figure 24.

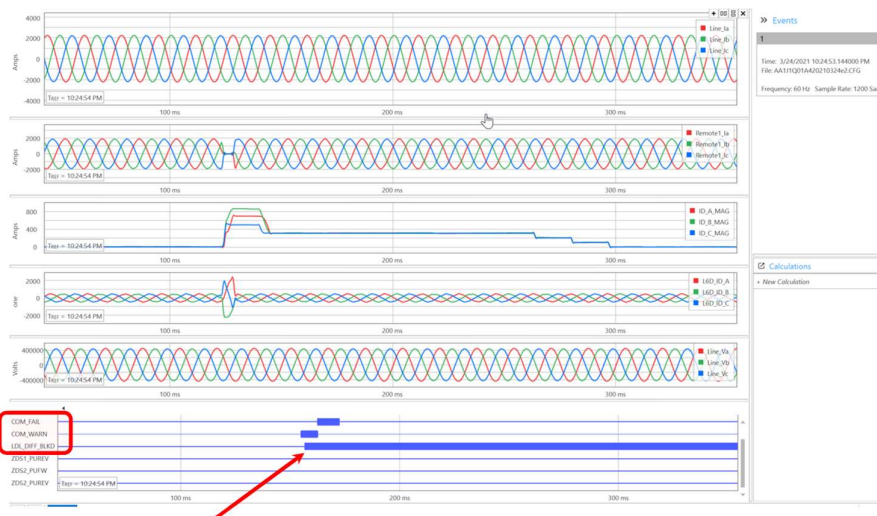
**Figure 25.** Event record captured with latest approved relay firmware

**Com Warning, Com Fail and Diff Blocked (LDL\_DIFF\_BLKD)** issued for signature *similar* to Event 1

One can note the presence of Com Warning, Con Fail and Diff Blocked signals when latest approved relay firmware was used. Differential protection got blocked. Based on this test one can conclude that the use of latest approved firmware could have prevented 87L in similar to Event 1 case.
