Open-Circuited CT Misoperation and Investigation

David Costello, *Schweitzer Engineering Laboratories, Inc.*

Abstract—A wire crimping error caused a current transformer (CT) to become open-circuited under load, a relay to operate, and an industrial plant outage. The wiring error was corrected, and the relay, internally damaged by severe overvoltage, was put back into service. Root cause analysis predicted and exposed the damage and led to corrective actions. This paper revisits the IEEE dielectric strength standard, safe design and work procedures regarding CTs, and what happens when a CT is open-circuited under load. The case study emphasizes the critical importance of commissioning tests and root cause analysis to power system reliability.

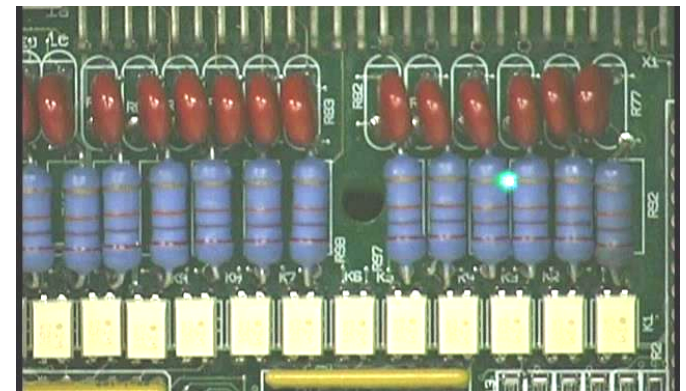
Fig. 8. Dielectric Breakdown of Relay B at 1,500 V

recommended that they do, either directly or through a third-party validated test laboratory. Fig. 8 shows the dielectric breakdown of Relay B at 1,500 V.

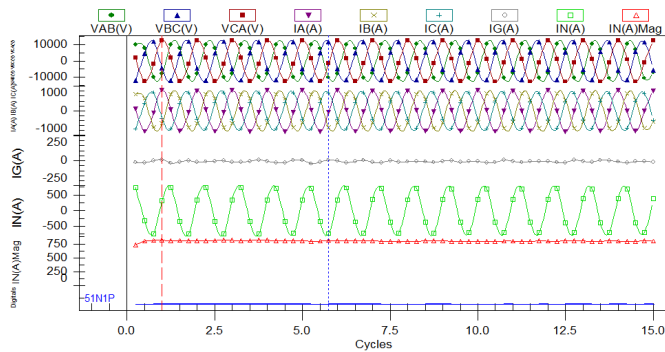
Fig. 12. 51N1P Picking Up and Dropping Out

Industrial plant personnel requested assistance from the relay manufacturer to help determine root cause of the original trip. Event records were downloaded and analyzed. Fig. 12 shows one of the first records. The phase-to-phase voltages are balanced, the three phase currents are balanced, the calculated IG current is zero, but the measured IN current is about 800 A primary. The 51N element is shown picking up and dropping out.

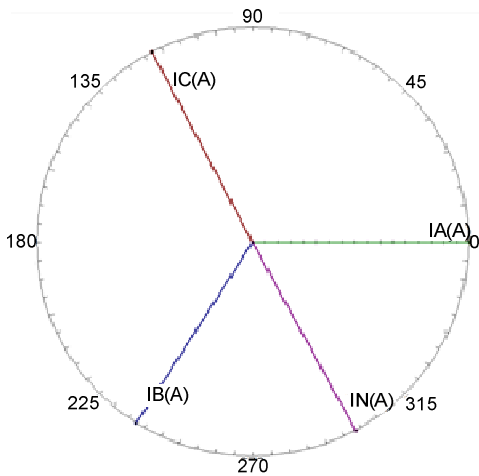
Fig. 13. Phasors at Cycle 5.75 in Fig. 12 Event

Fig. 13 shows the phasors at Cycle 5.75. Note that IN is equal to the sum of IA and IB currents (or -IC).

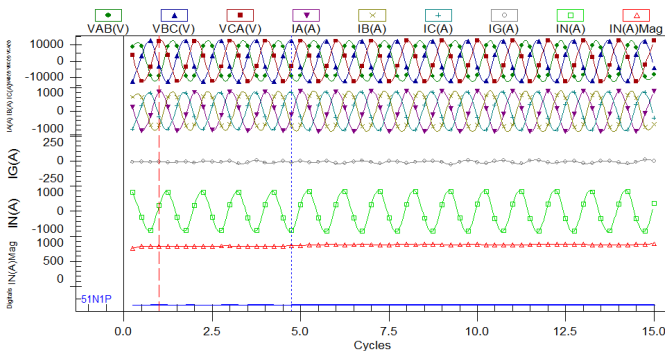
Fig. 14. 51N1P Element Timing to Trip

As the load was increased, the 51N element eventually picked up continuously and started timing to trip. Fig. 14 shows the element timing to trip.

When 51N1P finally asserted continuously, IN was equal to 817 A primary, just above pickup. At this current level and with an IEEE very inverse curve and a time dial setting of 5, the 51N element would take over 7.5 minutes to trip (see Fig. 15). Load current continued to increase, however, and IN increased in magnitude to over 900 A primary at the time of the trip. This sped up the trip time.

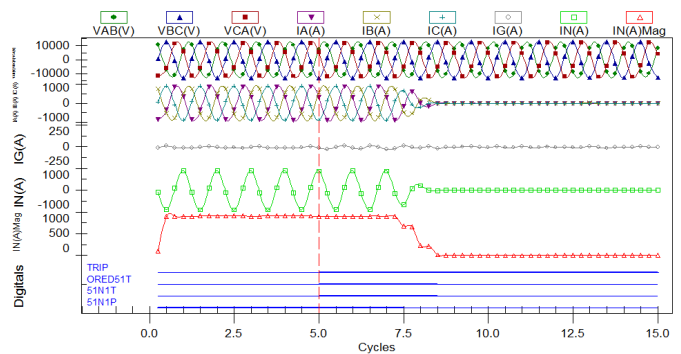
Fig. 16. 51N1T Trip

At the time of the trip in Fig. 16, note that the phase-to-phase voltages are balanced, the three phase currents are balanced, the calculated IG current is zero, and the measured IN current is near 1,000 A primary. The balanced phase voltages and currents indicate that there was no fault at the time of the trip.

There are two questions to be answered concerning the trip event. *First, why was the relay measuring IN neutral current while the three phase currents were balanced?* Because the 51N element caused the trip, this question understandably became the first priority and focus of the initial investigation. *Second, how can IG be zero while IN is large?* This question only was asked and noticed later in the investigation.

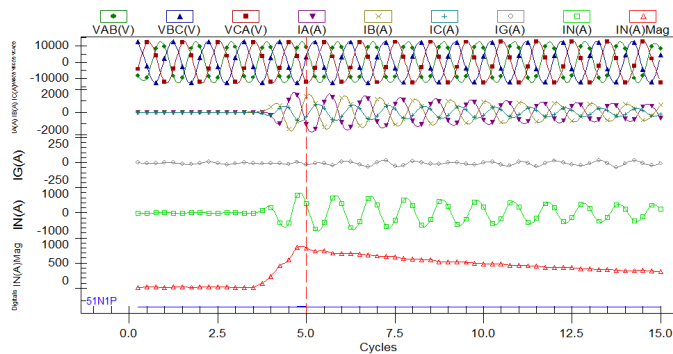
Fig. 17. Breaker Is Closed Without Root Cause Known

Event records confirm that the breaker was closed before the theory of an IN wiring problem was developed and resolved (Fig. 17). IN measuring significant current when no fault existed on the system led investigators later to suspect a wiring problem. As is the case too many times, operators were urgently trying to restore power to critical loads, and in their haste, the breaker was closed before root cause was known. After the breaker was closed, significant IN current was still present while phase currents were balanced. This led to a subsequent relay trip.

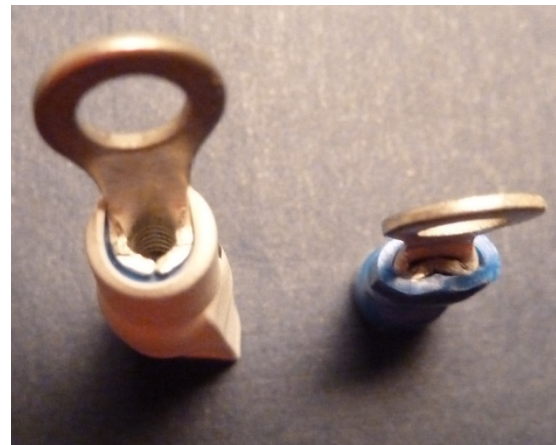
Fig. 19. Photograph of the Actual Ring Lug (Left) and Example Crimped Lug (Right)

The wire labels installed over the barrel of the ring lugs likely made visual detection of the original problem (no crimp) difficult. Subsequent relay testing, commissioning tests, and normal metering did not expose the problem because the stripped wire made decent enough electrical contact. Nonetheless, these tests should be performed because they do catch the majority of wiring problems.

The Oklahoma utility mentioned previously uses only uninsulated ring lugs and dictates that the barrel be installed to the outside and that wire and terminal labels be on the wire (versus covering the barrel) to make visual inspections easier and more effective. Fig. 19 shows the actual ring lug next to an example crimped lug. Beyond these wiring standards and visual inspections, *physically tugging on each wire to ensure the crimp is secure* is recommended as part of future commissioning checklists.

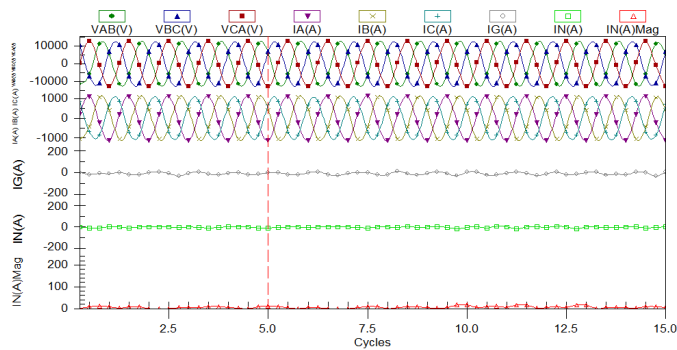
Fig. 20. Event Triggered After Crimp Fixed

Once the open circuit was discovered, the ring lug was crimped correctly, the wire was reinstalled, and the breaker was closed. Fig. 20 shows an event report that was triggered 11 days after the initial trip. The voltages and three phase currents are balanced, and I_G and I_N are both near zero. Now that everything appeared normal, some assumed that the work was over and that the problem had been solved. The breaker and relay remained in service for over two weeks.

The second question from the event analysis remained unnoticed and unanswered at the time that the crimp was fixed and the breaker was closed again. Only during later investigation did engineers focus on how I_G could be zero while I_N was so large during the events that showed the relay trip (Fig. 12, Fig. 13, Fig. 14, Fig. 16, and Fig. 17). After all, I_G is equal to the mathematical sum of the three phase currents, while I_N is equal to the physical summation. *More to the point, how could the relay measure C-phase current when a physical open or break in its circuit was visible* (Fig. 18)? Further, once the open circuit was fixed and restored to service, how was the relay measuring normal and expected values for I_G and I_N (as in Fig. 20)?

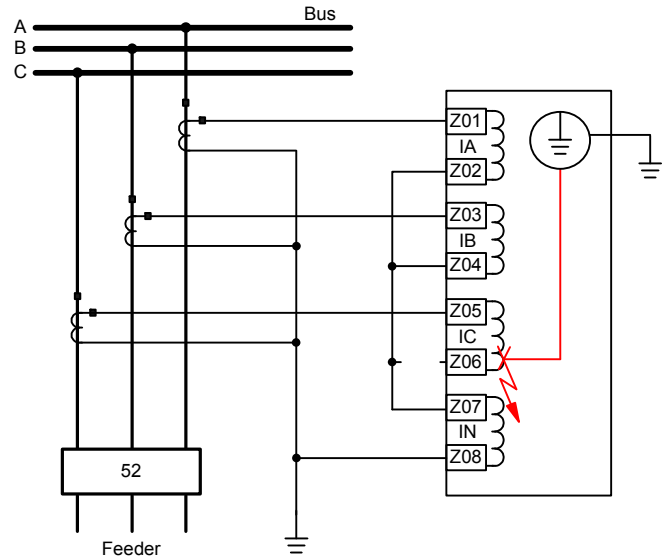
Fig. 21. Theory of Why I_G and I_N Did Not Match

Recall from the review of CT concepts that an open-circuited CT can develop dangerously high voltages. At the time of the relay trip, the C-phase CT was carrying nearly 1,000 A primary, or 2.5 A secondary, current. When the C-phase neutral connection became open-circuited, the only load or path for the CT secondary current to flow through was the very high magnetizing branch impedance (Table I, Point 1). This would have developed a very high voltage spike, driving the CT deep into saturation and decreasing the magnetizing impedance. During the next half cycle, this process would start all over again.

A theory was developed that would explain why the relay measured C-phase current while simultaneously having an open C-phase circuit external to the relay (see Fig. 21). The dangerously high voltages must have exceeded the dielectric strength of the relay, damaged the relay, and created a short circuit. In order for the relay to measure C-phase current, the short circuit to ground must have developed internal to the

relay, downstream of the C-phase current-sensing element but upstream of the open circuit at the relay terminal block.

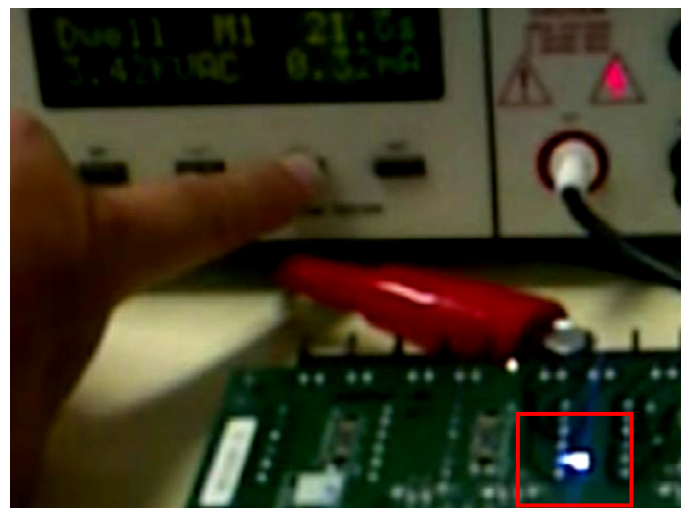
Fig. 22. Video From Dielectric Strength Test

To prove this theory in the laboratory, the relay manufacturer conducted a dielectric strength test on a circuit board from a like make and model relay. A video recording was made of this test. The relay specifications state that its analog inputs will withstand up to 2,500 Vac. This exceeds the IEEE standard minimum by 1,000 V. Voltage was applied between the polarity of IC (terminal Z05) and the relay ground. At approximately 3.4 kV, the relay failed the dielectric test. The test was repeated, and in the second test, we can observe a visible flash (see Fig. 22). No permanent damage was observed on the relay under test, primarily because the dielectric test equipment automatically shuts down the high voltage for safety when measured leakage current exceeds a threshold of about 300 mA.

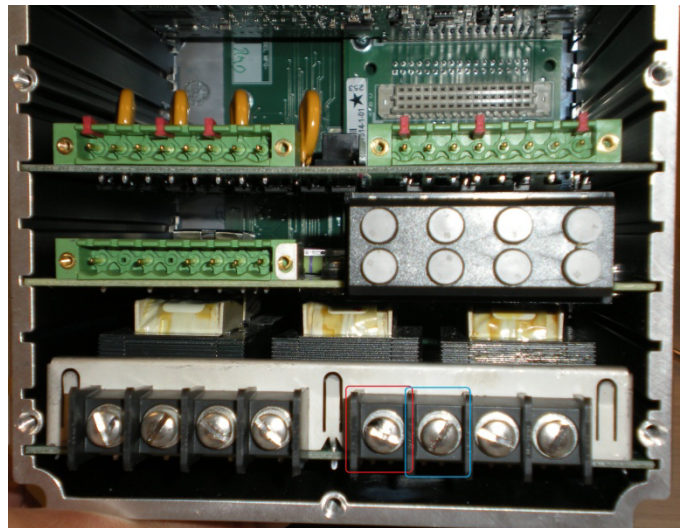
Fig. 25. Relay Rear Panel Removed to Expose Inside

Fig. 25 shows a photograph of the relay involved in this event with its rear panel removed. Compare Fig. 24 and Fig. 25. The CT terminals are visible, as are the internal instrument transformers themselves. The internal magnetics are mounted to the top of a circuit board identical to that in the video shown in Fig. 22.

With a theory and a dielectric test on a like make and model relay in hand, the industrial plant was advised that they had a damaged relay in service that needed to be removed from service and repaired immediately. After switching loads to an alternate source, the breaker and relay were removed from service for thorough inspection.

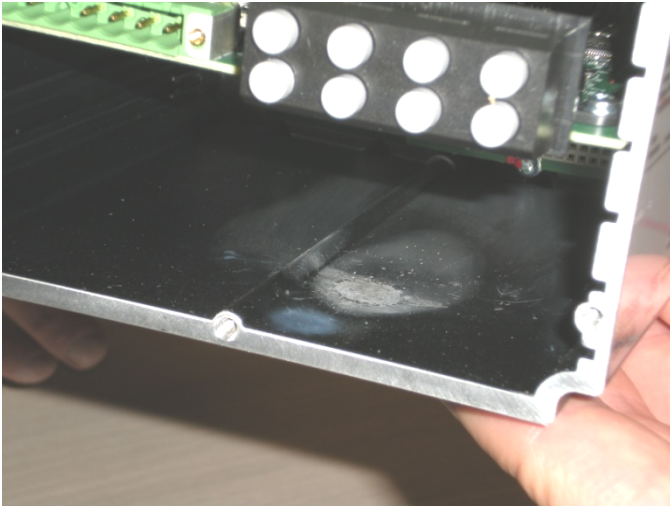
Fig. 26. With CT Board Removed, Heat and Arc Damage Evident

When the CT board was removed from the relay, the first obvious sign of damage was the heat and arcing evidence on the bottom inside of the relay chassis, directly under the CT board (see Fig. 26).

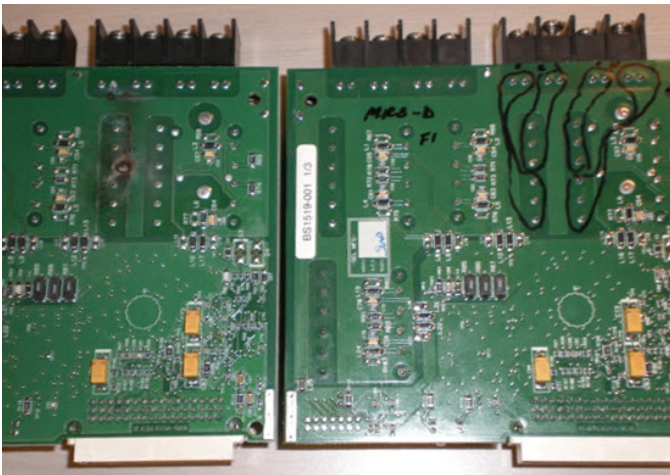
Fig. 27. Damaged Relay Board (Left) and Board From Dielectric Strength Test Video (Right)

Once the CT board was out of the relay, the circuit board damage and arc-induced short circuit were clearly visible (see Fig. 27). The circuit board on the left in Fig. 27 is the damaged board. On the right is the sample board used in the laboratory test and video.

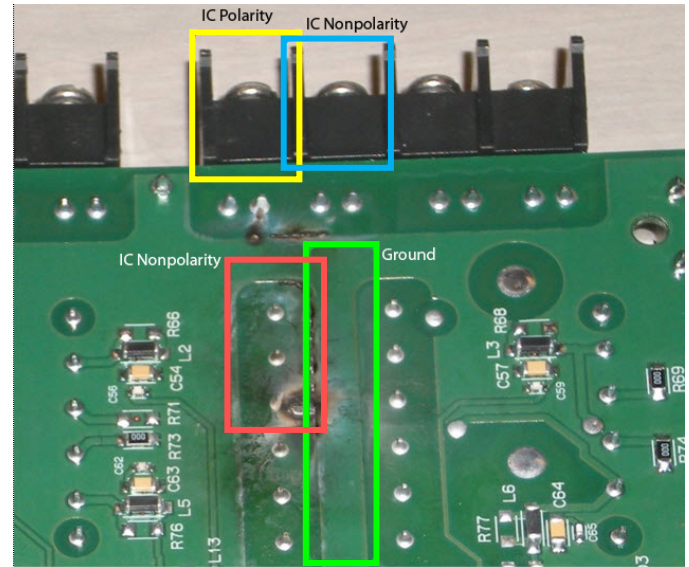
Fig. 28. Closer View of Damaged Board and Arc-Induced Weld Between Z06 and Ground

Fig. 28 is a close-up view of the damaged board. The relay transformers are mounted on the opposite side of the board. The red highlighted area, where the worst damage is, shows three through-hole pins that connect the nonpolarity Z06 terminal side of IC. The arc-induced weld from the third pin connects to a slightly lighter shade of green vertical area, which is a copper ground or reference plane in the printed circuit board. The open-circuited CT did indeed develop dangerously high voltage spikes, and these caused a dielectric breakdown, damage, and a short circuit to ground inside the relay. Once established, this short circuit to ground provided the path for current to flow through the C-phase-measuring

element within the relay to ground, while external to the relay, the neutral element only saw the sum of I_A and I_B currents.

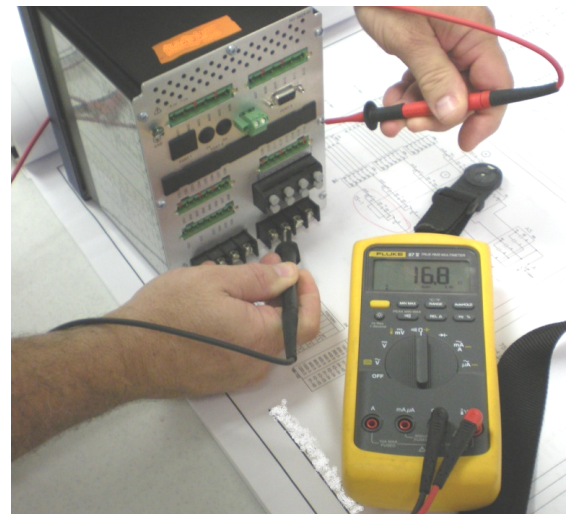
Fig. 29. Impedance Between Z06 and Ground

The impedance from Z06 to ground was measured at 16.8 ohms. This represents the impedance of the arc-induced weld on the circuit board (see Fig. 29).

On all of the other current channels, this should and did measure as an open circuit (infinite ohms). This explains why the relay, when returned to service as shown in Fig. 20, appeared normal. The external CT path wiring had a much lower impedance than the arc-induced weld to ground, so most of the current flowed through IC and on to the neutral bus.
