When Is Compensation A Bad Thing?

Problems In Applying Wye Connected Transformers With Delta
Tertiary Windings On Distribution Feeders

Steve Gooding

Georgia Power Company

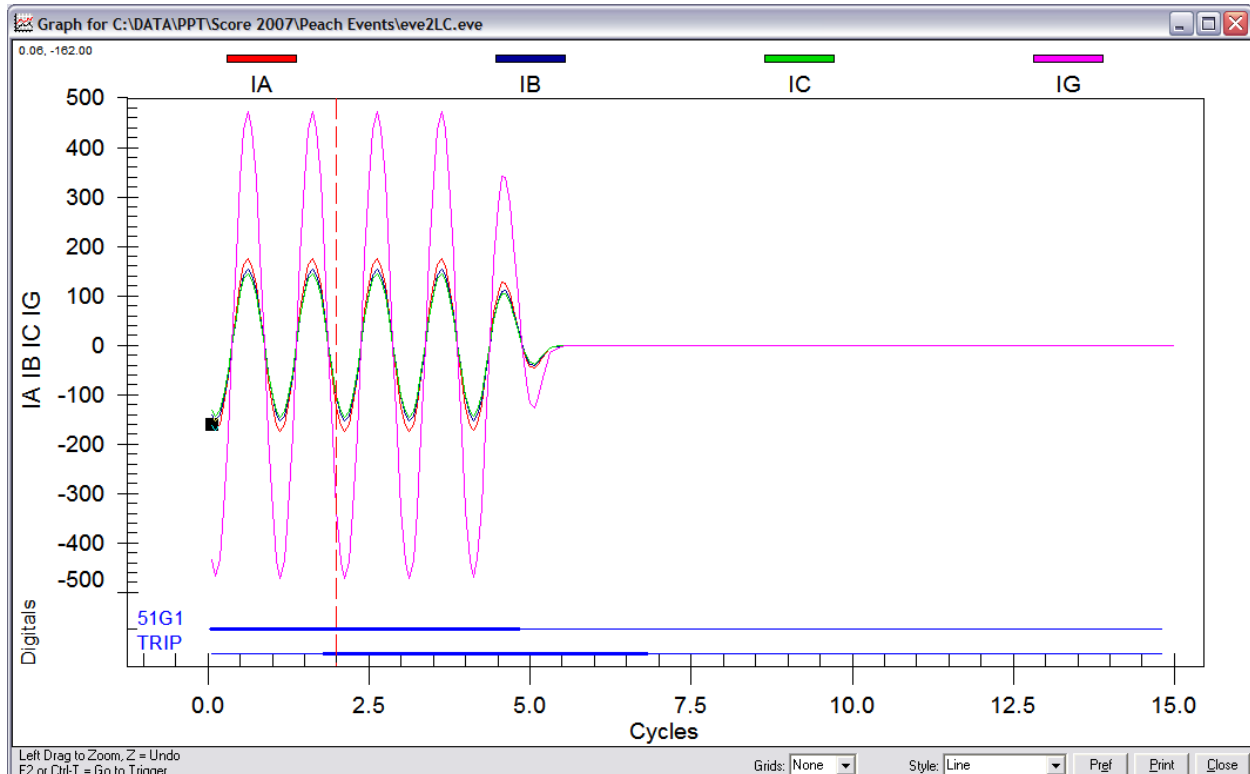
Peach Orchard - Feeder Relay Event Report

As can be seen in the event file, the phase A, B, & C currents are of equal magnitude and phase angle – a classic $3I_0$ display. The residual current is the sum of the three phases and exceeded the pickup of the residual ground time overcurrent element in the relay causing the relay to trip the breaker.

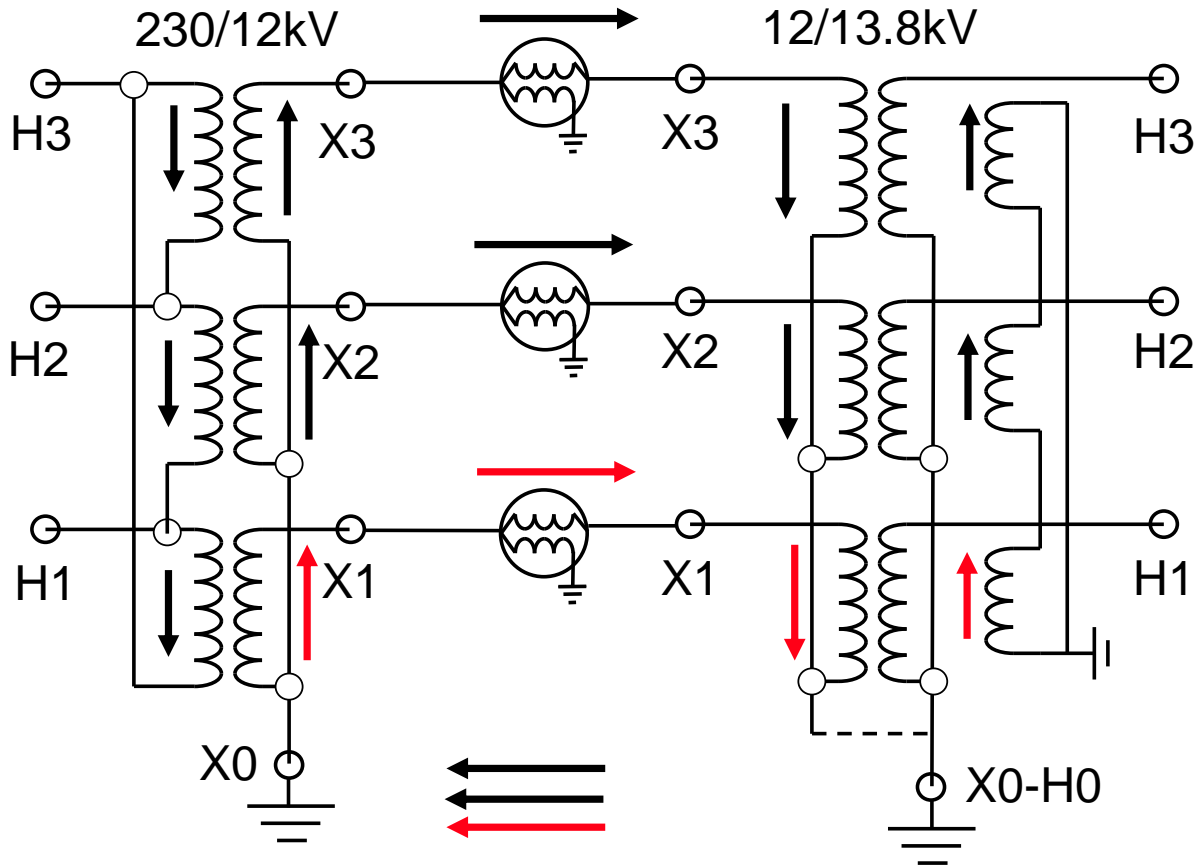
The 12/13.8kV transformer had a delta tertiary that caused the transformer to supply zero sequence current back into the 12kV bus. In this case the “runaway” regulator was driving the zero sequence current as shown in the following diagram:

In the above diagram, the red vectors indicate the current flow generated when the voltage regulator attempts to raise the voltage on one phase. The delta winding attempts to re-balance the unequal phase voltages. Current is forced into the 12/13.8kV transformer and circulates in the delta winding which then draws current from the other two phases in the station main transformer.

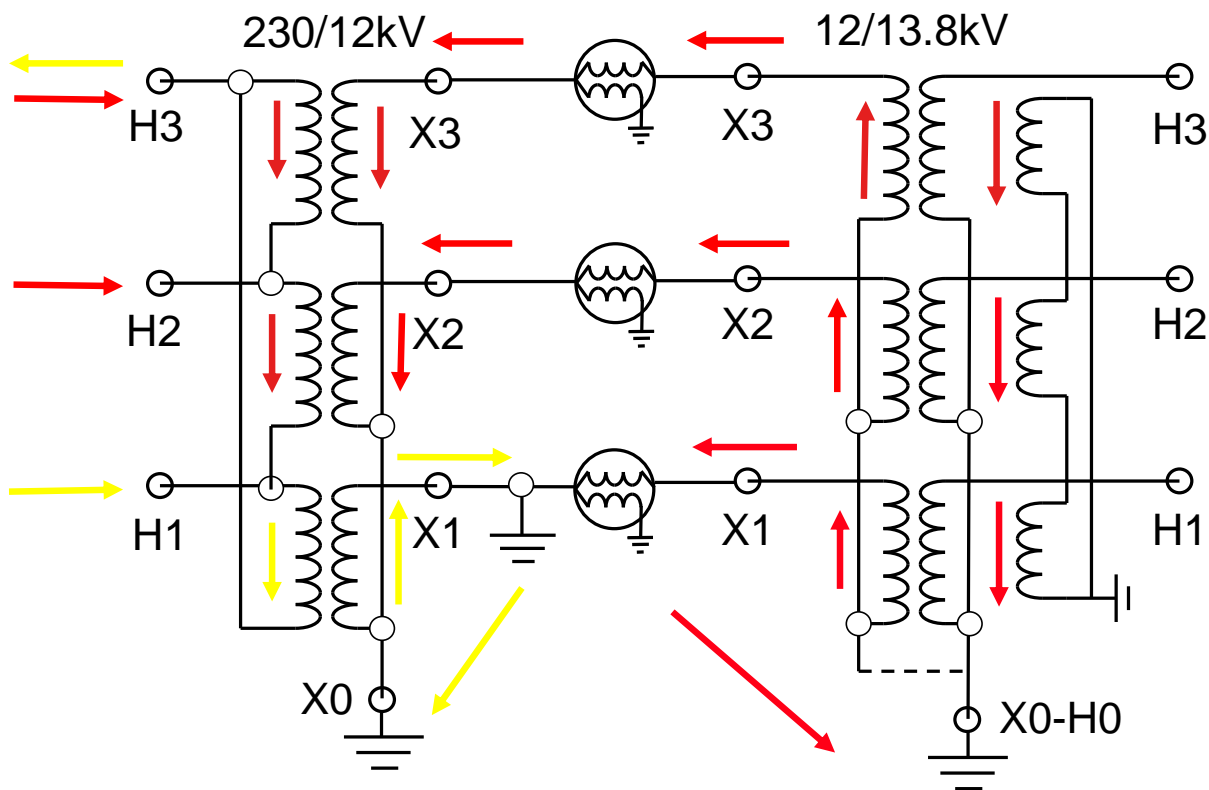
- A ground fault on the 12kV feeder will be fed by the 12/13.8kV transformer as well as the main 230/12kV bank. If the ground relay setting on the 13.8kV feeder is faster than the 12kV feeder the 13.8kV feeder could trip and possibly lock out for a fault on the 12kV feeder.
- This additional zero-sequence source will also desensitize the ground relay on the feeder breaker protecting the line and transformer for faults on the 13.8kV side of the transformer
- The backup ground relay on the main transformer neutral will be desensitized for faults on either feeder since the 12/13.8kV transformer will be supplying zero-sequence current to ground faults on either feeder.

This diagram illustrates how a fault on between the main transformer in the step-up transformer will be fed from both. The feeder breaker is omitted from this drawing for clarity, it would be located between the 230/12kV transformer and the voltage regulators.

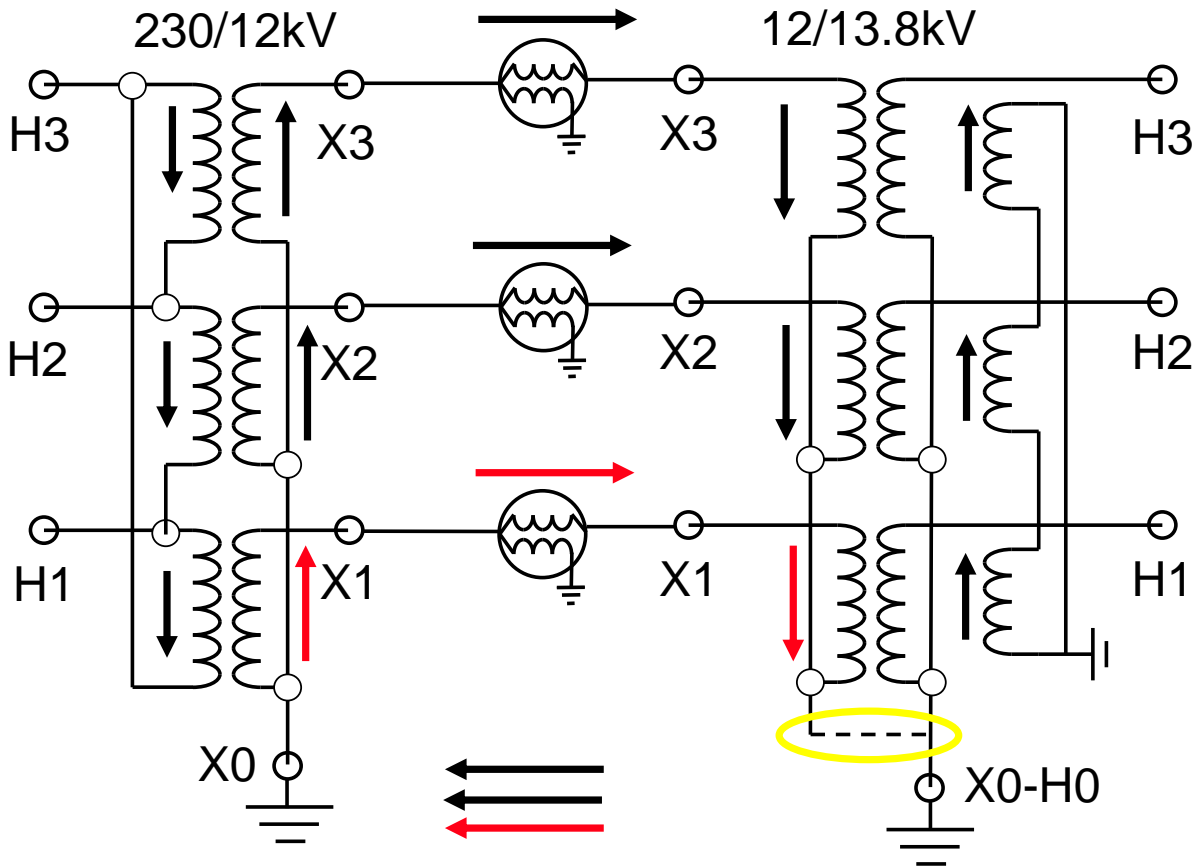
Since the X0, X1, X2, and X3 bushings are on the source side (towards the 12kV bus) this would eliminate the transformer being a source of zero sequence current back into the 12kV bus. However, this would also require bringing in a separate ground current from the 13.8kV side of the transformer to the breaker relay. In the diagram below, the current flowing into the fault from H3 of the 12/13.8kV transformer causes current to flow in the 12/13.8kV transformer delta winding. This circulating current is in turn reflected back into all three phases on the 12kV side. The current seen at X1 & X2 is $\frac{1}{2}$ the X3 current and opposite in phase angle. Because the vector sum of the currents seen in the breaker for an external ground is zero, the residual ground relay in the breaker will not operate for a ground fault on the 13.8kV feeder.

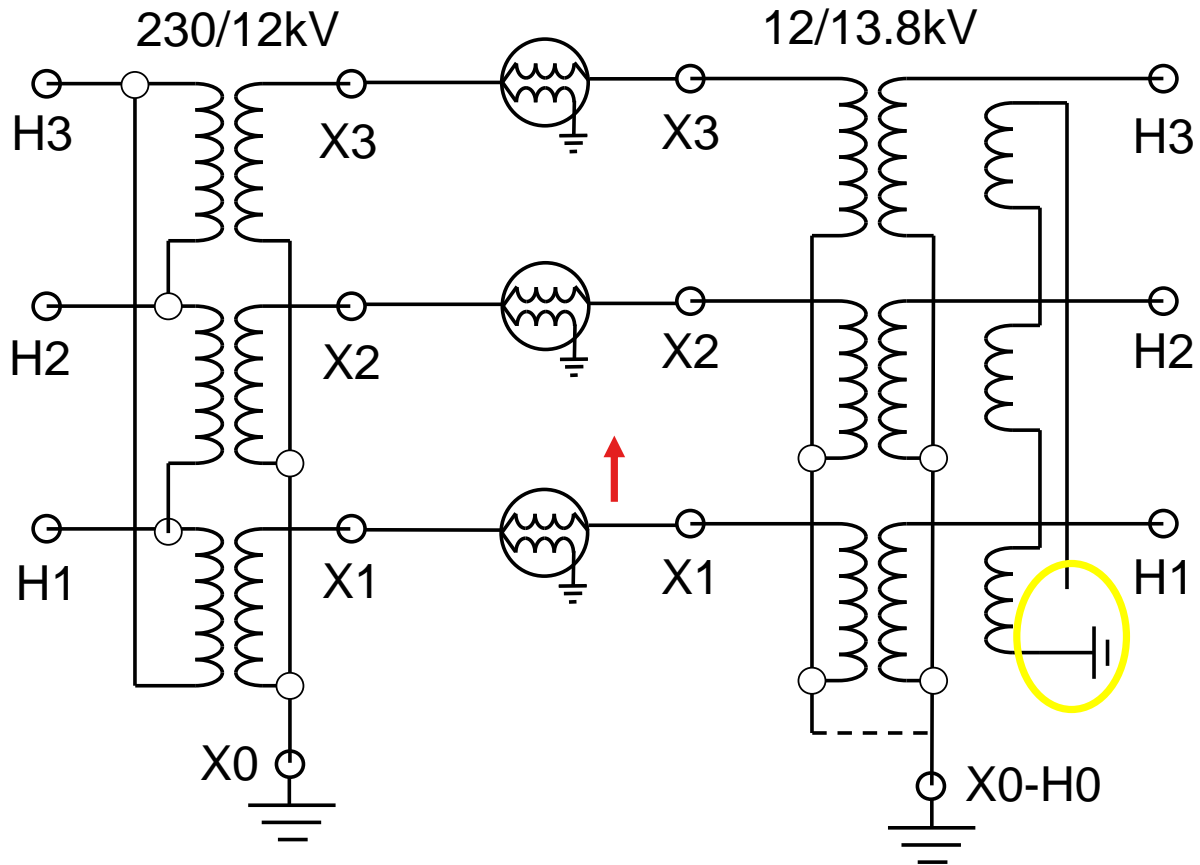
Solution #2 - Break tertiary delta connection

Without an intact delta tertiary, the transformer would no longer be a source of zero sequence current. The zero sequence current seen on the 12kV side of the transformer would be in direct proportion to the zero sequence current on the 13.8kV side. There would be no need to change the relay connections in the 12kV source side breaker.

This will increase the zero-sequence impedance somewhat, but this transformer is a 3-phase, 3-legged design, which means that the magnetic circuit (core) is "OPEN" for any zero phase flux. For this reason, it is unlikely that eliminating delta-connected tertiary will cause any problem. For any other core design, such as shell form, 4 or 5 legged, or bank of single phase units, it is most likely required to have a delta connected tertiary as a "stabilizing" winding.

Solution #2 was chosen for Peach Orchard. The tertiary winding was opened. The leads from one corner of the tertiary were connected to a grounding lug near an access cover on top of the transformer. One lead was removed and smoothed off to prevent corona, insulated, and tied clear of any other leads or windings.

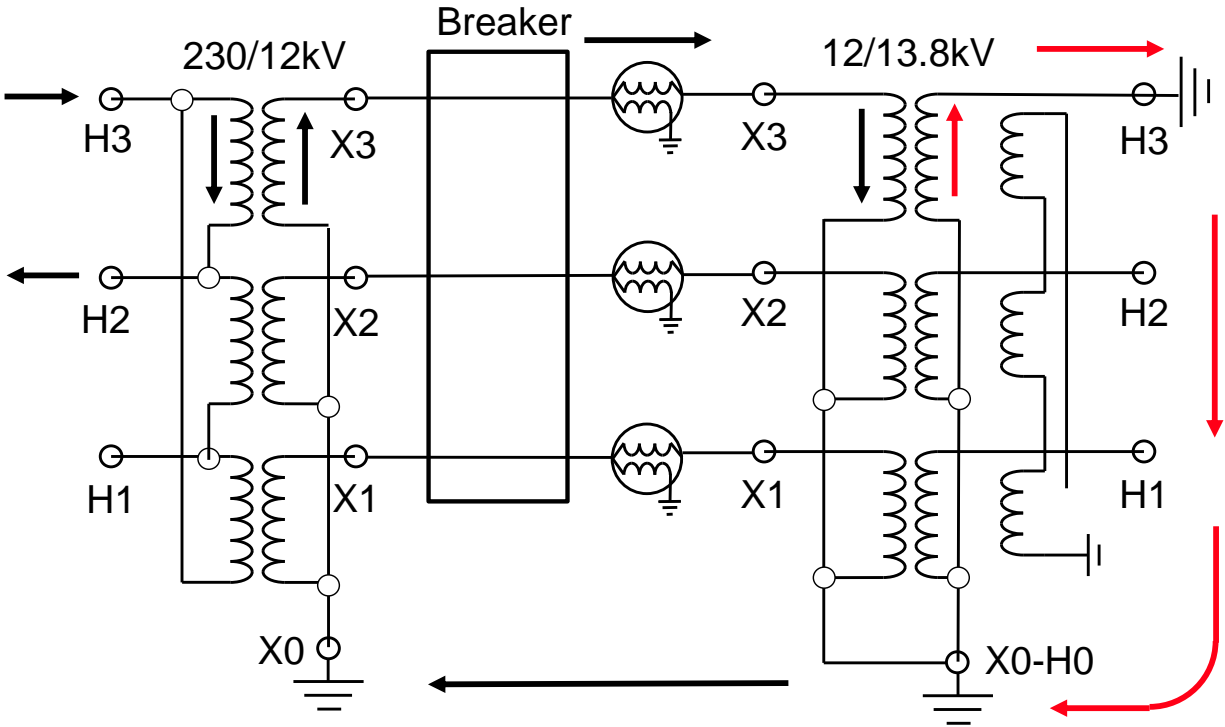
Line to Ground fault on feeder with delta winding broken

With the delta tertiary winding broken, the currents on the 12kV side of the 12/13.8kV transformer are now directly proportional to the current on the 13.8kV side. This makes it simple to set the breaker relay to protect for faults out on the 13.8kV line.

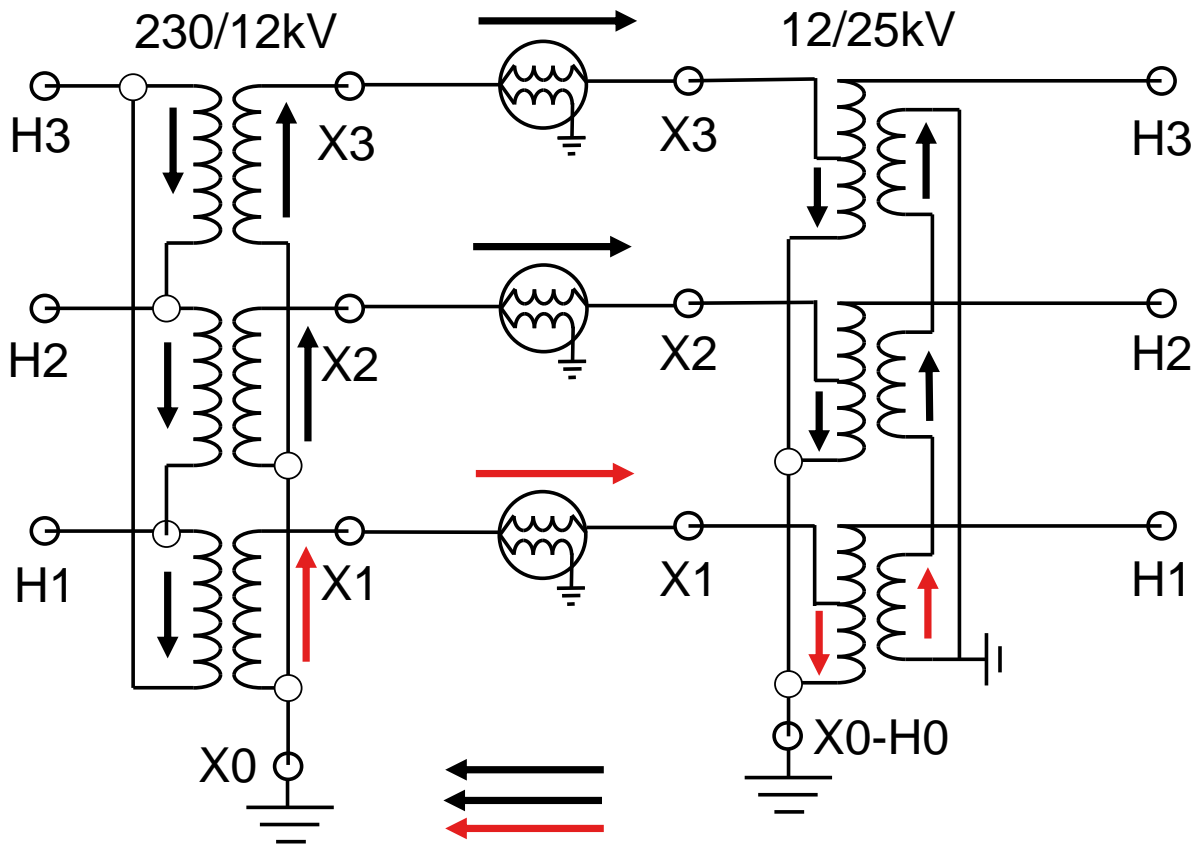
Looking at the 12/25kV transformer nameplate it was noted that just like Peach Orchard, this transformer had a delta tertiary winding. This transformer is an autotransformer where Peach Orchard was wye-wye but the problem is exactly the same. When a single phase voltage regulator tries to change the voltage the delta tertiary tries to rebalance the voltage causing current to circulate in the tertiary and this circulating current is then reflected back into the source side of the transformer.

Current flow in wye-delta auto when a regulator pushes circulating current through the 2 wye-delta connections.

The owner of the substation decided to break the tertiary winding as we did at Peach Orchard. This was done and the problem was solved.

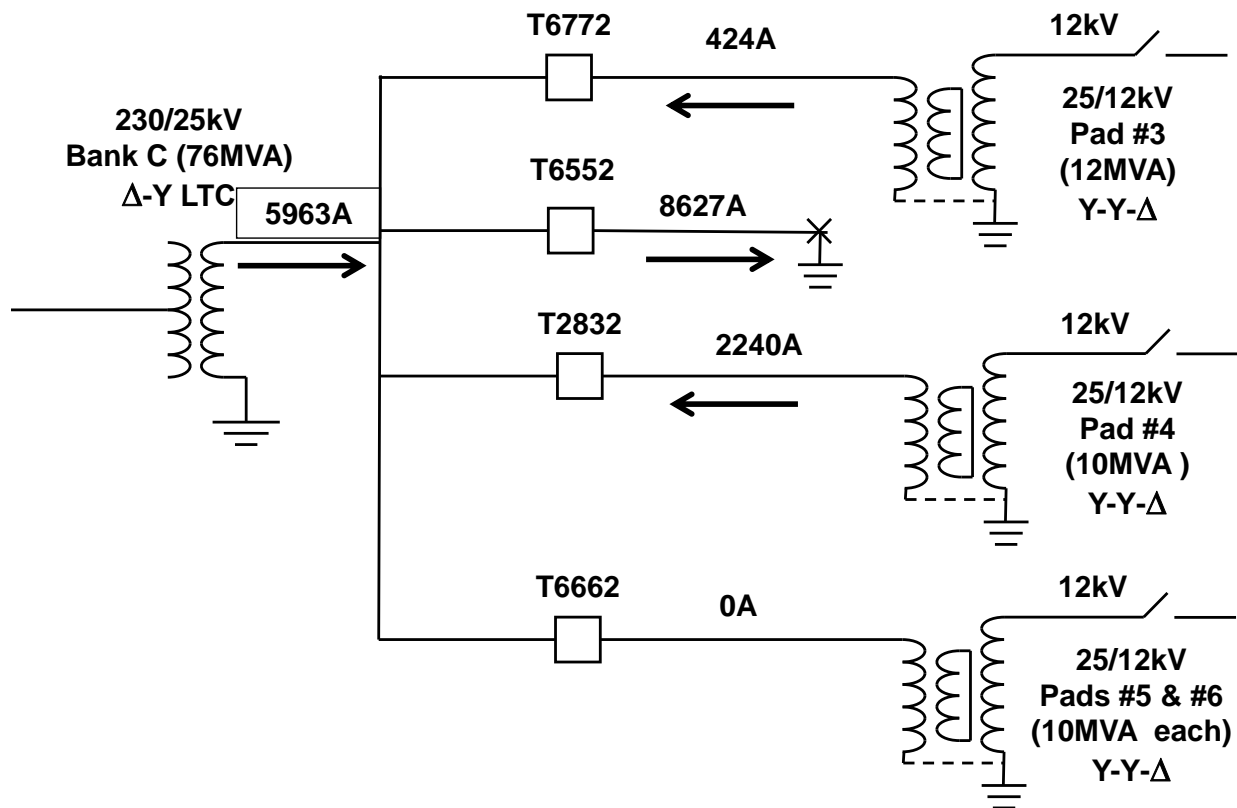
A Georgia Power customer, QTS is fed by 6 padmount transformers connected through switchgear with multiple throw-over schemes between 4 feeders. Overcurrent protection is also provided on the 25kV side of the padmounts. A fault occurred on overhead feeder T6552 which caused the switchgear on padmount #4 connected to feeder T2832 to trip on overcurrent.

Initially it was assumed that the trip was caused by sympathetic inrush, but an examination of the event records showed that current flowed from the padmount into the distribution bus.

Same as Peach Orchard and Busbee Parkway, the decision was made break the tertiary winding.

In this case removing the the ground connection on the 25kV side would also have solved the problem, however breaking the tertiary was chosen to be consistent with other distribution padmounts not containing delta tertiary windings.
