A Tale of Two Out-of-Phase Synchronizing Events at BC Hydro

Mukesh Nagpal and Lesley Gu, *BC Hydro*
 Ralph Barone, *Barone Technical Consulting Services Ltd*
 Ritwik Chowdhury and Michael Thompson, *Schweitzer Engineering Laboratories, Inc.*

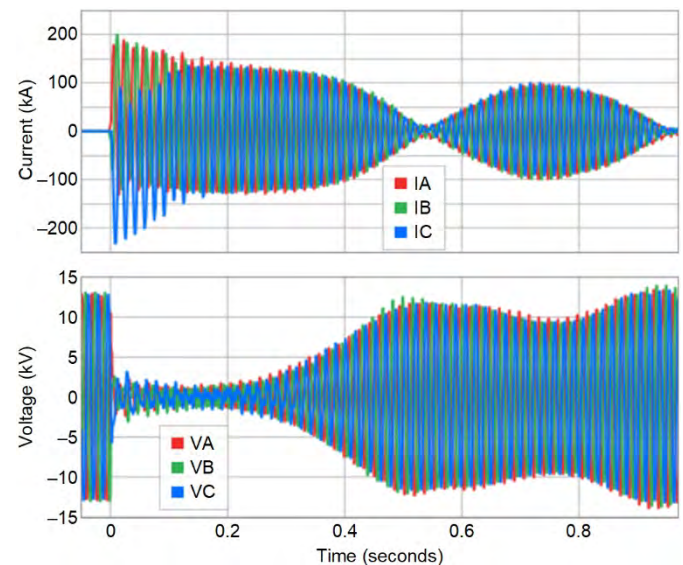
Fig. 2. Second OOPS event (December 7, 2021).

After the 30-hour-long T3 Heat Run Test completed, G3 was taken offline. The commissioning crew started to suspect that something had gone wrong, because there should have been minimal transient from the perfect manual closing via synchroscope. However, the transient data measured by the generator relay illustrated the opposite—a disturbance that was well beyond the size of a typical synchronization disturbance, with 232 kA peak current. This event report is shown in Fig. 2.

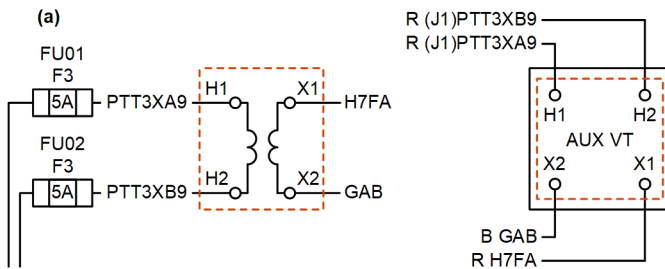
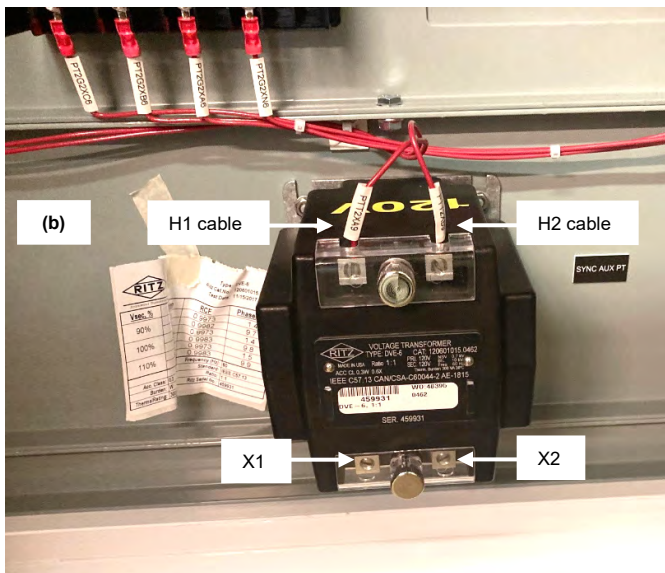
Fig. 3. Wiring drawing (a) and photo of terminal connections with error (b).

auxiliary VT replacement. It found that the polarities of the VTs had been connected backward. Unfortunately, all three devices (autosynchronizer, synchroscope, and sync-check relays) shared the same auxiliary VT source, which introduced a common-mode failure among all the synchronizing devices and caused them to fail simultaneously. The inverted polarities of the auxiliary VT resulted in a 180-degree OOPS event, despite an ideal synchronizing indication from the synchroscope.

The investigation then focused on why the wiring error occurred in the first place, and why it was not caught during commissioning. Fig. 3a shows the auxiliary wiring drawing and Fig. 3b shows a photograph of the auxiliary VT in the panel before the panel was installed. The VT is mounted at the bottom of the panel, which makes the terminal labels hard to see. The installer, instead of confirming the physical labels on the VT terminal block, assumed that the wiring drawing represented the actual physical layout. In the wiring drawing, X2 is below H1 and X1 is below H2. However, the physical layout on the VT terminal block is actually the other way around—X1 is below H1 and X2 is below H2.

- The synchronizer and any synchronism-check devices should be connected to independent circuits and separate VTs. This helps eliminate a common-mode failure from wiring and VT polarity errors.
- After modifications, wiring and polarity integrity should be verified before the synchronizing system is exercised for the first synchronization. The wiring and polarity can be checked by measuring the voltages at the terminals of the synchronization system (as supplied by VTs) when the unit is running and is synchronized using another system that is known to be functional.

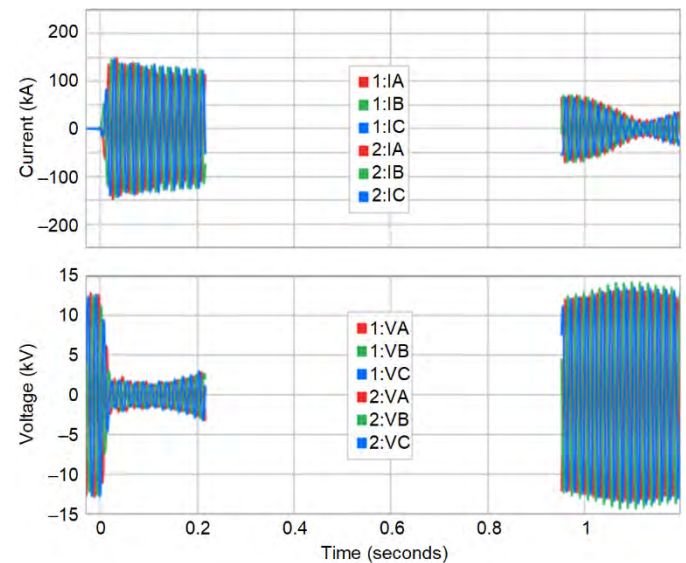
Fig. 4. First OOPS event (December 3, 2021).

The event data for the first event were from a filtered record, which does not capture the dc offset or harmonics. This event report is shown in Fig. 4. Because better data were required for some of the analyses, the event record for the second OOPS event (Fig. 2) is used for the rest of the discussions in this paper.

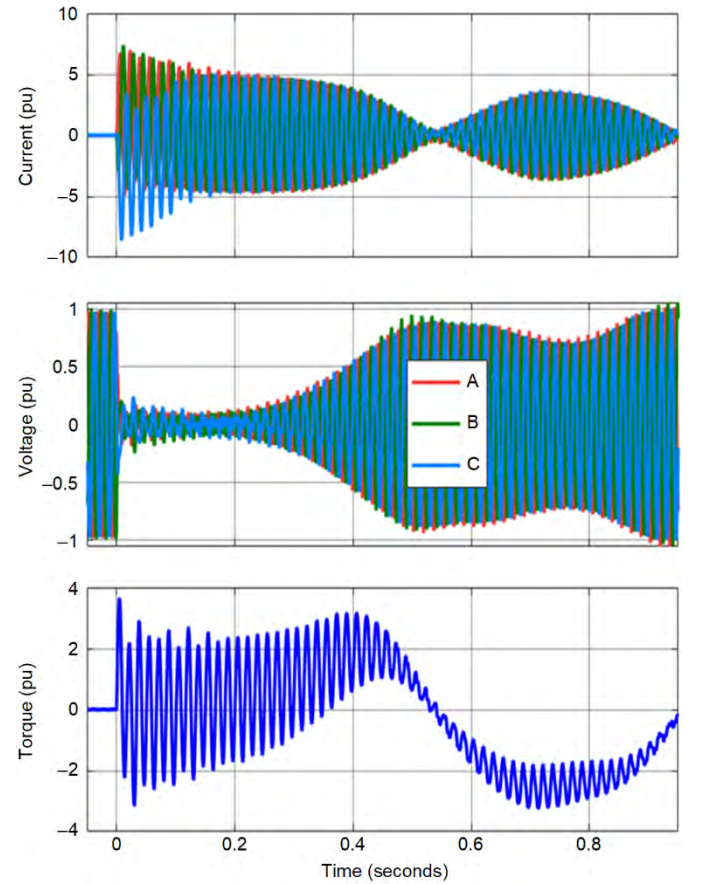
Fig. 8. Calculated torque during OOPS event.

With the use of the Z_{1SYS_MIN} parameter, the associated torque is 0.972 pu. If the system is made infinitely strong, with a Z_1 of 0 pu, then the associated torque is 1.06 pu. A 10-degree synchronizing angle, considering the impedances of the generator and the GSU, results in a transient torque that is very close to the generator rated torque. Therefore, using a per-unit torque calculation to get an indication of the severity of an OOPS event to the generator shaft and prime mover is a reasonable approach.

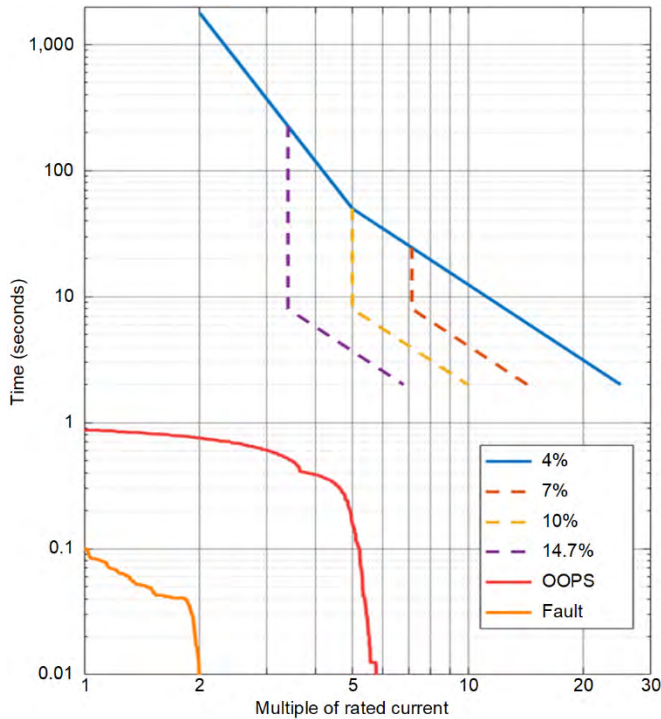
Fig. 9. Time overcurrent during events plotted, with respect to the standard Category IV transformer characteristics.

The standard characteristic in this figure, which the transformer is designed to withstand, has multiple curves for high currents because the transformer impedance limits the fault current from exceeding the upper values. For instance, for a transformer with a 10-percent impedance, the upper limit of the withstand characteristic ends at 10 times (100-percent voltage/10-percent impedance) the transformer rated current.

Considering the margin with the withstand characteristic, and considering through ground faults that can result in high fault currents in a GSU winding, this paper concludes that the torsional damage to the shaft is possibly a bigger concern [5] than overcurrent damage to the GSU winding during OOPS

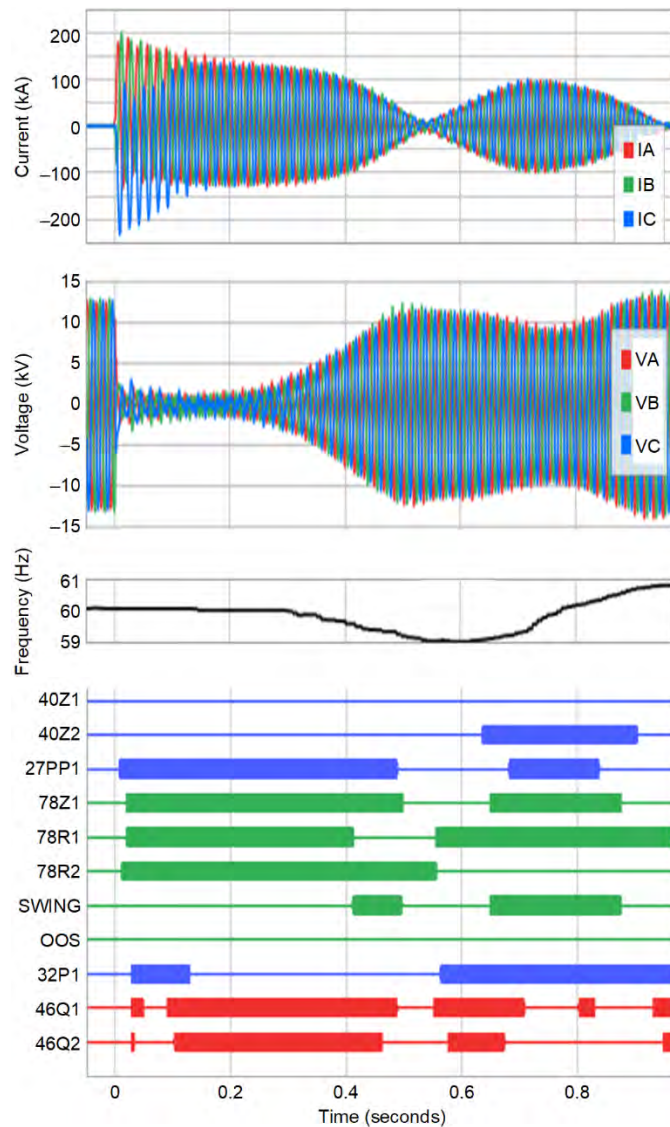
Fig. 11. Response of protection elements during OOPS event.

During both OOPS events, several of the common generator protection elements [9] [10] picked up. However, none of these elements tripped. The behaviors of the different generator protection elements are discussed in this subsection [11]. An event report with the response of the protection elements is shown in Fig. 11.

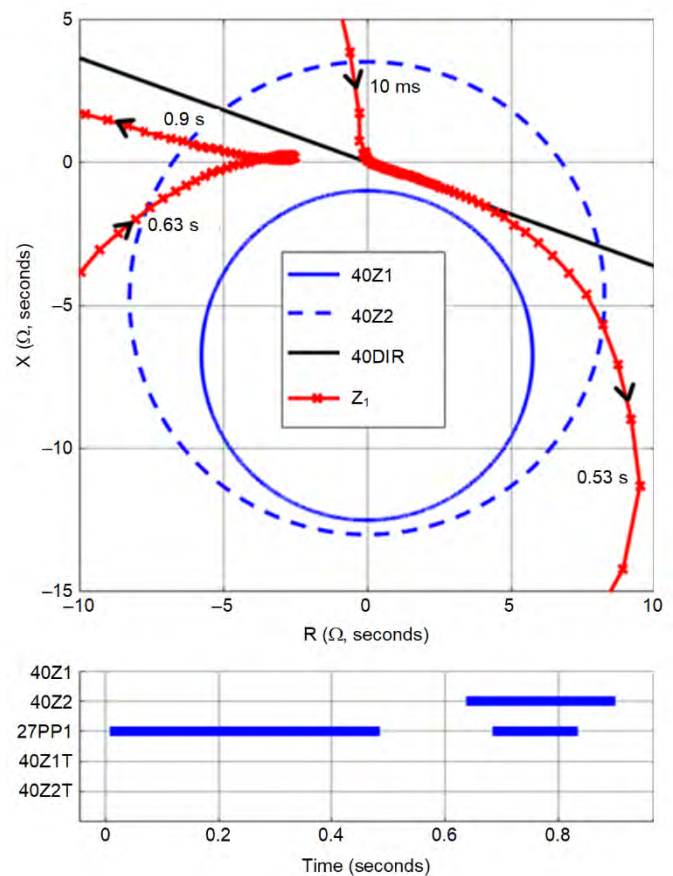
Fig. 12. Loss-of-field element response during OOPS event.

Immediately after the OOPS event, the impedance locus entered the Zone 2 mho characteristic but remained above the directional line; therefore, Zone 2 did not assert. If the directional line were set with a lower tilt of -10 degrees, then Zone 2 could have tripped on the accelerated path, because the undervoltage lasted about 0.47 seconds. The impedance locus never entered Zone 1.

After 0.63 seconds, the impedance locus entered Zone 2 from the left. This time, the directional check was satisfied, but the undervoltage condition lasted about 0.15 seconds; therefore, the element did not trip on the accelerated path.

This was not a loss-of-field event, and the protection element did not trip. However, it is clear that the element could have tripped on Zone 2 if the conditions were slightly different or if the directional element was set with a lower tilt of -10 degrees.

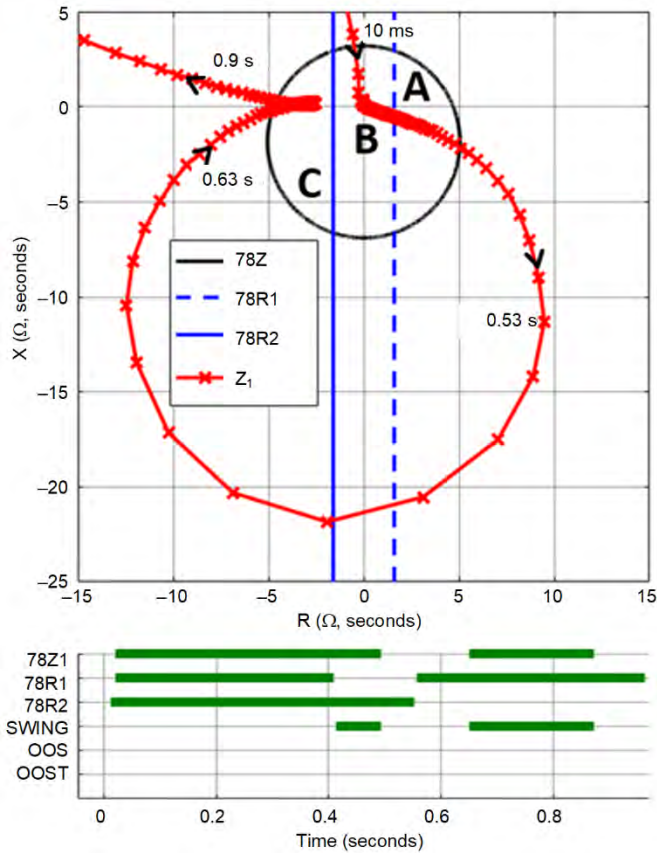
Fig. 13. Out-of-step element response during OOPS event.

The generator had no load prior to switching and was subjected to out-of-phase closing (the initial rotor position was 180 degrees). Immediately after the breaker closed, the impedance locus entered Region B from about 90 degrees. Even if it had entered from the right, the scheme requires the impedance locus to remain in Region A for at least three samples to ensure that it is a swing with slow trajectory and not a fault with fast trajectory. Because the initial change associated with the OOPS event was sudden, as it would be for a fault, the element did not classify it as a power swing.

After 0.65 seconds, the swing locus entered Region C. The impedance locus moved slowly and behaved like a swing; therefore, the SWING bit asserted. However, the characteristic never entered Region B and, therefore, was not classified as an out-of-step condition because the swing remained stable. This is also visible in the currents and voltages of Fig. 11, where the system recovered. If the swing had become unstable, and the associated impedance locus moved from Region C to Region B and then exited from Region A, the single-blinder scheme would have been expected to trip.

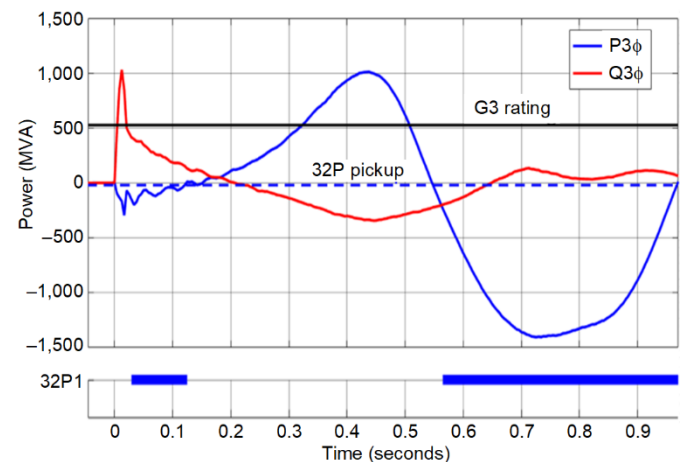
Fig. 14. Reverse power element response during OOPS event.

The reverse power element response is shown in Fig. 14. It asserted initially for about 100 milliseconds when the machine motored slightly. Then, after 0.56 seconds, when G3 absorbed nearly 3 pu real power, the element asserted for about 0.42 seconds. The element never timed out to alarm or trip during this event because of the oscillations.

The reverse power element did not trip during the transient, but it could trip later, during load, for OOPS events caused by other wiring errors. If the VTs used by the generator relay are inverted in polarity and the machine starts generating, it can appear as if the machine is motoring to a reverse power relay. However, this is not a reliable indicator. As was the case here, the VTs used by the generator relay could be wired correctly.

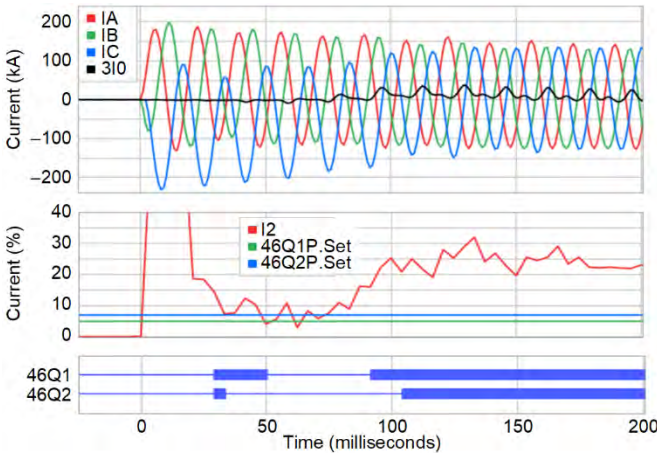
Fig. 15. Presence of I_2 and I_0 due to CT saturation during OOPS event.

The response of the element is shown in Fig. 15. This event had balanced currents, but there is evidence of dc CT saturation at about 50 milliseconds, where the C-phase current lost its dc component quickly. In this raw event record, the other set of phase CTs associated with the differential was not available, so the residual current ($3I_0$, shown in black in Fig. 15) was used to get a clearer indication of saturation. This is a sound approach for analysis because the high-impedance grounding meant that $3I_0$ was not expected. The $3I_0$ crept up when the CT saturated, as shown.

The I_2 magnitude associated with the saturation, ignoring the initial filter transient and pole scatter, increased to a value of about 30 percent of the generator rating, before it started to decrease and eventually dropped to zero at about 0.5 seconds (not shown). The protection worked correctly because it was intended to not operate on switching operations introducing I_2 transiently from unequal saturations of three-phase CTs. A value of about 30 percent is associated with a current unbalance element trip time of about a minute. CT saturation should not be relied on to detect this condition, even though (as explained later in Section IV.D) it sometimes causes a sympathetic trip during an OOPS event.
