Western Protective Relay Conference 2022

Power Plant Protection Event Analysis and Condition Monitoring

Steven Turner

Senior Engineer – Arizona Public Service (APS)

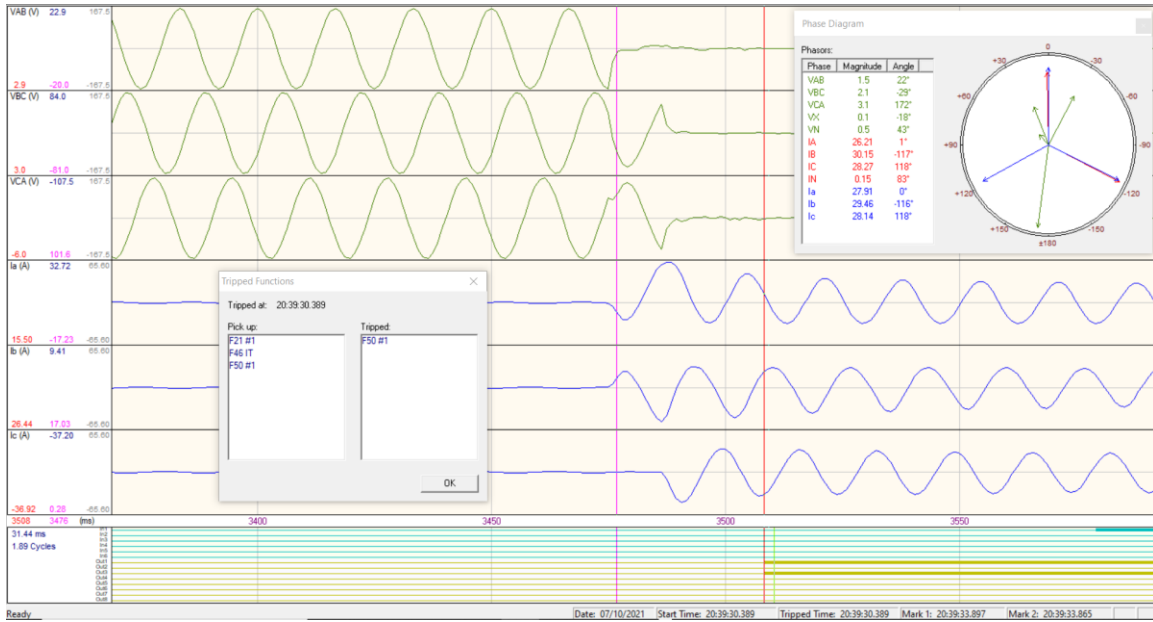
FIGURE 1. Oscillography for 1st Event

A large gas combustion turbine generator experienced a close-in three-phase fault during a summer rainstorm. The generator terminal voltage is rated 13.8 kV line-to-line and the machine is high impedance grounded. The phase VTs are connected open delta. Figure 1 is the corresponding oscillography captured by the generator protection relay.

The fault was located close to the phase VTs and just external to the generator differential zone of protection. The fault was properly cleared by the 50 high set phase instantaneous protection which operated just under two cycles following fault inception. The generator breaker tripped open four cycles later. Pre-fault load current was 50 percent of rated full load.

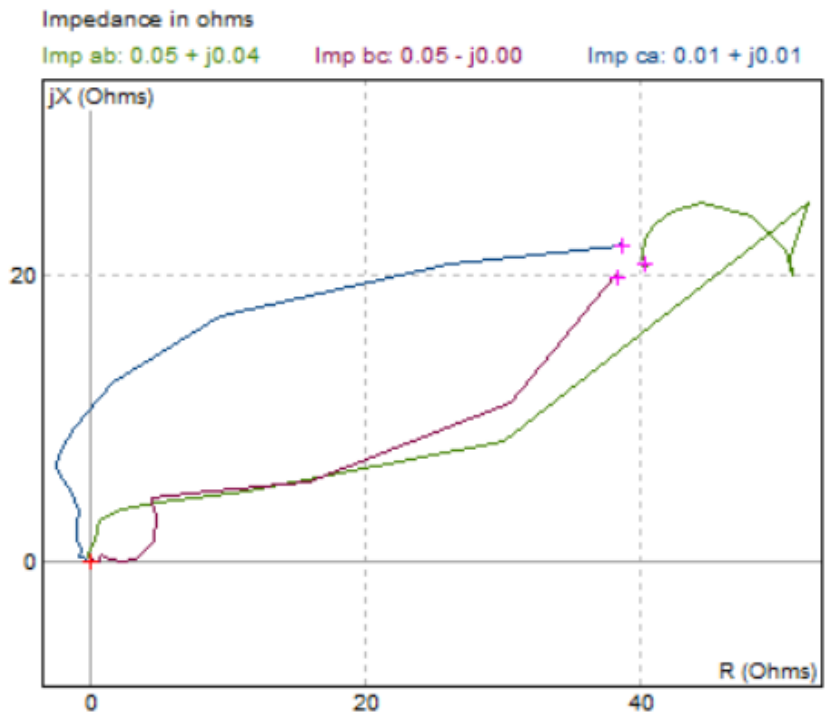
FIGURE 2. Fault Impedance Measured by Generator Protection Relay

Figure 2 shows the fault impedance Z_{AB} , Z_{BC} and Z_{CA} measured by the generator protection relay. The pre-fault load impedance drops close to zero ohms following fault inception.

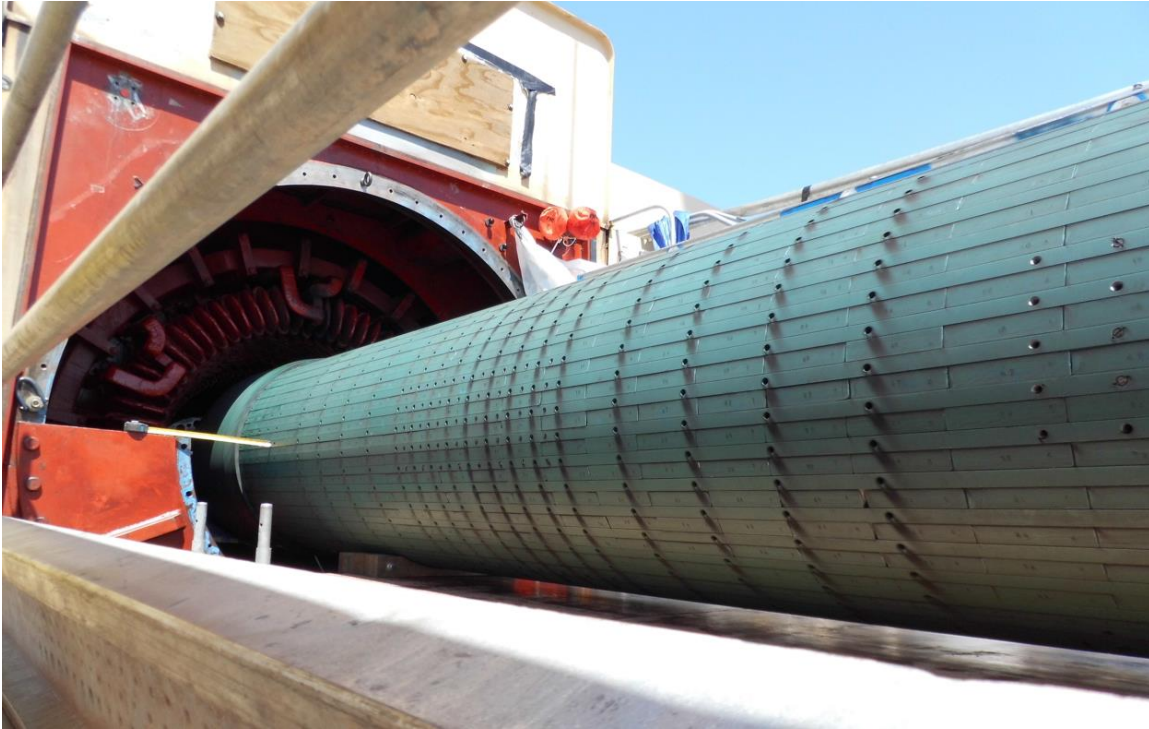
FIGURE 3. Rotor

Figure 3 shows the machine rotor which was pulled for inspection due to the fault.

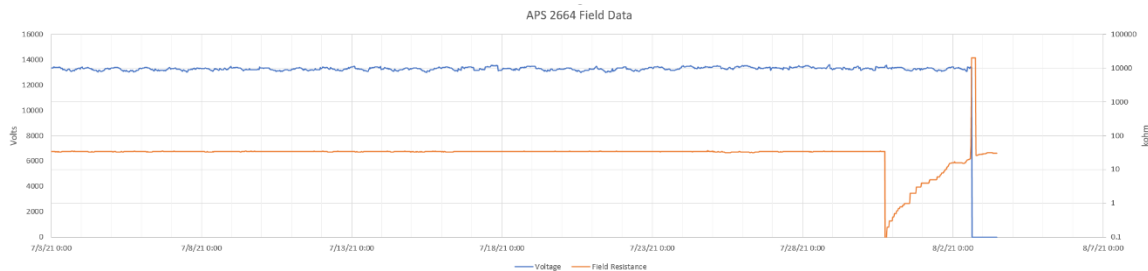
FIGURE 5. Rotor Field Resistance to Ground

The orange plot is of interest and represents the measured rotor field insulation resistance to ground. The ground fault occurred between 07-28-2021 and 08-02-2021. Review of the plot shows that the field resistance dropped to zero then slowly began to increase back to the pre-fault nominal value over the course of several days. The ground was due to water ingress which evaporated over time following the rainstorm. The spike was due to testing following the event; that is, the relay reports a large value when the measuring module is removed from service.

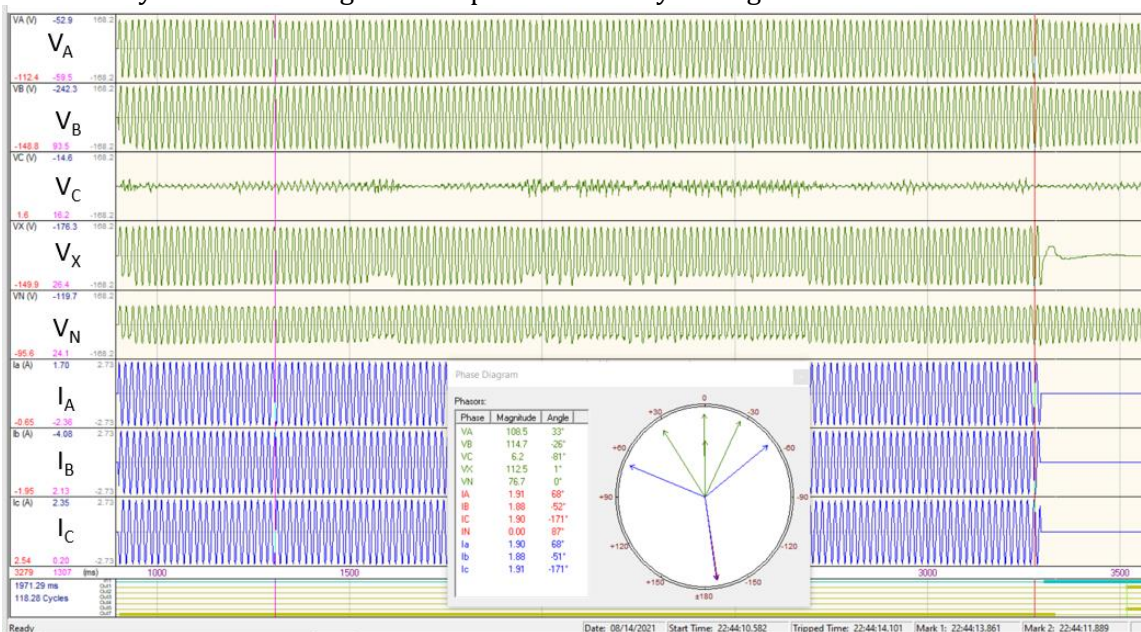
FIGURE 7A. Oscillography

Figure 7A and 7B shows the oscillography and phasors corresponding to the fault signals recorded by the numerical generator protection relay during the event.

It can easily be seen by visual inspection of the oscillography that the stator ground fault was located on phase C.

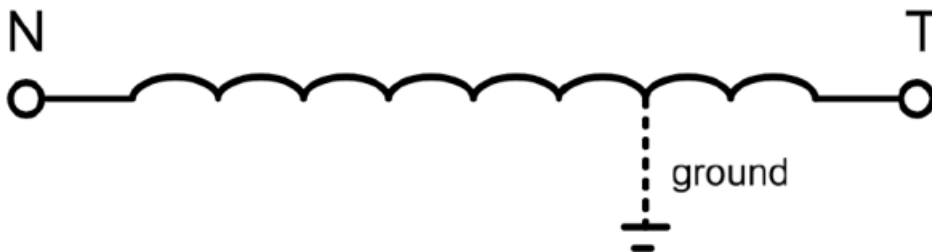
FIGURE 8. Fault Location with Respect to Generator Neutral

- 1) Generator Terminal Voltage = $13.8 \text{ kV} / \sqrt{3} = 7.97 \text{ kV}$ line-to-ground (primary)
- 2) Voltage Across Grounding Transformer (V_G) = $(7.97 \text{ kV}) / 100 = 79.67 \text{ V}$ (secondary)
- 3) Neutral Voltage (V_N) = 77 V (secondary) taken from oscillography
(Voltage drop across neutral resistor)
- 4) Fault Location with respect to generator neutral:
 $(V_N * 100\%) / V_G = 96.64\%$

The actual fault location was close to the generator terminals and just external to the stator windings. There is some error in the calculated fault location due to relay accuracy and resistive losses in the grounding transformer. This calculation provided confidence that the stator ground was not internal to the stator winding and the generator could quickly be returned to service.

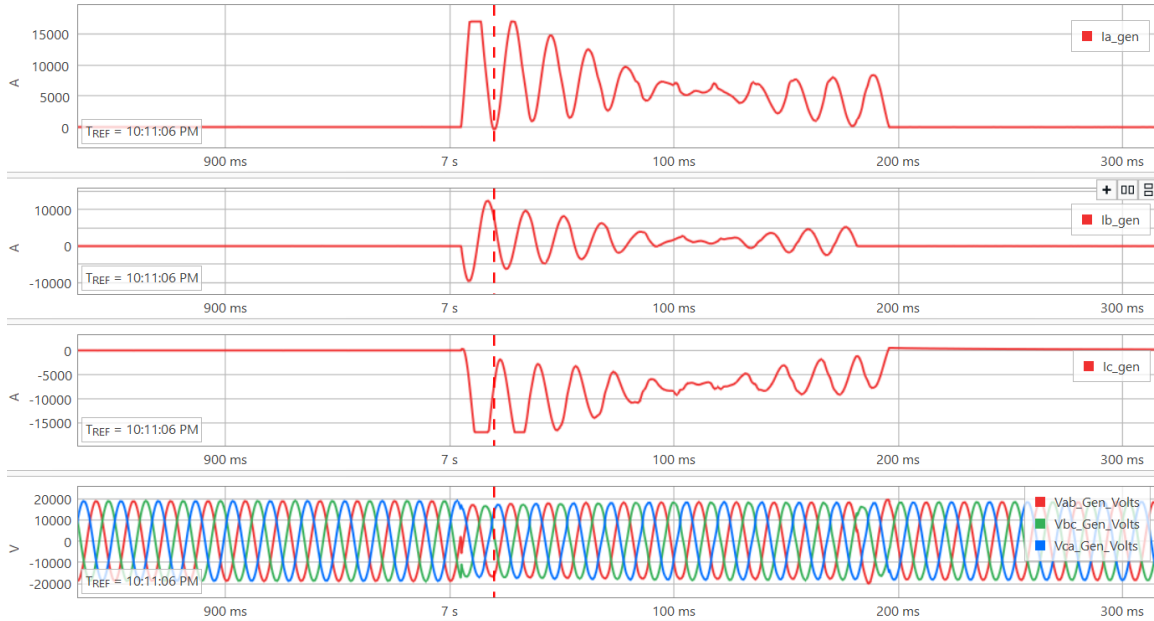
FIGURE 11. Generator Currents

Figure 11 below shows the oscillography captured by a digital fault recorder (i.e., DFR) for the event. The currents shown ($I_{a_{gen}}$, $I_{b_{gen}}$ and $I_{c_{gen}}$) are measured on the neutral side of the generator stator winding, which is the current flowing through the generator. Note that these signals are unfiltered and reveals the large dc offset present in these currents.

At first glance the event appears to be an A-Phase-to-C-Phase fault, however the generator terminal voltages are balanced and nominal magnitude. Note that the generator currents are fully offset during the entire event. Figure 12 below shows the filtered currents flowing through the generator; that is, the 60 Hz fundamental component for each current waveform. Review of these waveforms reveal that the current magnitude is close to nominal and the currents are all balanced approximately 120 degrees apart. Thus, there was no phase fault present during the event.

The bad sync was the source of large dc offset present in the generator currents. It is suspected that the internal relay CTs saturated as a result, which accounts for why the main 87 phase differential protection picked up and dropped out four times during the event.

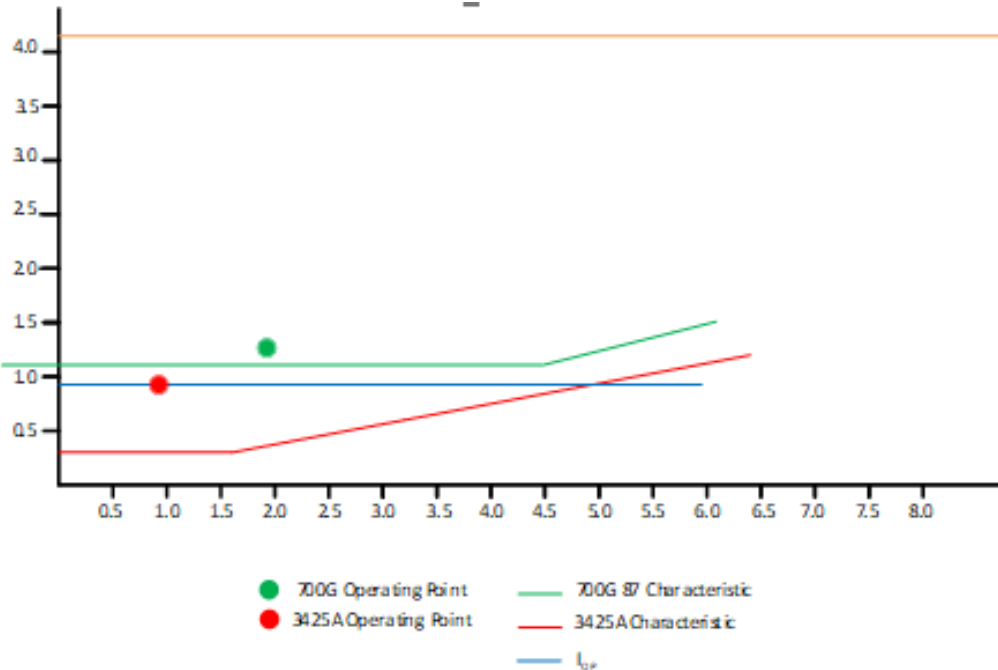
FIGURE 13. 87 Phase Differential Operating Characteristics, Main and Backup

Figure 13 below shows the corresponding 87 phase differential operating characteristics for both the main generator and backup protection. The operating point for the main protection is well within the zone of operation, while for the backup protection it is outside.

The root cause of the unwanted trip was due to a bad sync; that is, the electrical angle across the generator breaker was close to 60 degrees at the time of the closing because of improper timing. 180 degrees is the worst case electrically, while 90 degrees is the worst case mechanically. Improper synchronization can affect the health of the power system and results in electrical and mechanical transients that can damage the prime mover, generator, transformers, and other power system components.

Review of the 87 phase differential characteristics illustrate that the main protection is much more sensitive than the backup protection with respect to the operating point for this event. There is no need to change relay settings and the trip alerted the utility that there was a problem with the sync.

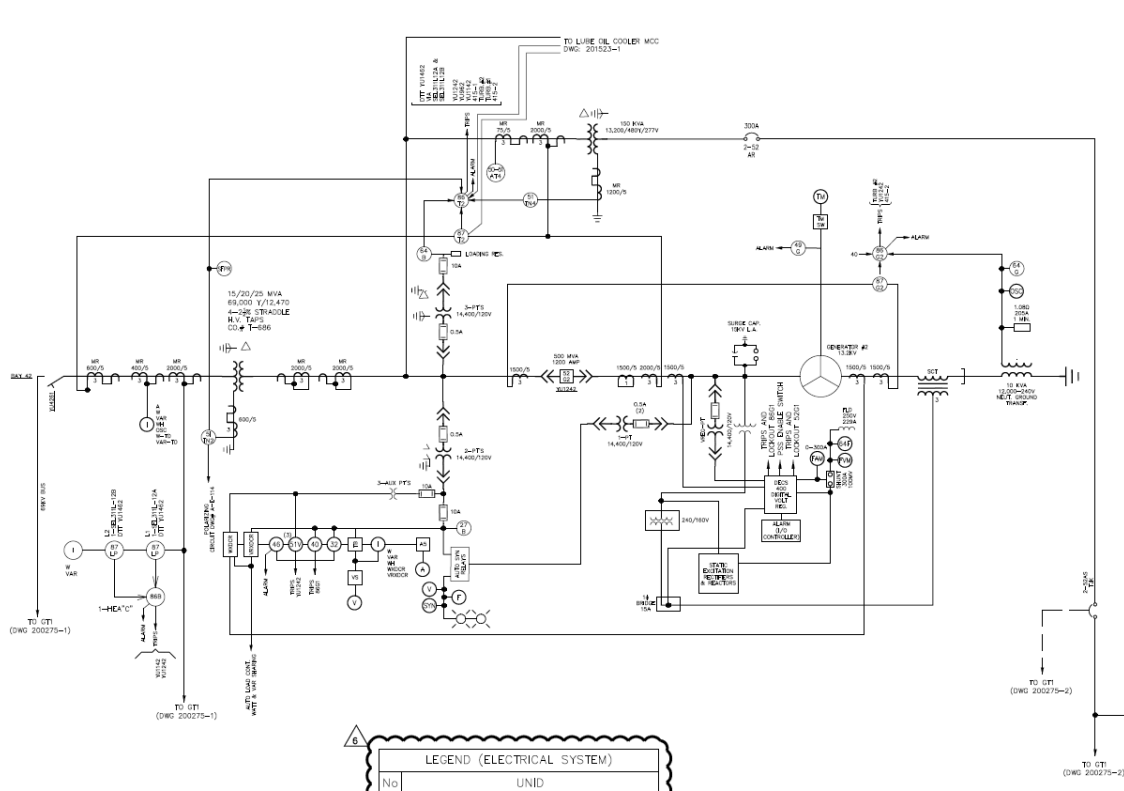
FIGURE 18 – Differential Single Line Diagram

The overall differential protection for a GSU began to trip when the generator was synced to the plant switchyard. Figure 18 below is the one-line diagram for the overall differential protection. There is one set of CTs on the high side of the GSU, one set of CTs on the low side of the GSU not including the generator, and one set of CTs on the high side of the auxiliary transformer.

Field inspection of the CT wiring revealed that both sets of CTs on the low side of the GSU had A-Phase and C-Phase rolled. Engineering initially requested that the wiring be changed to eliminate rolling the CTs, however inspection of the low side bus then revealed that A-Phase and C-Phase were also rolled. Further field inspection revealed that the B-Phase wire running from the set of CTs on the low side of the GSU had failed as a high impedance (refer to Figure 19).

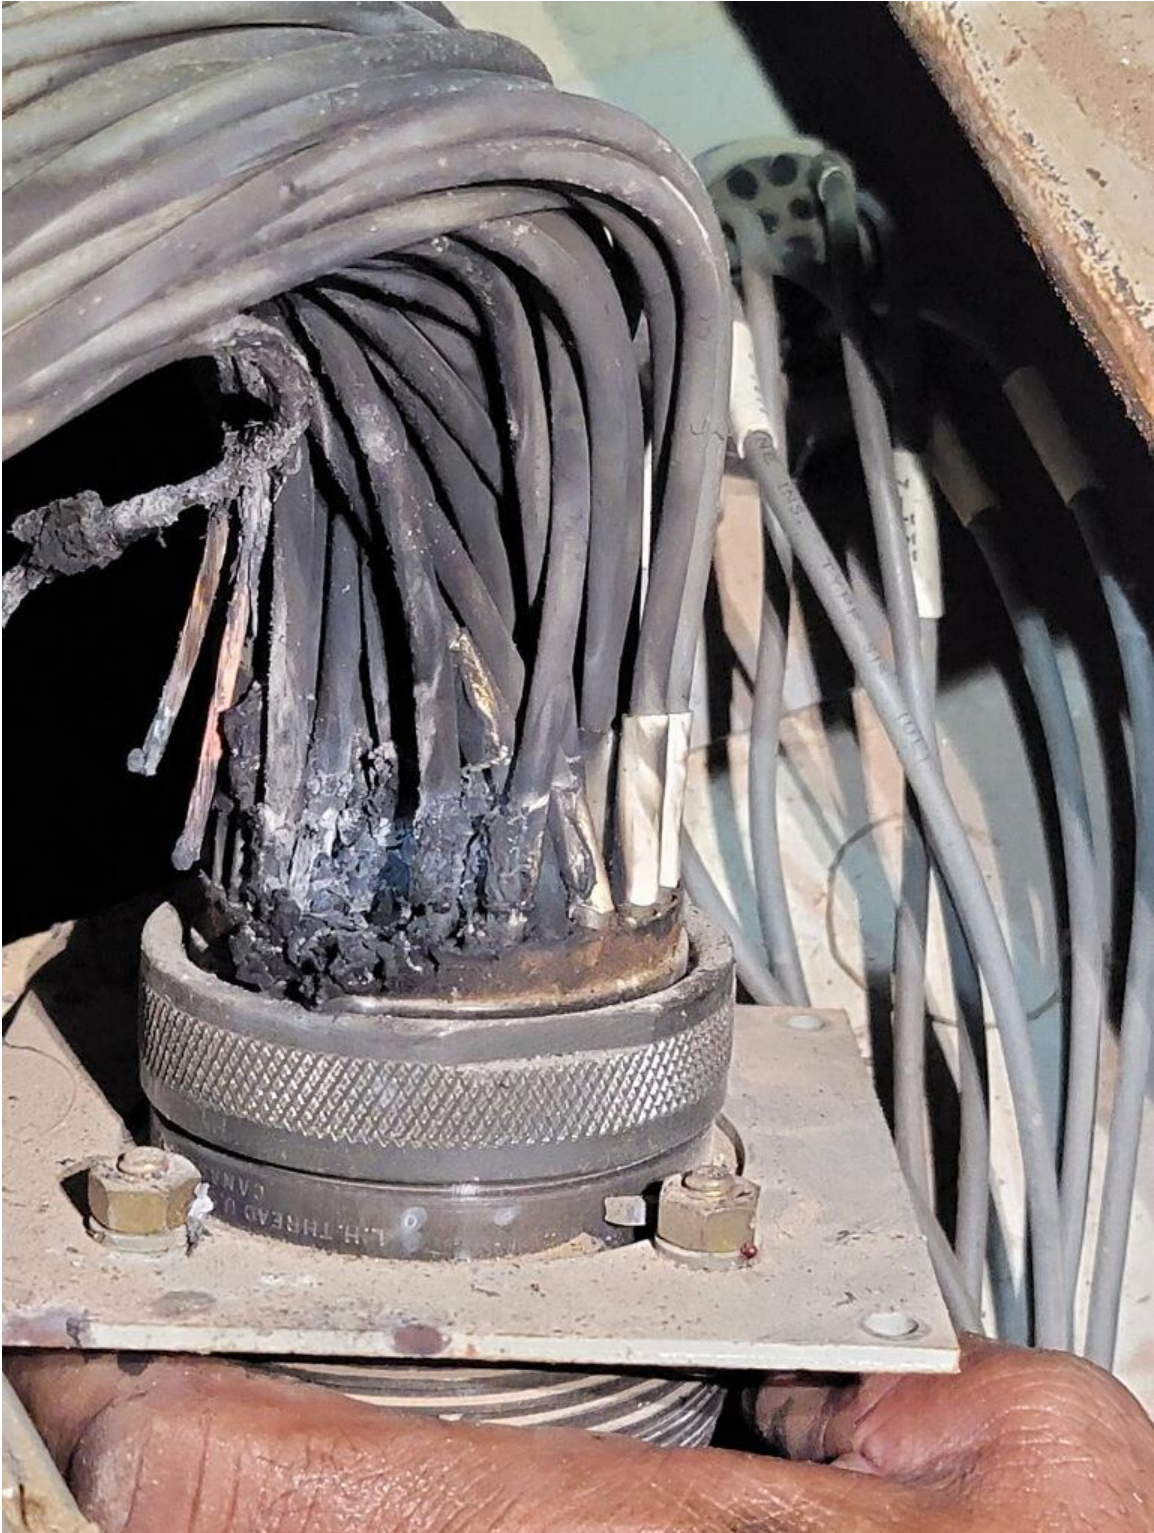
FIGURE 19 – Wiring Conduit

The differential protection would have still tripped, had the wiring for the low side CTs been rolled, and it would have made discerning the actual root cause more difficult to determine. The adage “If it’s not broke don’t fix it.” comes to mind.
