Finding Common Ground: A Case Study of Phantom Currents and Ground Loops

Matthew Boecker and Genardo Corpuz
Lower Colorado River Authority

Jared Candelaria and Ariana Hargrave
Schweitzer Engineering Laboratories, Inc.

Presented at the
47th Annual Western Protective Relay Conference
Virtual Format
October 20–22, 2020

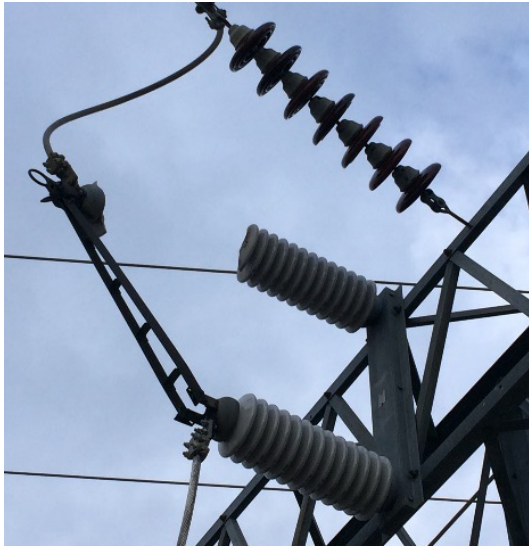
The first fault occurred on February 14 at 3:34 a.m. It was an AG fault on Switch S11 on the side of the open circuit breaker, CB5. Fig. 5 shows the switch, where a flashover to the structure caused the switch to break away from the insulator. The location on the system is shown as Fault Location 1 in Fig. 4. Even though this fault was clearly not in the transformer relay's zone of protection, the relay tripped on the C-phase percentage-restrained differential element. The 138 kV circuit breakers (CB2 and CB3) and the 69 kV circuit breaker (CB4) opened in response.

Fig. 5. First fault on A-phase of Switch S11

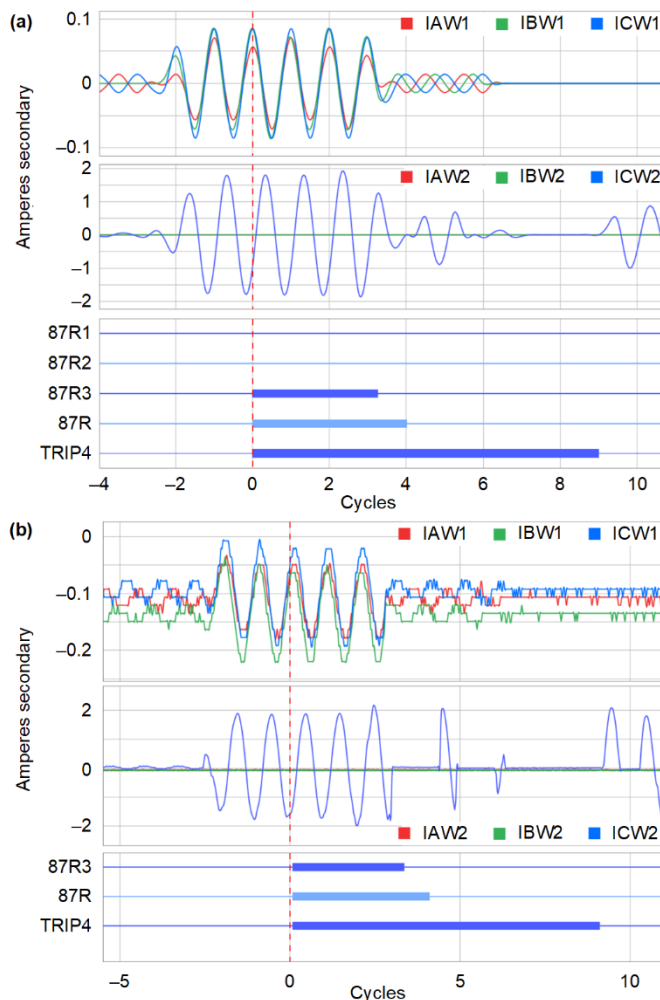
Fig. 6a shows the filtered event report and Fig. 6b shows the raw event report retrieved from the transformer differential relay after the fault. Winding 1 (W1) currents are from the 138 kV side and Winding 2 (W2) currents are from the 69 kV side.

Analyzing the events, what immediately stands out is that the W1 currents are all approximately equal, low in magnitude, and in phase with each other. This is characteristic of zero-sequence ground current. This current is expected, since there is a long path that connects the Substation A 138 kV side to another 138/69 kV grounded autotransformer at another substation and to the 69 kV system. This provides an alternate

Fig. 6. Filtered (a) and raw (b) event reports from transformer relay after first fault

The second thing of note is that W2 measured current on the C-phase. This was not expected. With the 69 kV side of the transformer isolated, as shown in Fig. 4, no current should flow on W2. The events also show that the current on C-phase W2 is arcing. This arcing continued even after the transformer tripped. The length of this arcing time was due to the remote electromechanical ground time-overcurrent relay taking 34 cycles to clear the fault.

Based on the explanation in Section II of how current differential protection works and how IOP and IRT are calculated, we can conclude that the transformer relay tripped due to the relay detecting current on W2 and very low (effectively zero) current on W1. Since current into the zone of protection did not equal current leaving the zone of protection, an operate current was present and caused the relay to trip. The relay operated correctly based on the currents it was measuring, but the question remained: Why was it measuring these currents in the first place?

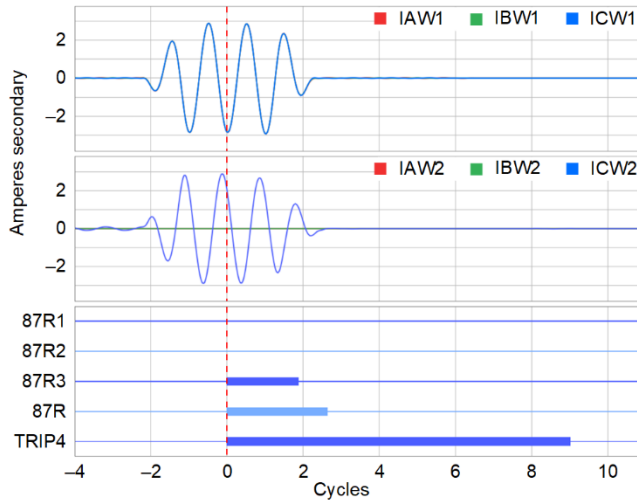
Fig. 7 shows the filtered event report from the transformer relay. The raw event looks similar.

Immediately evident is that the W1 currents are all exactly equal and in phase with each other, again indicating pure zero-sequence ground current. The magnitude is higher this time, since the transformer is serving as a ground source to a fault on a nearby line. W2 is again detecting current on the C-phase with the 69 kV side open. The magnitude is higher this time, as well, and there is no arcing on the W2 currents.

Fig. 7. Filtered event report from transformer relay after second fault

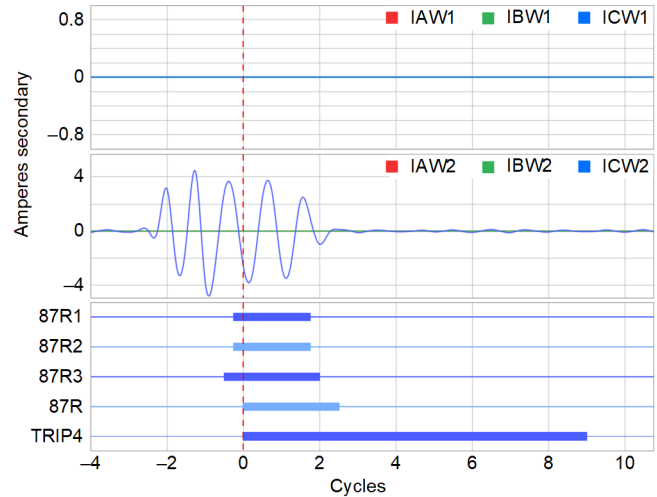
Fig. 8 shows the filtered event report retrieved from the transformer relay after the fault. Since the transformer was completely isolated from the system, there should not be any currents on either of the windings. However, there is still current detected on C-phase W2.

The assertion of all three-phase differential elements was correct based on the transformer compensation settings, which were set at 12 for both W1 and W2. For further information about transformer differential compensation, see [2]. For this fault, the relay again operated correctly based on the currents that it measured. But the question remained: Why did the relay measure those currents?

Fig. 8. Filtered event report from transformer relay after fourth fault

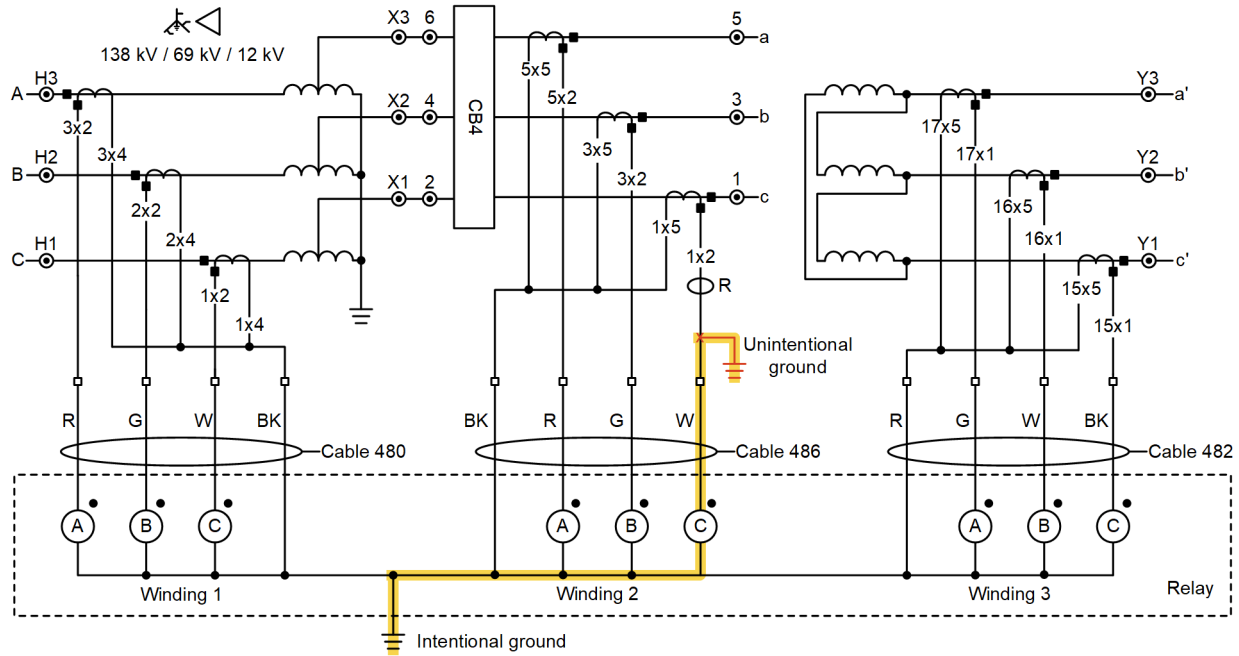
We now knew where the intentional ground was located, and we also knew that current flowed through the C-phase current input (IC) on W2 of the relay. Since the primary circuit on the 69 kV side was open at the time of the faults, that open circuit would reflect on the secondary side of the CT, causing the secondary CT winding (1x2 to 1x5) to appear as an open circuit as well. Keeping this in mind, the only way for current to flow from the intentional ground through the IC input of the relay was through the highlighted path shown in Fig. 10. The unintentional ground would have to be located on the polarity side of the C-phase W2 input of the relay, as shown in Fig. 10.

Fig. 10. Simplified three-line diagram of differential circuit

An unintentional connection to ground may also occur when the integrity of the insulation on the CT secondary leads has been compromised. Due to the arcing, we hypothesized that insulation breakdown was causing the unintentional ground and was the reason for the misoperations. We asked the technicians to look for an unintentional ground between the polarity side of the C-phase CT and the polarity side of the C-phase W2 input of the relay.

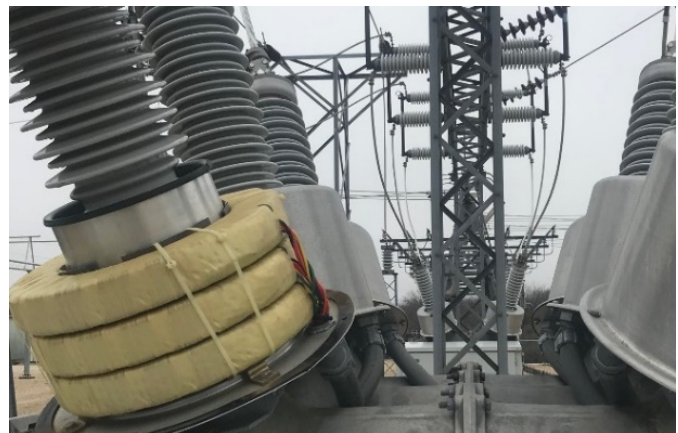
Next, the utility removed the CT cover from Pole 1 (C-phase) on the 69 kV side of the transformer to inspect the CT wires. This is shown in Fig. 11.

Fig. 11. Cover of Pole 1 removed

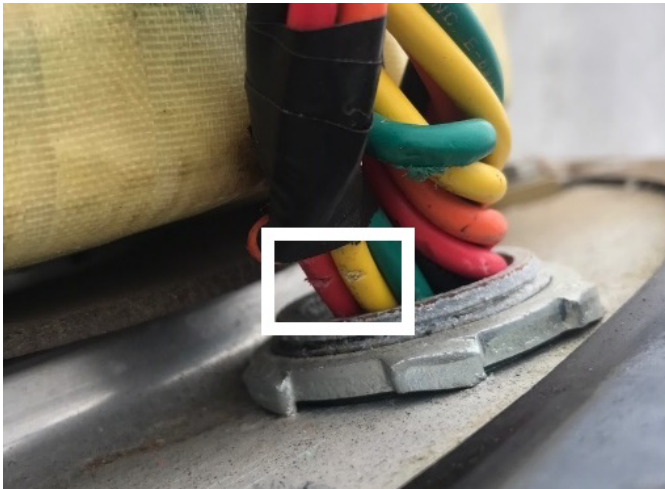
Fig. 12 shows a close-up view of the CT wires. The differently colored wires correspond to the different CT taps of the multi-ratio CT. The wires from the CT are run in flex conduit to the breaker control cabinet, where each wire is terminated. Cable 486 is then connected from the chosen tap points at the breaker control cabinet and routed back to the relay at the control house. Fig. 12 shows that two of the wires (red and yellow) had nicks in them. The wires were rubbing against the side of the flex conduit coupler.

The red wire in Fig. 12 is connected to 1x2, and the yellow wire is connected to 1x4. Fig. 10 shows that 1x2 is brought back to the relay via the white wire in Cable 486. This wire hits the polarity side of the C-phase W2 input on the relay, which is exactly where the phantom current in the event reports was measured.

Fig. 12. Nicked CT wires (red and yellow)

One may initially think that the nicks on the yellow wire (1x4) could not cause an issue since that wire corresponds to an unused tap on the multi-ratio CT. The yellow wire is terminated at the breaker control cabinet and not brought back to the relay. Fig. 13, however, shows how the unintentional ground on the yellow wire could have also caused a problem if the 69 kV side of the transformer had not been open. If 1x4 and 1x5 are both grounded, it effectively creates a short circuit on the secondary side of the CT between 1x4 and 1x5 (highlighted path). This short will cause all the current on the secondary side of the CT to circulate in this highlighted path, instead of forcing the desired ratio current to flow between 1x2 and 1x5. A similar issue could have occurred due to the unintentional ground on the red wire, with current circulating in the short circuit between 1x2 and 1x5, and not being sent to the relay. A misoperation could have easily occurred for either of these cases since the relay would not be measuring correct ratio current.

When the technicians discovered the nicks in the CT wires, they moved the wires to prevent them from contacting the conduit coupler. Before the wires could move again, they quickly performed another insulation resistance test, which passed. Because they were able to turn the problem on and off, root cause was confirmed.

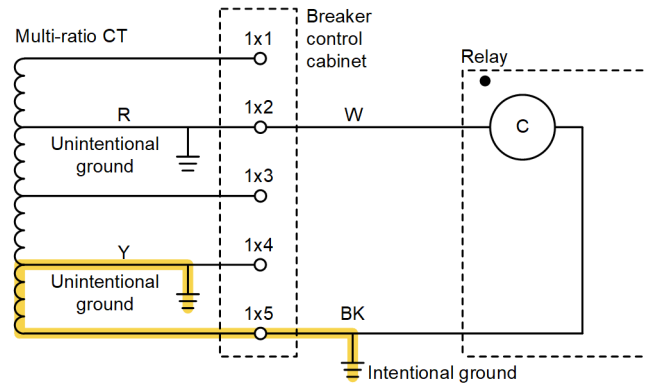
Fig. 13. Ground current path due to unintentional ground on yellow wire

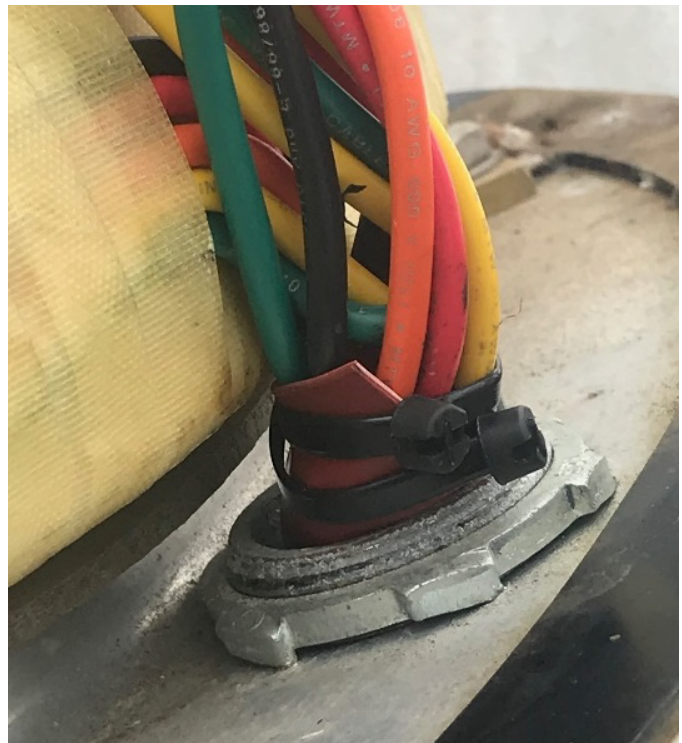
Fig. 14. Corrective action

To repair the issue permanently, the technicians first applied electrical tape to the individual conductors, to cover and insulate any exposed wiring. They then bundled the conductors and secured them together. Cork was then inserted into the flex coupler to prevent the cables from contacting and wearing against the side of the coupler. This final solution is shown in Fig. 14. The technicians performed a final insulation resistance test on the CTs and Cable 486 and everything passed.
