Event Investigation of 69 kV Double-Circuit Faults

Ahsan Mirza, Christopher Bolton, Girolamo Rosselli, and Sergio Flores
San Diego Gas & Electric

Presented at the
47th Annual Western Protective Relay Conference
Virtual Format
October 20–22, 2020

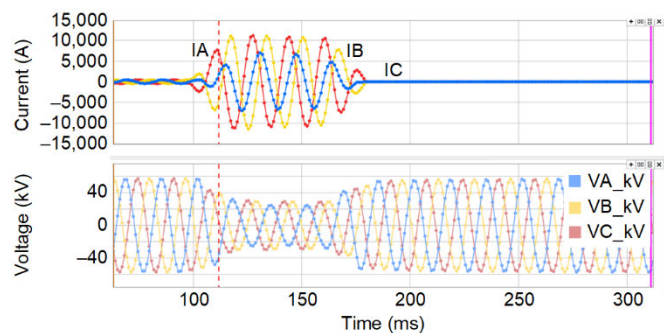
Fig. 2. T7P Relay Current and Voltage Oscillography

It is immediately clear that this oscillography reflects fault conditions, as all three phase voltages are depressed and currents are as high as 10 kA peak value. Something that also catches the eye is the unbalance in currents, even though there is high current in all three phases (reflecting that all three phases are faulted). There is slight unbalance in the voltages as well. All three phases are involved in the fault, but a conventional fault involving all three phases is a three-phase fault, which is mostly balanced in nature (ignoring the effects of line untransposition). That is not the case here, so a natural question arises: What kind of three-phase fault would create such significant current unbalance? There is little doubt that we are dealing with an unorthodox fault type.

It is interesting to see that at the intersection of the IA and IB waveforms lies the peak of the IC waveform. This waveform oddity manifests itself in the form of a clue from the current phasor diagram of Fig. 3. In the top pane, we see that the IC phasor is acting as an angular bisector of the IA and IB phasors. An additional hint as to the fault type and location is disguised in the ambiguity presented by unequal current magnitudes, where IA and IB are equal yet larger than IC. We compare this

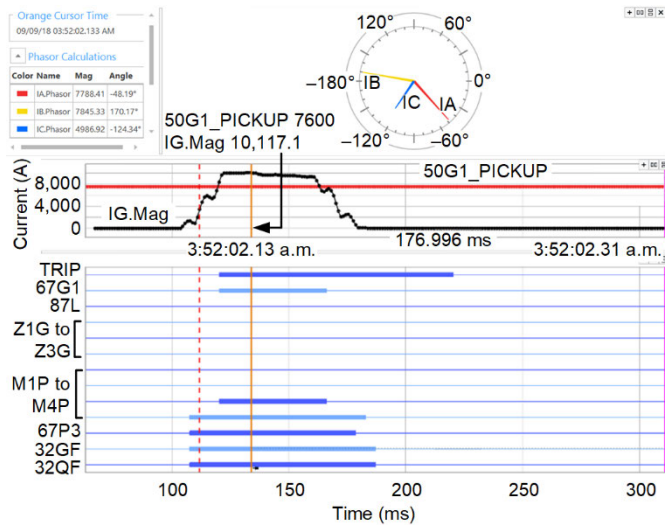
Fig. 3. T7P Relay Phasors and Protection Element Response

For a classic three-phase fault, the current magnitudes of all three phases are equal. The fact that we have equal A-phase and B-phase magnitudes but an unequal C-phase magnitude implies that A-phase and B-phase are faulted together at one location, while C-phase is faulted at another location.

Further, if the IC phasor was flipped 180 degrees from its position in Fig. 3 (and made equal to IA and IB), it would have represented a forward three-phase fault flow. (The same phasor diagram in Fig. 3 is also shown in Fig. 13 along with voltage phasors). But in reality, IC lies opposite of this forward three-phase fault position, or simply, the IC phasor lies in a reverse flow position compared with the IA and IB phasors.

What this suggests so far is a case of double faults: a forward fault from the relay location involving A-phase and B-phase, and a fault in another location behind the relay (reverse) involving C-phase.

The 67G1 bit (ground directional overcurrent element) asserted at the exact same time as the TRIP bit. The 67G1 assertion suggests ground involvement for this unusual fault. If we look at the phasor diagram in Fig. 3, the way IA, IB, and IC

- The 67G1 element of the T7P relay protecting Line L567 operated because it was set too sensitive and because of the nature of the fault. The double-circuit fault caused forward flow on A-phase and B-phase and a reverse C-phase flow, which led to higher ground current (calculated by the relay) than there actually was. This is because of the spatial arrangement of IA and IB and the reverse flowing IC current was additive in nature, hence the larger-than-actual IG ground current (Fig. 3).

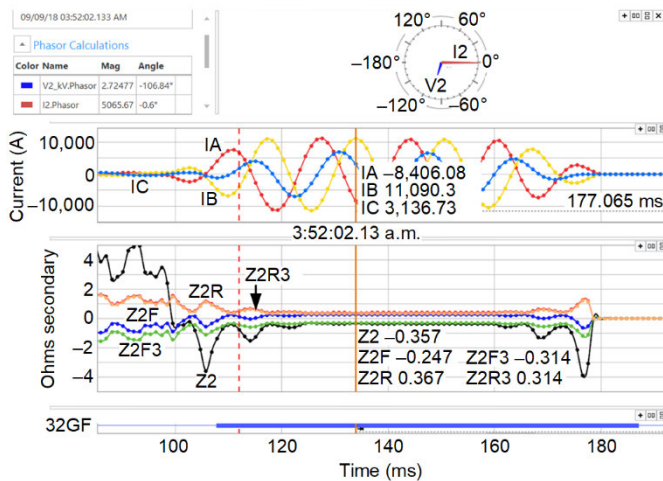
Fig. 5. Negative-Sequence Impedance Plot of T7P Relay

The plot of calculated negative-sequence impedance Z_2 and the T7P relay Z_2F and Z_2R threshold settings are shown in Fig. 5. Clearly, the calculated Z_2 (black) was well below the Z_2F (blue) threshold. And even if Z_2F and Z_2R were moved -0.3 and 0.3 ohms, respectively (shown by Z_2F3 and Z_2R3 analog quantities), the calculated Z_2 still lies beneath the Z_2F3 (green) trace, but barely. Note that the relay adds dynamic boosts to these fixed thresholds of Z_2F and Z_2R , which is why traces of Z_2F3 and Z_2R3 are not seen at values of -0.3 and 0.3 .

With Z_2 calculated at -0.357 , Z_2F at 0.247 , and Z_2F3 at -0.314 , it is clear the Z_2F3 did far better than the Z_2F threshold and missed, by a fine margin, safely not declaring this fault as forward.

- The directional element at the T7P relay saw the reverse CG fault on Line L12 as forward. This is because the V_2 and I_2 relationship observed by T7P is surprisingly the signature of the V_2 and I_2 relationship for a conventional forward SLG fault. It should not be

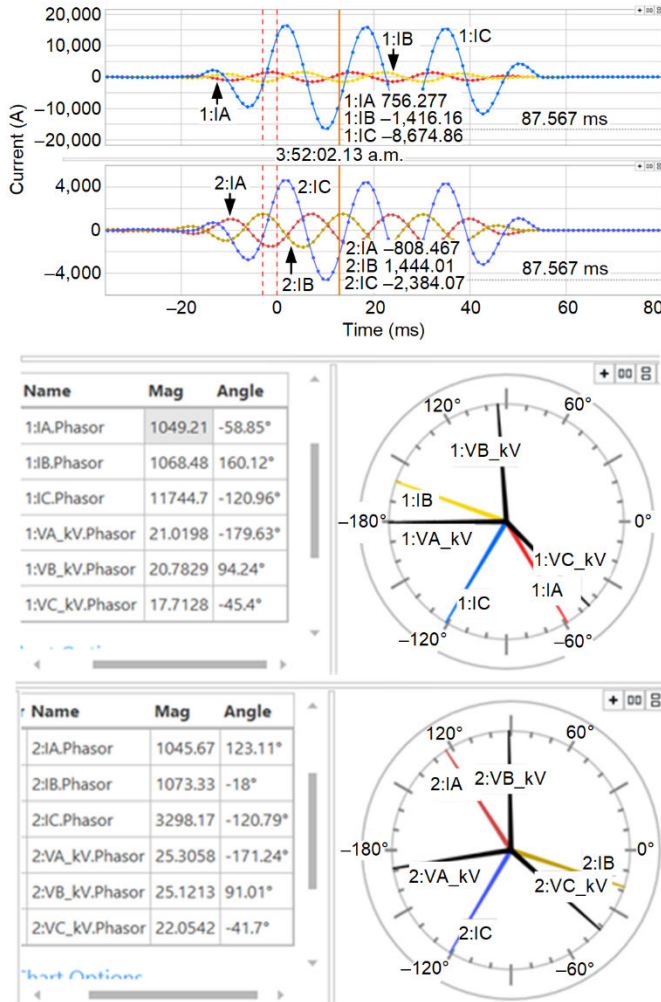
Fig. 6. T1S and T2S Combined Event Reports

Fig. 6 shows the oscillography and phasors from two combined event reports of the T1 secondary (T1S) and T2 secondary (T2S) relays. The C-phase currents are high at around 11.7 kA and 3.29 kA for the T1S and T2S relays, respectively. Moreover, both IC phasors lag their respective VC phasors by roughly 75 degrees. This pointed toward an internal fault on Line L12 involving at least C-phase. On the other hand, A-phase and B-phase seem unfaulted. This is evident from their relatively low magnitudes compared to C-phase and the fact that I_A at T1 ($1,049.21 \angle -58.53$ A) is roughly equal in magnitude to I_A at T2 ($1,045.67 \angle 123.11$ A), but near 180 degrees out of phase in angle. The same observation could be made for the B-phase current phasor.

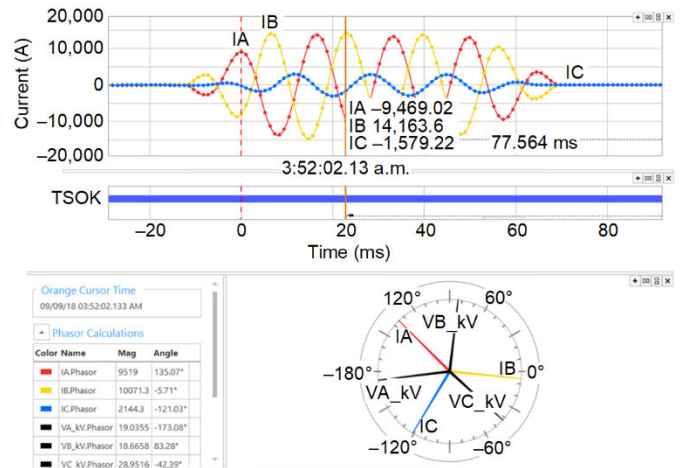
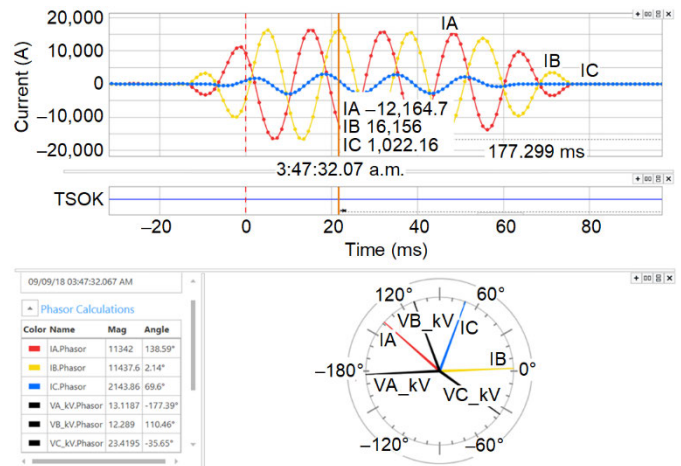
Next, we examine the fault oscillography captured by the T3 secondary (T3S) and T4 secondary (T4S) relays protecting Line L34. These are shown in Fig. 7 and Fig. 8, respectively. The T3S and T4S relay event reports could not be combined because the T4S relay was not time-synchronized when the fault occurred. This was evident from deassertion of TSOK in the T4S event report. However, this does not prevent us from concluding that A-phase and B-phase are faulted and C-phase is not. This can be deduced by comparing C-phase current phasor magnitudes in Fig. 7 (IC is at 2,144.3) and Fig. 8 (IC is at 2,143.86 A). Additionally, IC is lagging VC by 78.6 degrees at Terminal T3, whereas IC is leading VC by 105.25 degrees at T4. This implies current IC flows in through T3, lagging VC by 78.6 degrees, and flows out of T4, lagging VC by 74.75 degrees ($180 - 105.25 = 74.75$ degrees). On the contrary, A-phase and B-phase current magnitudes are different on either terminal and significantly larger than IC. IA is 9.5 kA at T3 and IA is 11.3 kA at T4, with similar magnitudes for IB. The IA and IB angular relationship with its corresponding phase voltages (VA and VB) is not immediately clear to explain the type of fault on Line L34. However, the closest resemblance of a fault type would be an A-phase-to-B-phase-to-ground (ABG) fault, but we cannot say with certainty if that is indeed the fault type.

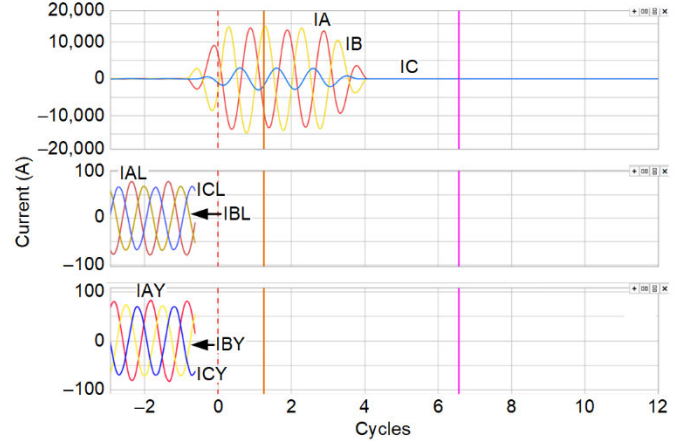
Fig. 10. T3P Event Report Showing Local and Remote 87L Currents

However, the T4P relay is the remote 87L partner relay for T3P (to protect Line L34), so the T3P event report should have captured remote 87L currents as well. So, an attempt was made to obtain IAT4 and IBT4 currents by opening T3P's event report (shown in Fig. 10). Surprisingly, both of T3P's local (IAL, IBL, and ICL) and remote (IAY, IBY, and ICY) 87L currents abruptly disappeared after the first two cycles.

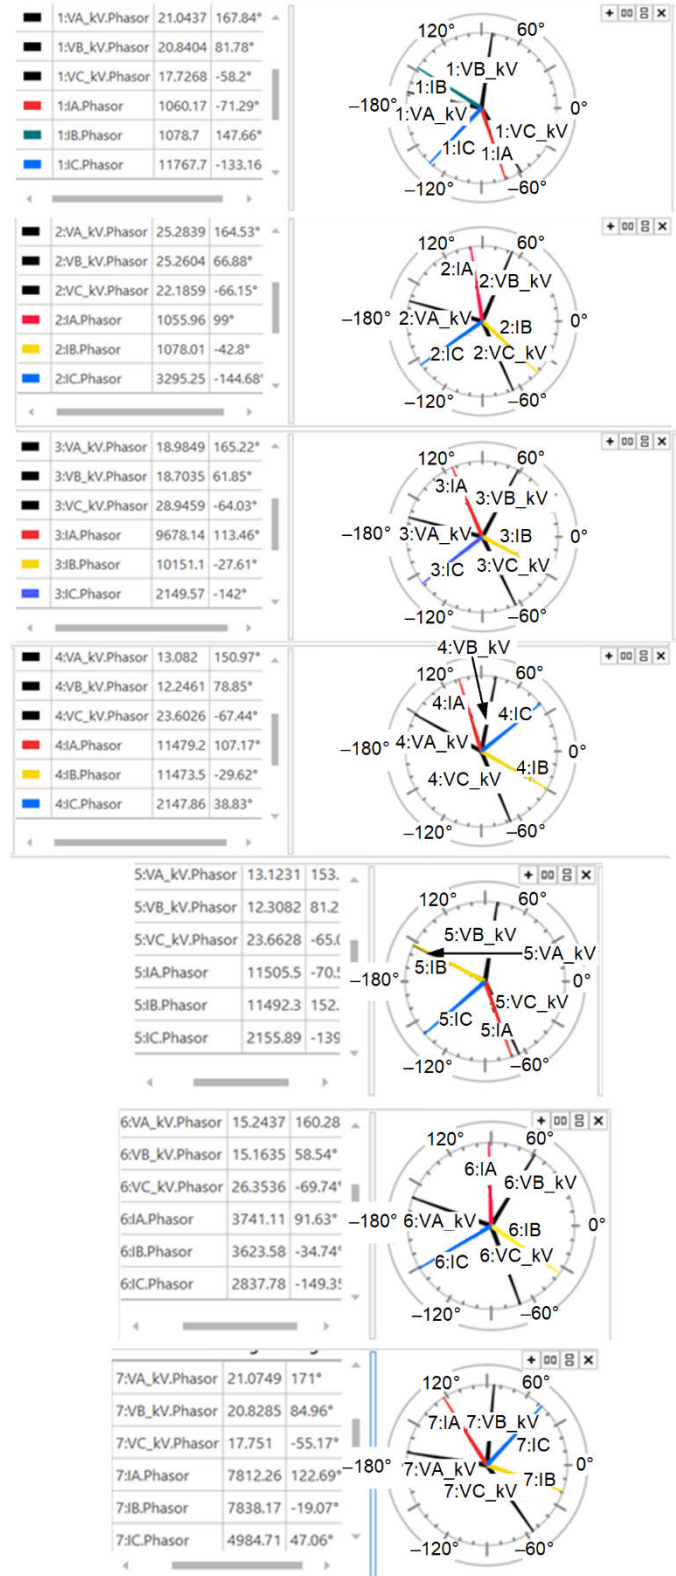
Fig. 13. Global Phasor View From Combined Time-Aligned Event Reports of All Seven Terminals

Not surprisingly, we still have roughly the same magnitudes of 8,453 and 8,454 A of IfT123 and IfT4, respectively, just like we saw in Fig. 11. But now we know their respective angles (now that all the event reports have been time-aligned) as well. IfT123 and IfT4 are roughly 170 degrees apart from each other, The 10-degree difference (180–170 degrees) is enough to reveal the existence of ground current of ~1,423 A.

- Taking a system-wide view in the event viewer software by combining event reports from all of the terminals (Fig. 13) corroborated the current flow distribution presented in Fig. 12. This approach and the custom calculations were key in determining the fault type and whether ground was involved in the double-circuit fault.

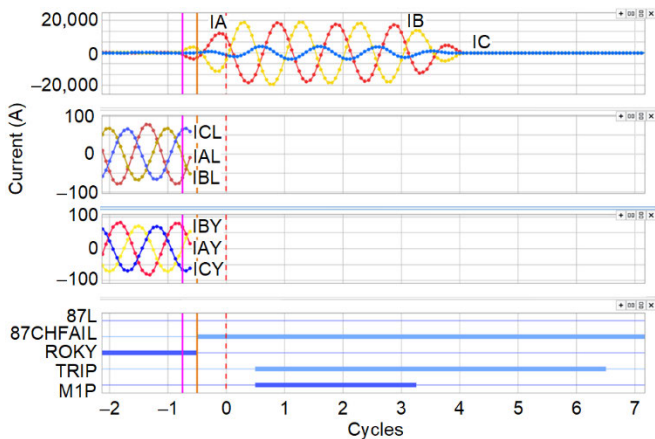
Fig. 15. T3P Event Report Showing 87L Element Behavior

As noted in the previous section, the T3 and T4 relays did not operate on their 87L elements for the internal fault on Line L34 like they should have. Upon further investigation, it was found that the Receive 87L data OK from Channel Y (ROKY) bit in the T3P relay had deasserted just a few milliseconds after fault inception (Fig. 15). Channel Y is the communications channel through which T3P exchanged 87L data with T4P on the other end of L34. ROKY deassertion is an indication of a potential communication problem with Channel Y, which causes the 87L element in the T3P relay to be disabled. One manifestation of 87L disablement appears in the form of the vanishing of IAL, IBL, and ICL (87L local phase currents of T3P) and IAY, IBY, and ICY (87L remote phase currents of T3P; that is, local current of T4P obtained via Channel Y), as shown in Fig. 15.

While 87L disappears right when the fault starts, M1P (Zone 1 phase mho distance element) fortunately comes to the rescue and operates in about 1.25 cycles, clearing the fault. This showcases the importance of having local backup protection elements.

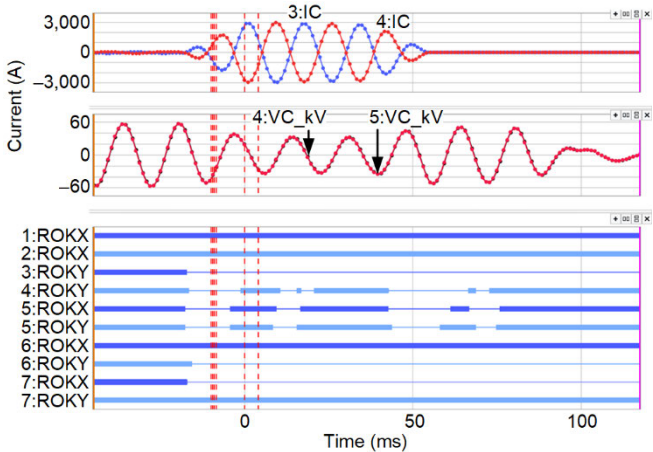
Fig. 16. Combined Event Report of All Seven 87L Relays Showing ROK Bits

To get to the root of the issue, we decide to plot ROK bits of all seven relays together. The bottom portion of Fig. 16 shows the pertinent ROK bits of all seven 87L relays (T1P, T2P, and so on) combined.

Based on this behavior, we look for the commonality in the data and observe that channels connecting the T4P and T5P relays are the ones affected. The T4P and T5P relays belong to the same substation and therefore must be using the same communications equipment or technology—perhaps the root cause behind the 87L element disruption at multiple relays. The 87L elements of T1P and T2P were intact perhaps because they used a communications channel independent of communication equipment and media at the B45 substation.

- The 87L scheme for both Lines L567 and L34 disabled right after the double-circuit faults started. We took advantage of the already combined and time-aligned event reports to lay out the 87L communications channel health indicator bits (ROKX and ROKY) for all the relays. Systematically examining the ROK bits suggested issues with the communications equipment at the N45 substation housing the T4 and T5 relays. It was later found that these 87L schemes indeed used leased copper telecom lines at the N45 substation, which would be affected during nearby system ground faults. There is a project underway to upgrade 87L communication technology for these 69 kV lines.

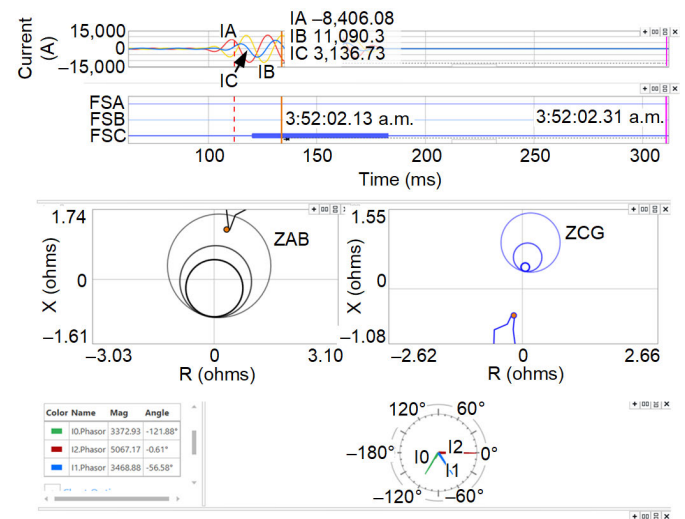
Fig. 17. T7P Mho Element Response

Fig. 17 shows the mho element response for the Zone 1, Zone 2, and Zone 3 mho phase elements of ZAB and the mho ground elements of ZCG. The reason we show ZAB and ZCG (and not ZBC, ZCA, ZAG, and ZBG) is because only ZAB and ZCG are enabled by the relay during the fault. This is evident by FSC assertion and deassertions of FSA and FSB. FS_n ($n=A, B, \text{ or } C$) is the output bit of the FIDS algorithm described in [7] that determines which two mho elements out of six to enable. The FSC assertion from a relay standpoint represents the fact that either there is a CG fault *or* there is an ABG fault. Interestingly, FSC has asserted when *both* fault types are present. This correct determination can be attributed to the spatial displacement of the I_0 and I_2 phasors. For a CG or ABG fault, I_2 leads the I_0 phasor by roughly 120 degrees. And in this case of a double-circuit fault, the same angular relationship between I_2 and I_0 is observed (Fig. 17) at T7.

First, we break down the double-circuit fault(s) into two individual faults, one on Line L34 and one on Line L12. The fault on L34 involving A-phase and B-phase is forward with respect to T7P. This manifests in the R-X impedance plane (ZAB in Fig. 17) with the operating point (orange dot) lying in the first quadrant. The first quadrant of the R-X plane symbolizes forward direction of fault current flow. The operating point is well outside the Zone 1 and Zone 2 mho circles but within Zone 3.

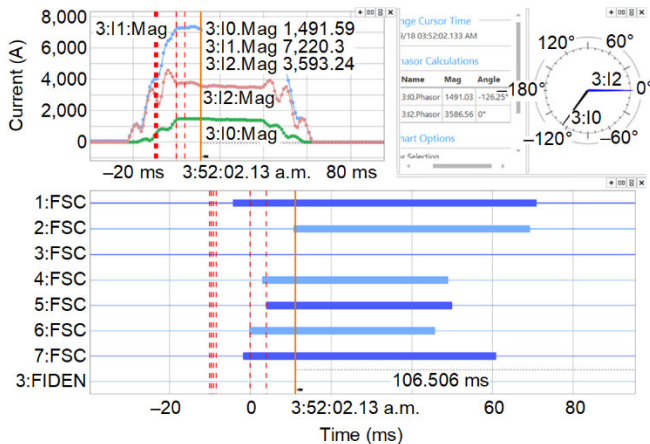
Fig. 18. Combined Event Report of All Seven Terminals Showing Respective FIDS Logic Response

Fig. 18 shows the FIDS logic response in the form of FSC bits for all seven relays (only primary relays shown). Not shown in Fig. 18 are the FSA and FSB bits, which remained deasserted. Once again, FSC assertion indicates either a CG or ABG fault from a relay standpoint. Every relay asserted its FSC bit (which was arguably a correct assertion) except the relays at Terminal T3.

Fig. 18 also shows that I2 leads I0 by roughly 120 degrees, but still FSC did not assert. Why? The fault identification logic is designed to detect faults that involve ground. The zero-sequence current and zero-sequence voltage measured by T3P for this fault were not of sufficient magnitude to enable the FIDS logic. This is evident by the FIDS enable bit, 3:FIDEN in Fig. 18, never asserting.

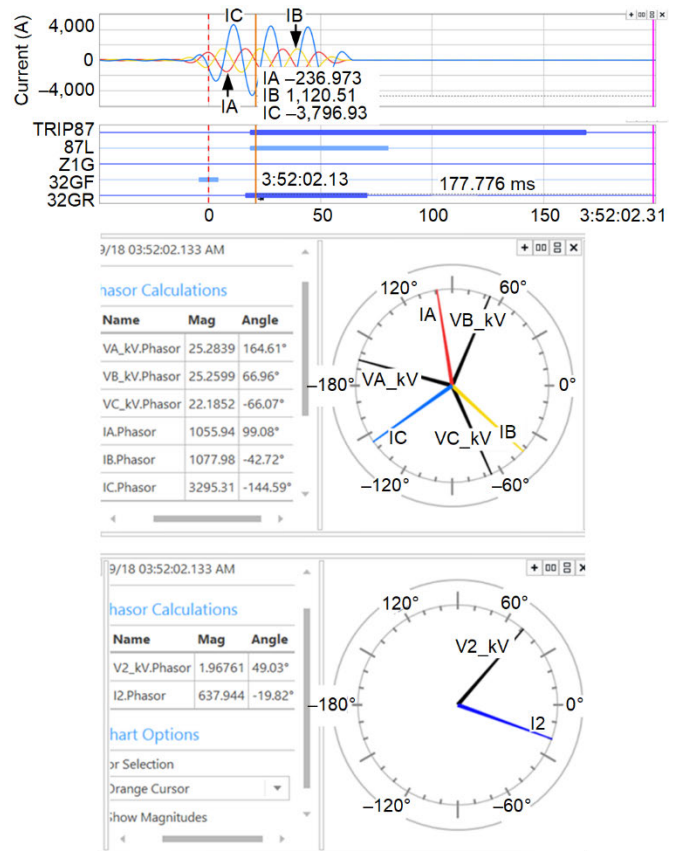
Fig. 19. T2P Event Report Showing Mho Ground Zone 1 (Z1G) Element Remaining Deasserted

We observed that the mho elements of relays at T5 and T6 remained secured, as expected. Mho elements of relays at T1, T3, and T4 operated as expected. What was not expected was the mho element dormancy for the T2 relays. There was an internal fault on Line L12 protected by T2P and T2S, so their mho elements should have operated. Fig. 19 shows Z1G in T2P remaining deasserted throughout the event duration. Why?

The answer lies in the negative-sequence voltage (V_2) and current (I_2) values seen by the relay for the double-circuit fault. In Fig. 19, which shows V_2 and I_2 phasors as seen by T2P, V_2 leads I_2 with an angle less than 90 degrees. This is, in fact, the V_2 and I_2 relationship expected for a reverse single-line-to-ground (SLG) fault! This rare double-circuit fault has been successful yet again in challenging the relay directional element, this time by hiding the forward directionality of the fault.

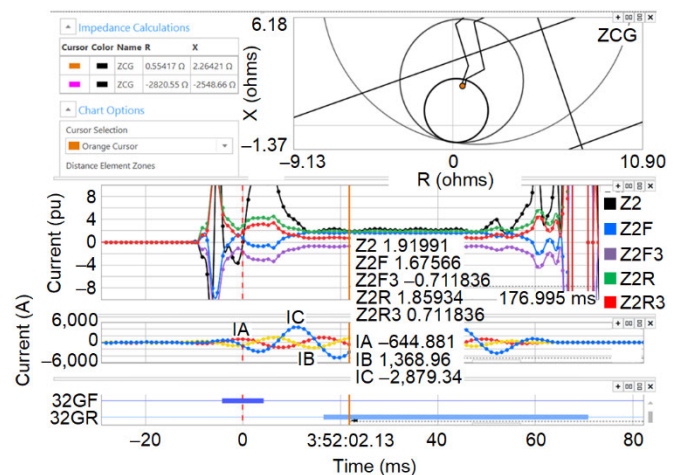
Fig. 20. Negative-Sequence Impedance Calculation of T2P Relay

We investigate the deassertion of the T2P Z1G element by exploring the three core components of a mho element previously discussed. The 2:FSC bit assertion in Fig. 18 showed the FIDS component of the Z1G mho element working correctly. Further, the top pane of Fig. 20 shows the impedance calculation of ZCG. The operating point (orange dot) lies within the Zone 1 mho circle, which proves the impedance calculation portion of the Z1G mho element is also working correctly. The last portion to evaluate is the forward directional element supervision portion. Fig. 20 shows the 32GF (forward

direction) and 32GR (reverse direction) bits of the T2P relay. Unbeknownst to us, T2P’s directional evaluation was challenged as well, although in a contrary fashion to T7P. T2P saw the forward (internal) fault on Line L12 as a reverse fault (evident by 32GR assertion), and therefore did not allow supervision for the Z1G mho element. The negative-sequence impedance (Z2) calculation for T2P’s directional element is also shown in Fig. 20. Z2 is computed as 1.919 secondary ohms by T2P and is barely (yet clearly) above the Z2R setting value of 1.859. Why?
