Protection Engineer Campfire Tales

Presented to
Western Protective Relay Conference
Oct 2009
Spokane, Washington, USA

Prepared by
Ralph Barone, PEng
Senior Protection Planner
BC Hydro

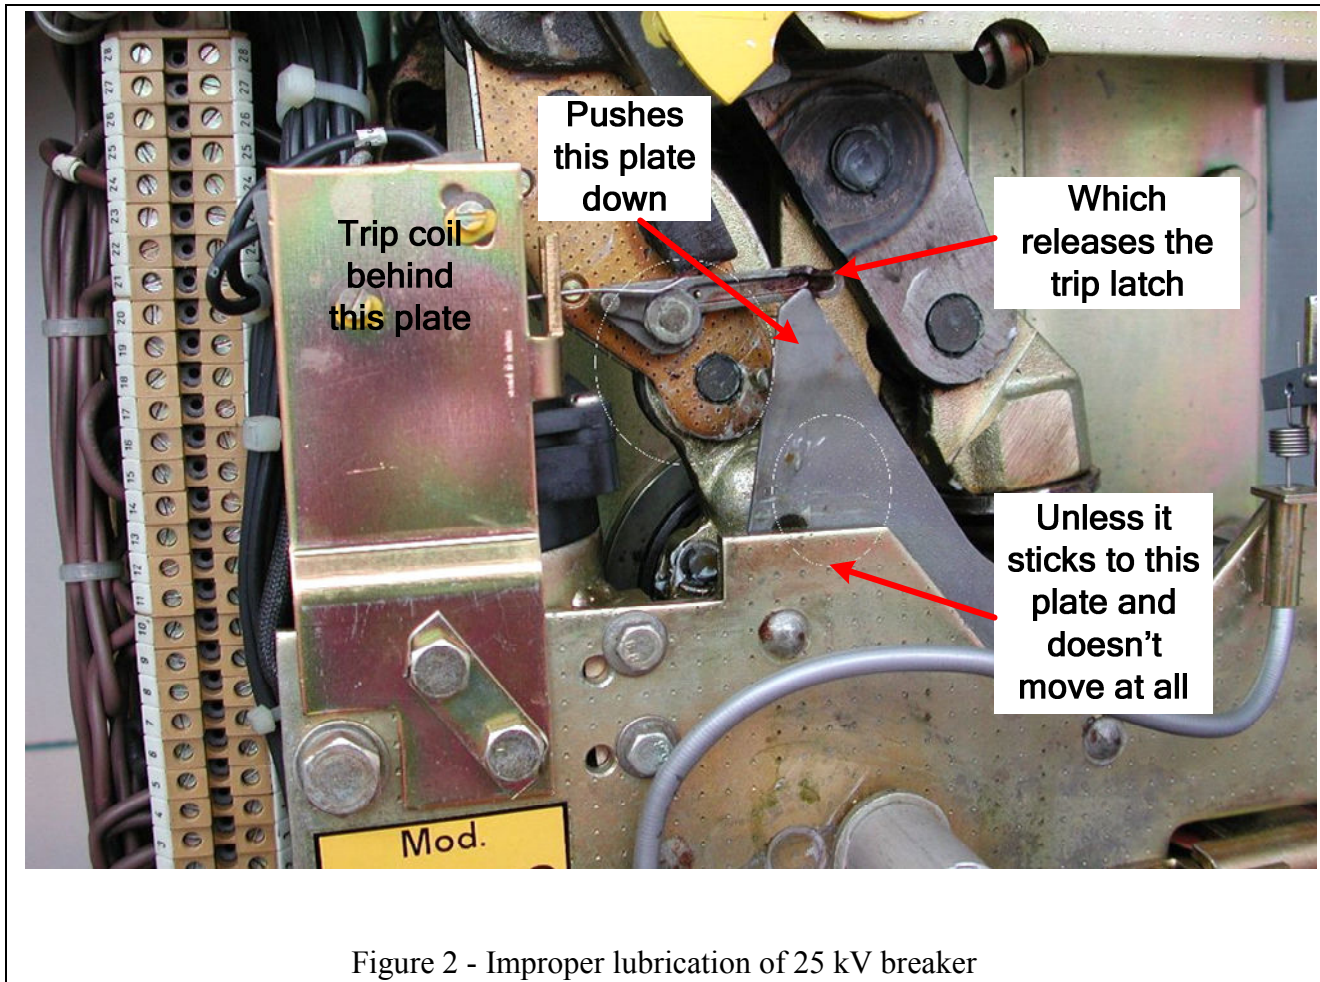
Timing tests performed on the breakers after these incidents showed very interesting behaviour. The first test trip operation of the breaker would be very slow (up to ½ second)³. However, subsequent trip commands would be processed faster, until by the second or third operation, the breaker would be operating at nameplate speed. Inspection of the breakers showed that improper maintenance procedures had been used, including the use of a non-recommended grease. This grease had thickened with age, causing sticking between two plates in the mechanism, which the low powered trip coil could not overcome.

Figure 2 - Improper lubrication of 25 kV breaker

On a less philosophical level, these outages spotlight the importance of proper (and properly documented) maintenance procedures. As companies downsize, experienced staff retires, or work is contracted out to third parties, some of these subtle but important maintenance procedures can be lost, either due to the disappearance of key staff, loss of critical documents, or contractual reasons

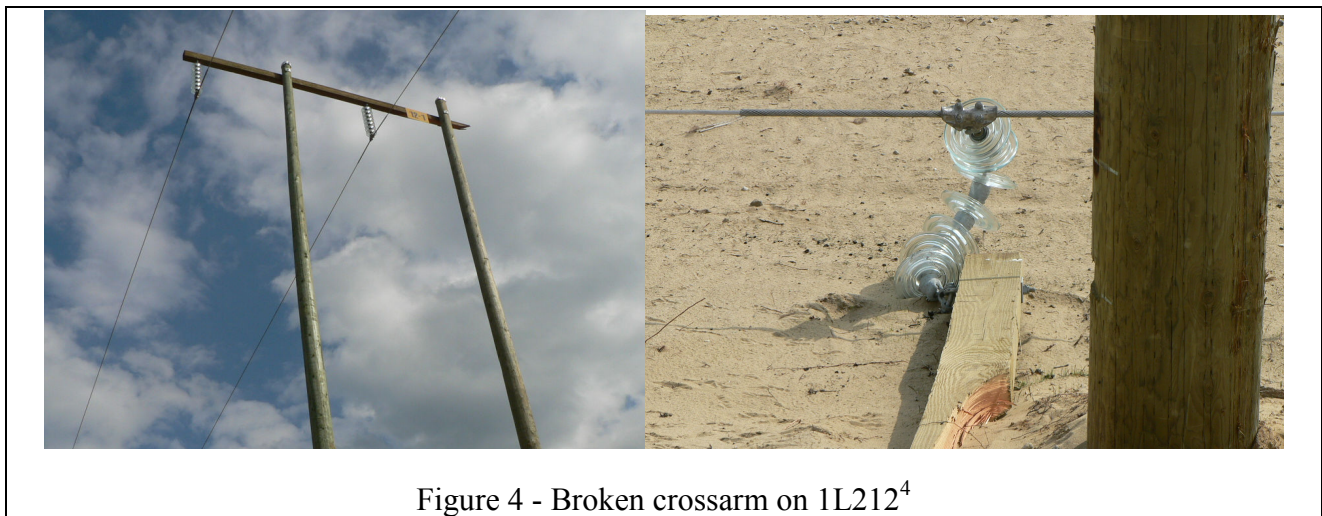
On 2007-06-18, existing AVO 1L211 line protection operated twice, isolating customer load at BLU and VLM, as well as the industrial load at FPS, ABA and REG. A line patrol failed to find any faults on 1L211. After sectionalizing at VLM, the line was successfully reenergized, however it tripped off again after 1L212 was reenergized. A line patrol of 1L212 found a broken cross-arm, one conductor hanging a foot above the sandy soil, and two dead bears near the conductor.

Figure 4 - Broken crossarm on 1L212⁴

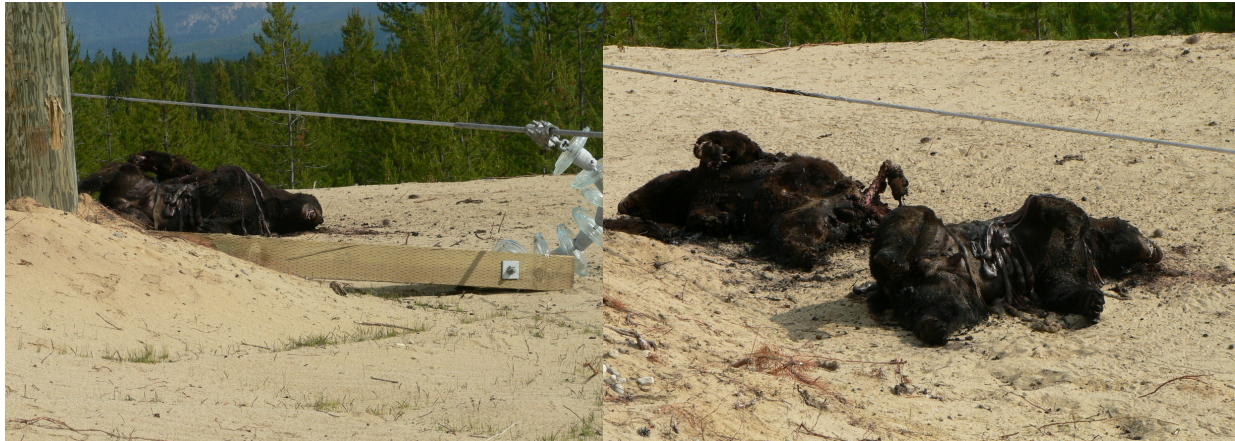
Figure 5 – High impedance ground fault on 1L212

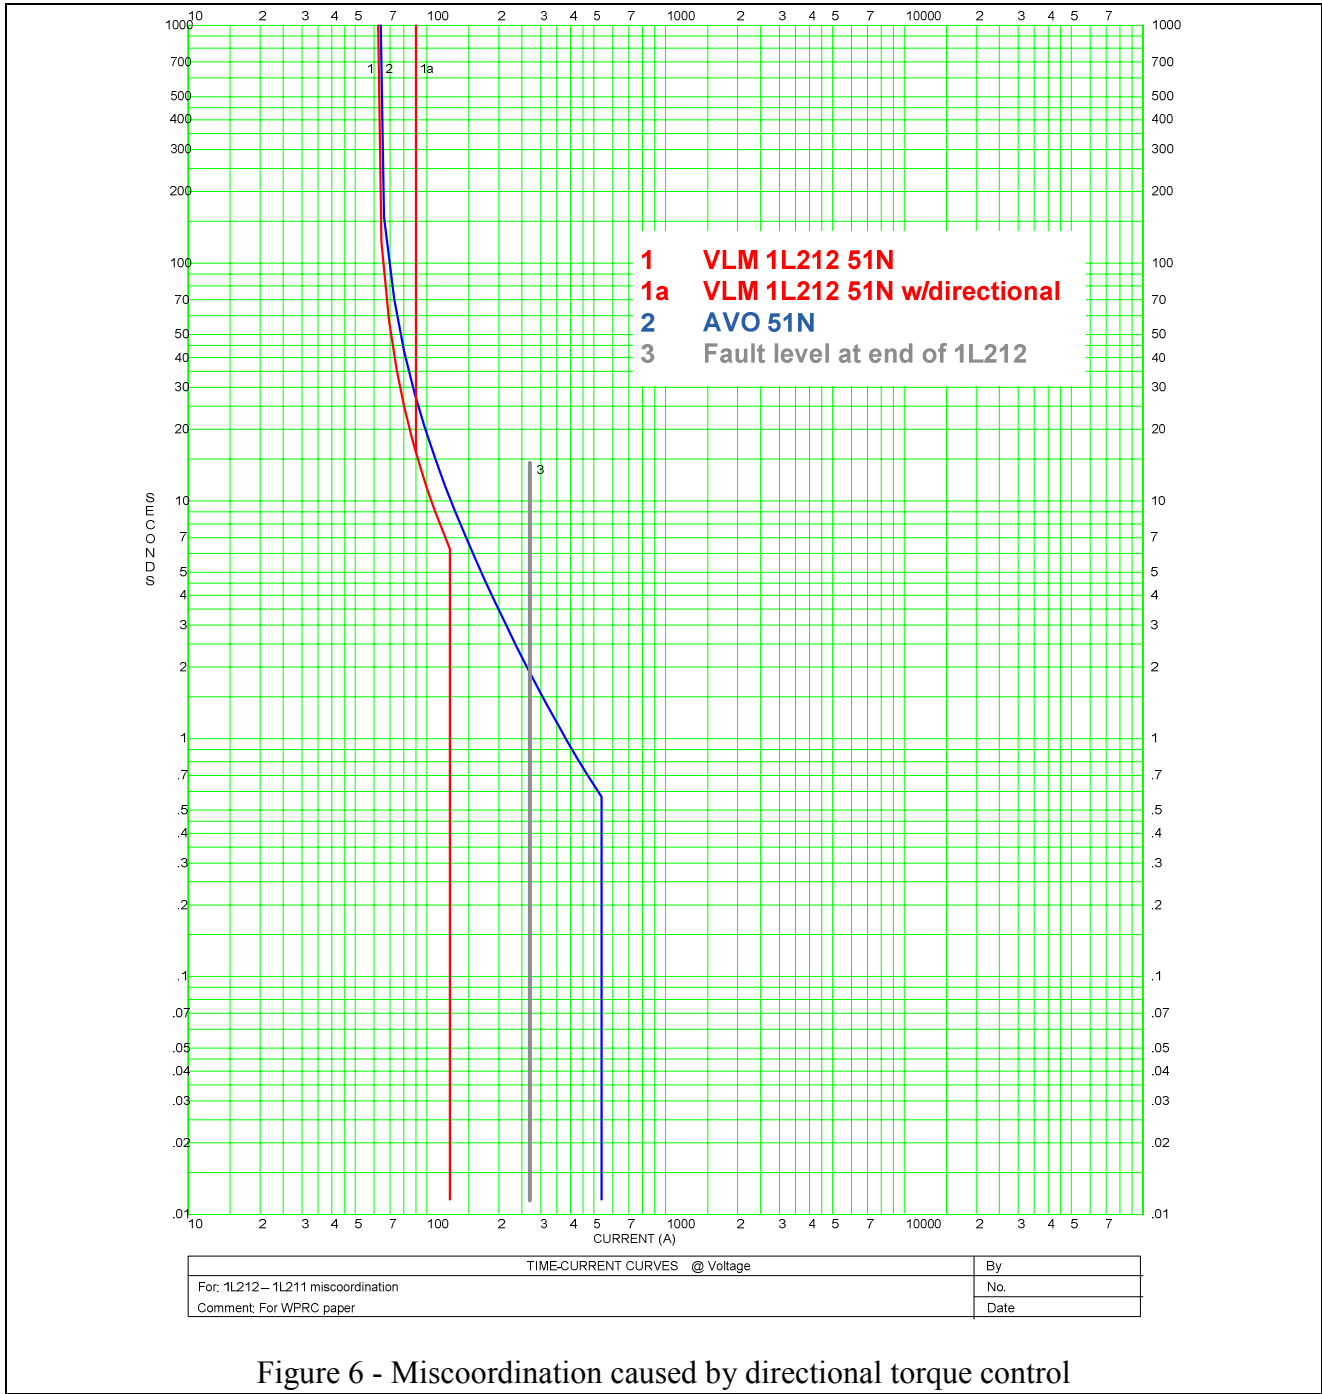
Post-analysis of the event records and settings from the AVO 1L211 and VLM 1L212 relays showed a subtle miscoordination between the ground elements on the two line protections. Both inverse time ground overcurrent elements were properly coordinated, but the effective pickup of the directional element torque controlling the 1L212 51N was set above the pickup of the element it controlled. The effective curves of the two overcurrent elements are shown in Figure 6. Note that the area of possible miscoordination is fairly small, especially when compared to the minimum bolted SLG fault level at the end of the line.

Figure 6 - Miscoordination caused by directional torque control

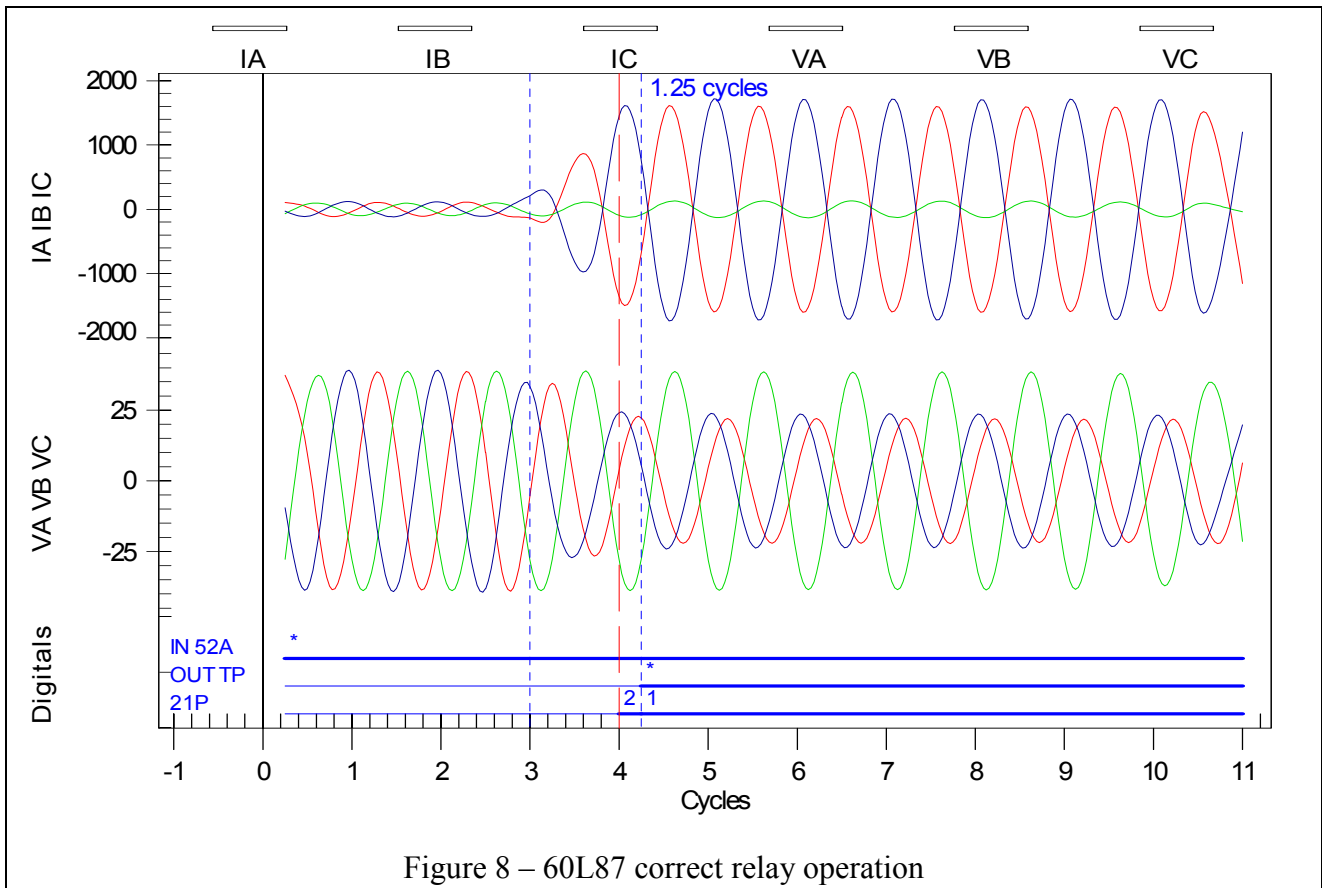
Post-disturbance analysis of the fault determined the initiating incident to be a phase to phase fault on line 60L87. The numerical stepped distance protection on the line at GOW substation detected the fault and tripped in 1.25 cycles. The breaker cleared the fault 6.75 cycles after that for a total of 8 cycles total fault clearing time. The event record for 60L87 is shown in Figure 8.

Figure 8 – 60L87 correct relay operation

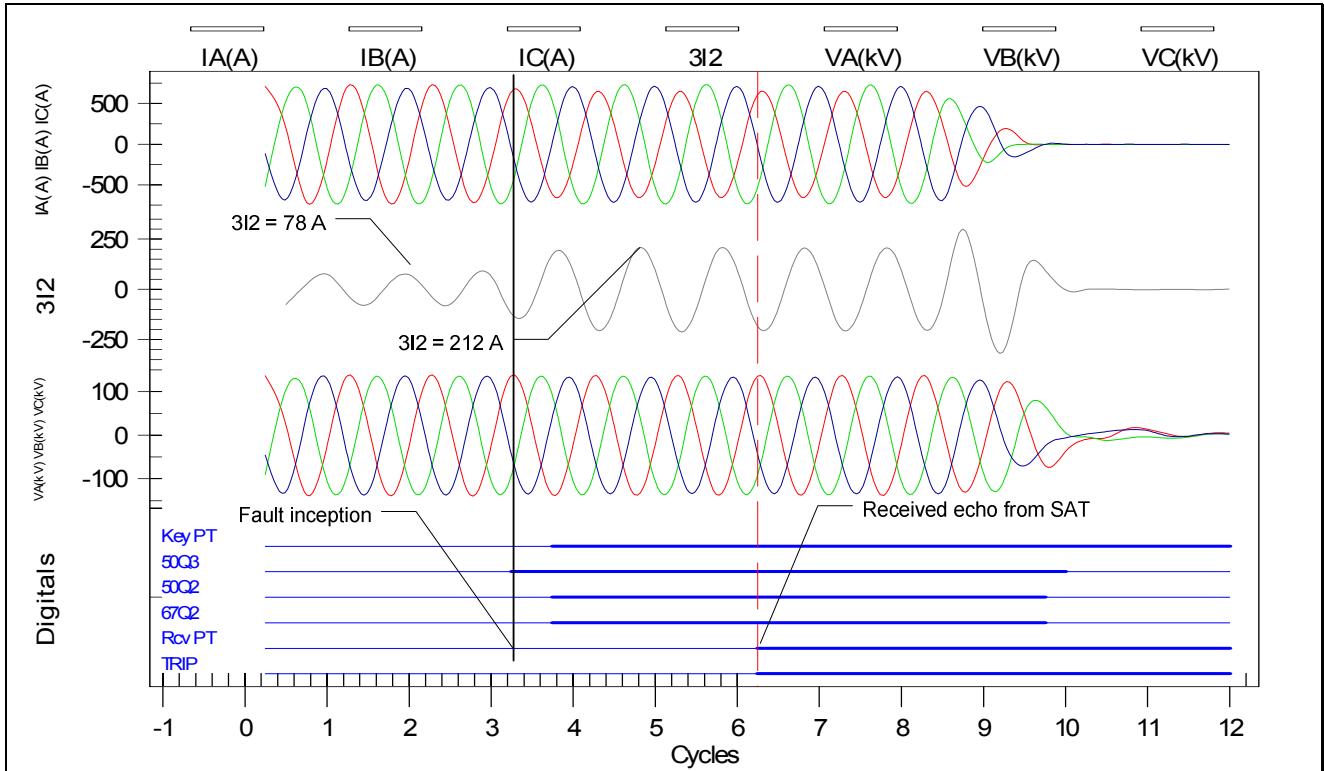
However, the fault quantities were also seen by the 2L128 protections at both SAT and DMR terminals. The permissive overreaching transfer trip scheme used for 2L123 and 2L128 uses forward and reverse looking phase mho elements for multi-phase faults, together with negative sequence directionalized negative sequence overcurrent elements for unbalanced faults. A setting error at DMR terminal (DMR terminal had a different CT ratio, but negative sequence overcurrent elements at both terminals had the same setting in secondary amps) resulted in the DMR terminal seeing the fault in the forward direction, while SAT was not able to see it in the reverse direction. As a result of this, DMR keyed permissive trip, SAT reverse blocking elements failed to block the echo, and DMR tripped upon receipt of it's echoed permissive trip. In Figure 9, the 60L87 fault inception can be seen at approx 3 cycles. 67Q2 (the forward looking negative sequence overcurrent element) picks up at 3.75 cycles, resulting in the keying of permissive trip to the SAT terminal. At 6.25 cycles, the echoed permissive trip is received from SAT and the DMR terminal trips and keys DTT to SAT.

Figure 9 – DMR 2L128 Misoperation

At DMR, because of the setting error, 50Q2 and 50Q3 (the level detectors in the negative sequence portion of the permissive scheme) were set at 200 and 132 pri A respectively. At SAT,

50Q2 and 50Q3 were set at 300 and 200 pri A respectively. In the event records above, the level of 3I2 after fault inception (approx 2.75 cycles into the fault record) is approx 212 A at DMR, while the SAT event record indicates 196 A of 3I2. The difference in measured I2 is reasonable, considering CT error, relay error and distributed negative sequence line charging current. However, this difference in measured I2, coupled with the setting error, caused the permissive scheme to fail to coordinate and the DMR terminal tripped after received echoed permissive from SAT.

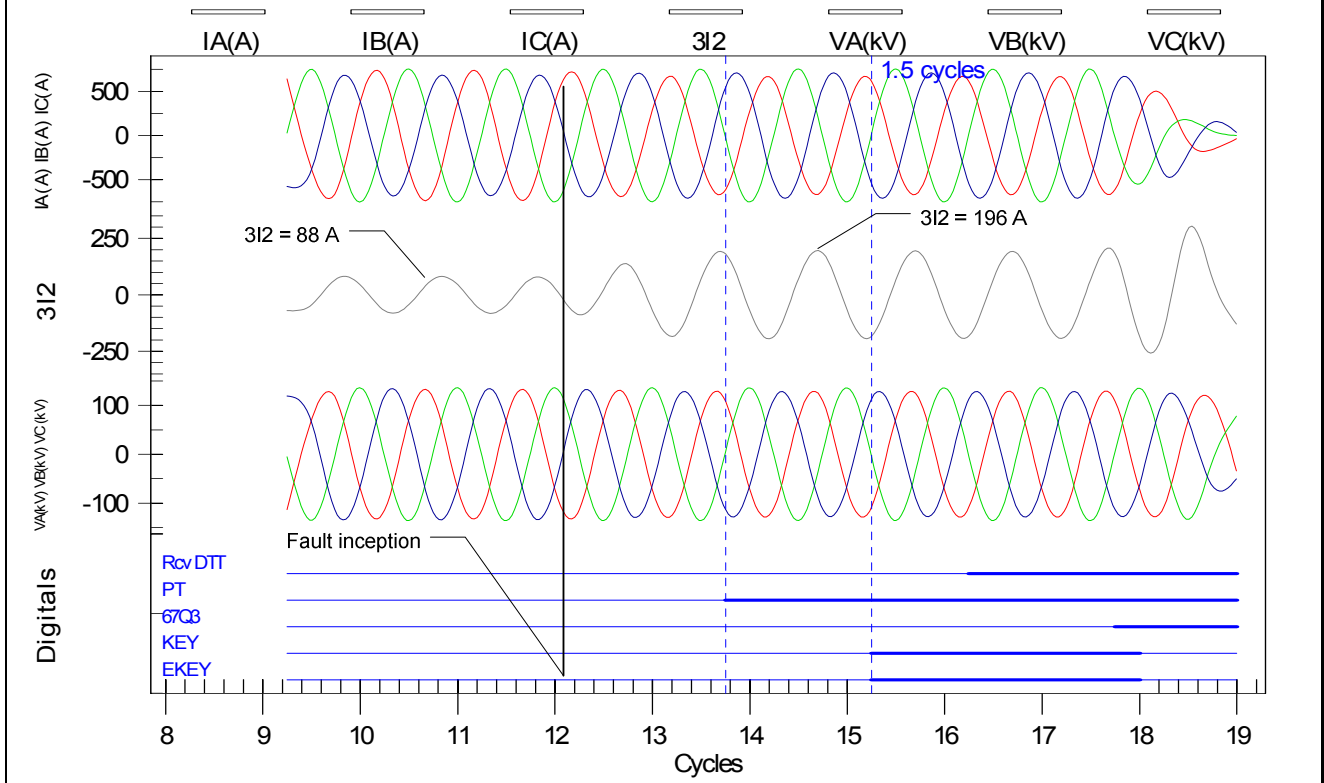
The event record from the SAT terminal is shown in Figure 10. Note that the reverse looking 67Q3 element does not pick up until the 2L128 breakers start to open. The absence of 67Q3 pickup allows the incoming permissive trip to be echoed after a 1.5 cycle delay. One cycle later, a DTT is received from DMR, indicating that DMR has tripped.

Figure 10 - SAT 2L128 failure to block

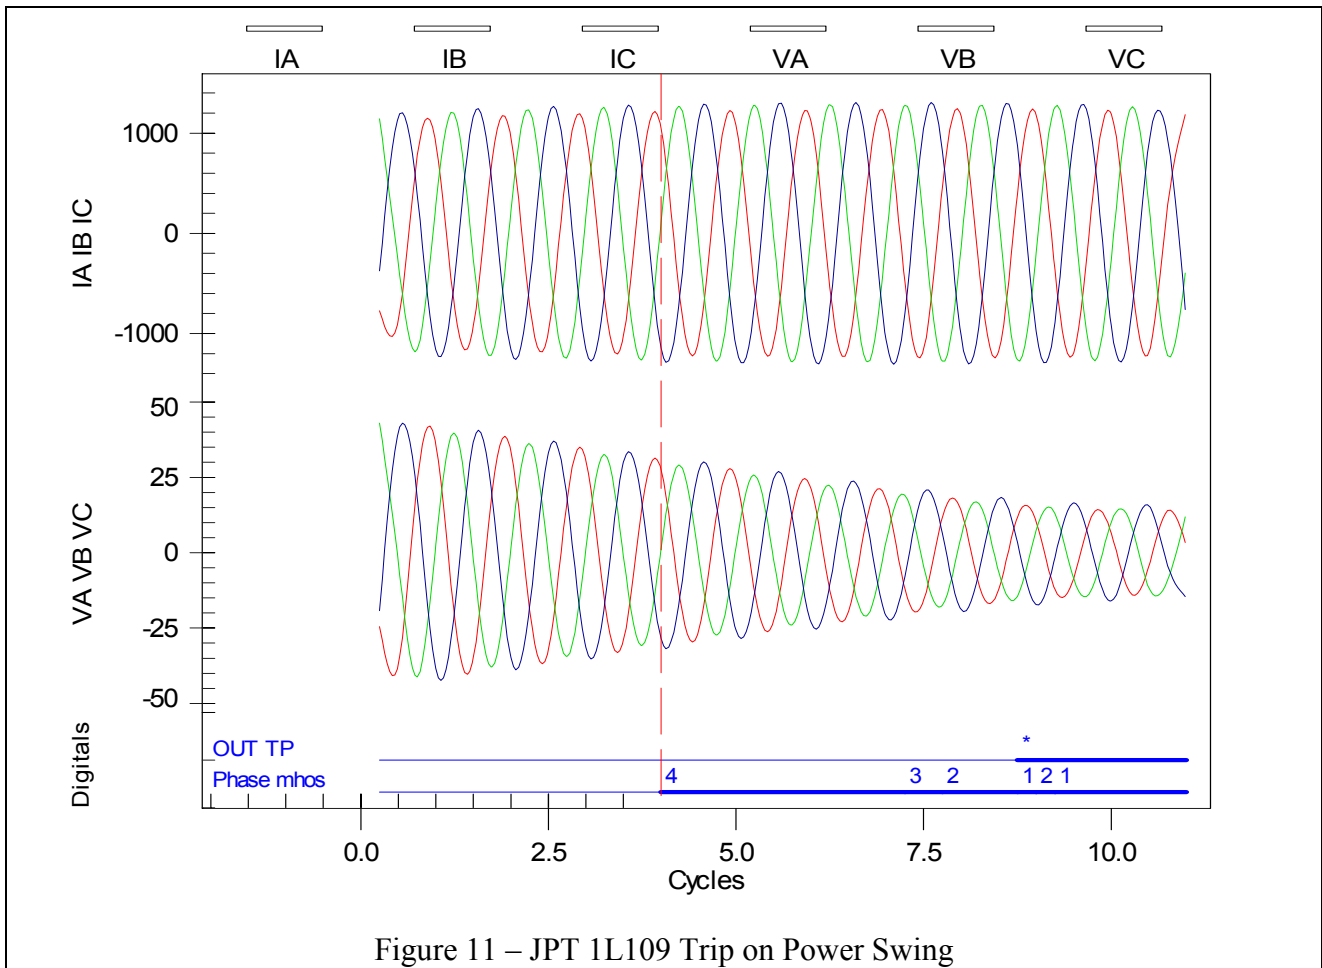
After 2L123 tripped, all SVI load previously fed via the 230-138 transformers at VIT was now solely connected to the DMR 138 kV bus (the HVDC supply at VIT was out of service). The load exceeded the transfer capability of the 138 kV lines and the three 138 kV lines between JPT and VIT tripped on their zone 1 distance elements as the power swing travelled through the lines, dropping all remaining load on the SVI system.

Figure 11 – JPT 1L109 Trip on Power Swing

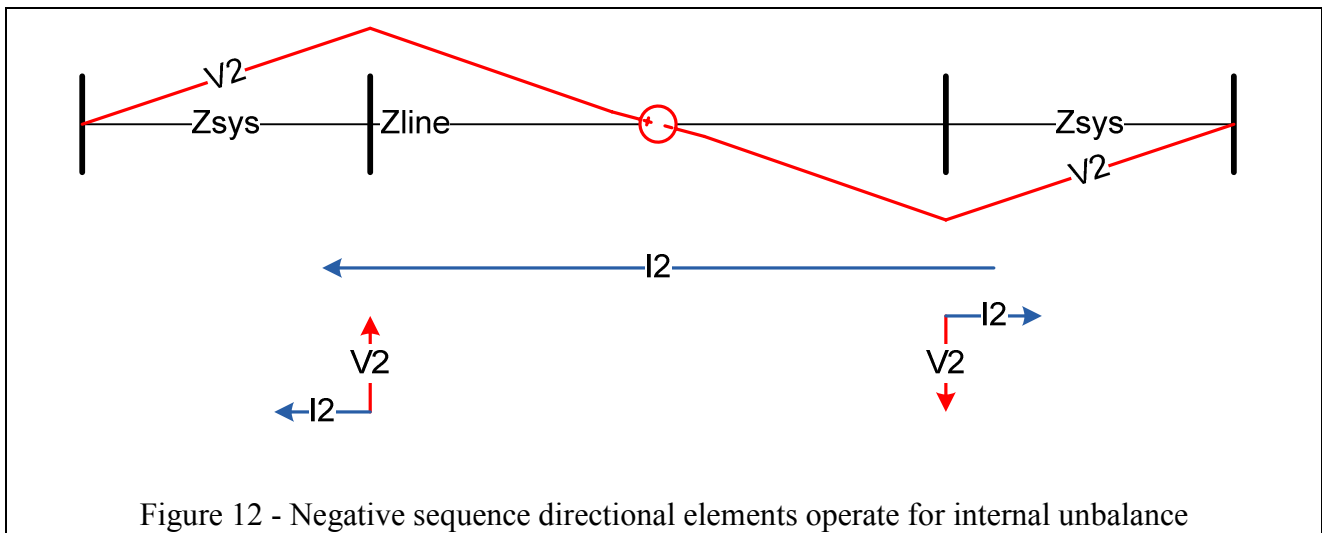
Unless transmission lines are properly transposed, positive sequence load or fault current through the line will result in zero and negative sequence quantities being generated within the line. The mathematical process for deriving the coupling coefficients are given in the EPRI red book[3], as well as the paper “Introduction to Symmetrical Components”, by Zocholl and Schweitzer[4]. Due to the non-zero off-diagonal elements in the sequence impedance matrix, imperfectly transposed (or untransposed) lines will have negative and zero sequence voltages induced along them due to positive sequence current flowing through them. These voltages will then drive negative and zero sequence current flows through the line. The important thing to note is that because the voltage source is **inside** the line, directional elements at both ends of the line will tend to see these quantities as a forward fault.

Figure 12 - Negative sequence directional elements operate for internal unbalance

In order to prevent directional elements from misoperating on internal imbalance caused by lack of line transposition, one can either block the elements when the negative (or zero) sequence current

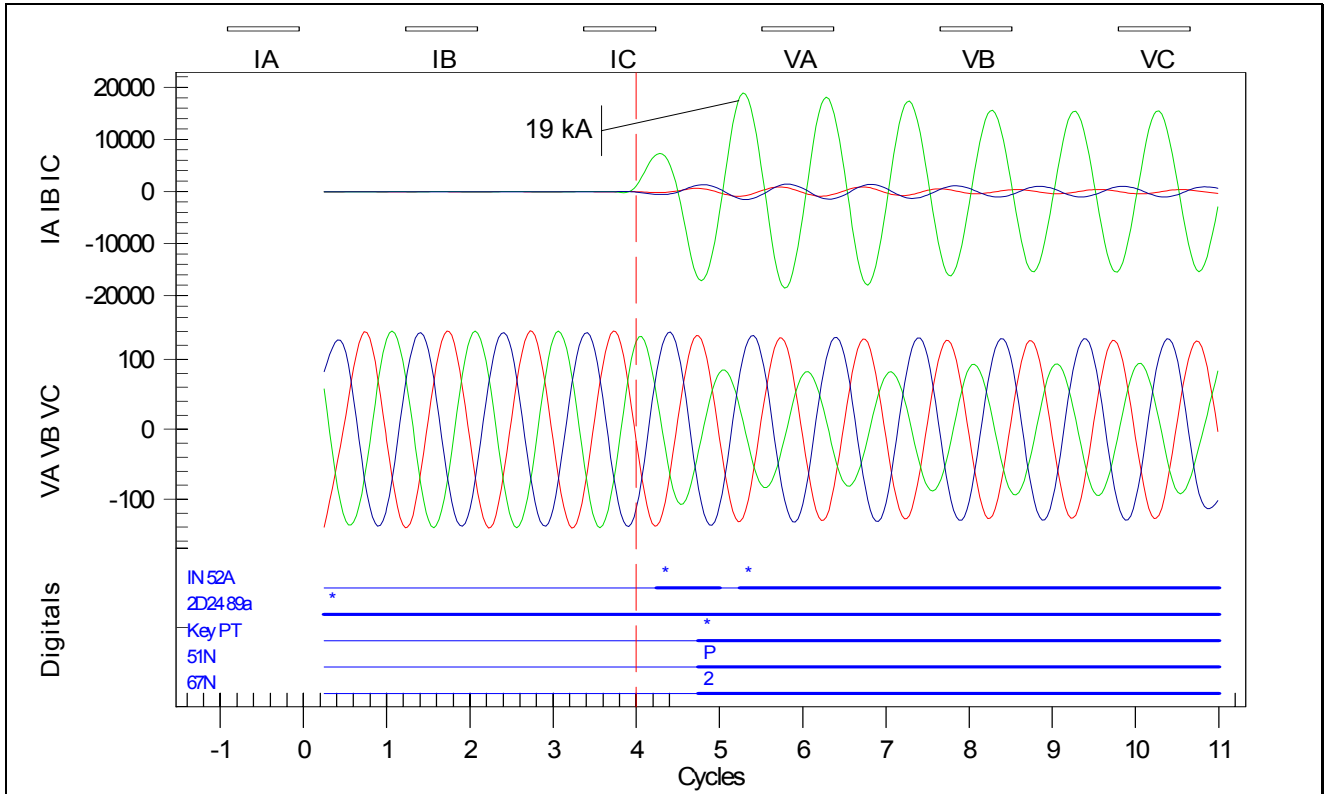
The initial fault record from HPN is shown in Figure 15. The nature of this fault (combination of open phase plus short circuit on a line with tapped load which was energized from the remote end) acted to allow this fault to go undetected by many of the standard schemes that protection engineers apply. A high set ground instantaneous overcurrent trip was not applied at HPN due to coordination difficulties (being a fairly short cable circuit, the fault levels do not change much over the length of the line) and ground mho elements were not applied since that vintage of relay did not have those elements. Since the fault was undetected by local protection schemes, it would have been expected that the permissive scheme would quickly clear the fault. However, due to the open circuit on B phase at HPN and infeed via a tapped station on 2L51 (BND), the negative sequence directional element on the COK end of the line saw the fault in the reverse direction (ref Figure 17) and blocked operation of the permissive scheme.

Figure 15 - HPN 2L51 Event Record (fault initiation)

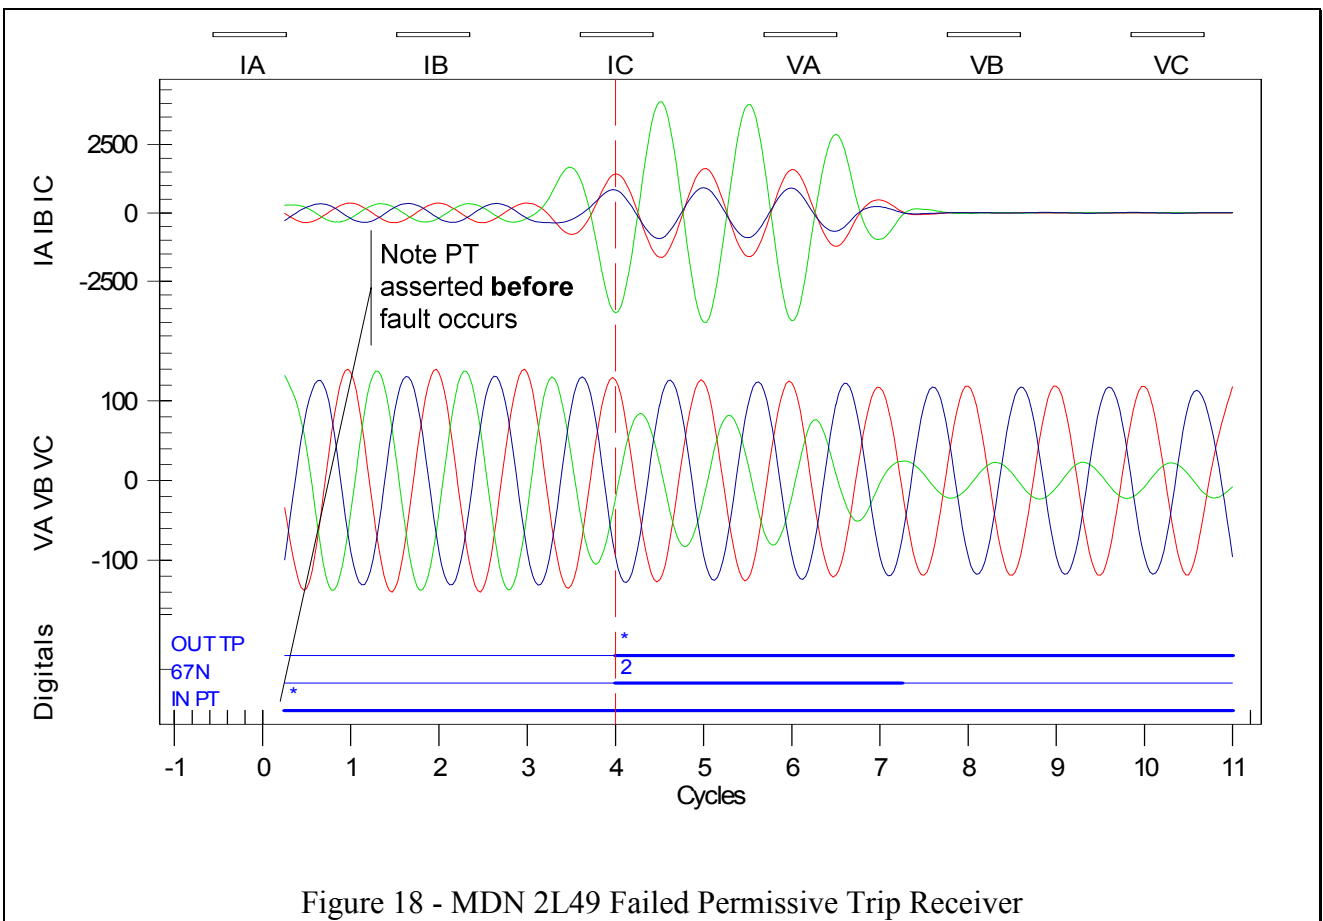
At this point, fault clearing was left to the inverse time ground overcurrent element at HPN. However, while this element was timing out, a number of other protections misoperated. The first misoperation was at the MDN terminal of 2L49, where a failed permissive trip tone receiver had resulted in the MDN 2L49 standby protection receiving a constant permissive trip. This terminal was able to see the HPN fault in the forward direction, so as soon as the forward elements picked up, the relay tripped.

Figure 18 - MDN 2L49 Failed Permissive Trip Receiver

The 2L49 outage (failed permissive trip tone receiver) highlighted the value of monitoring equipment. One of the outcomes of this outage was the creation of a “Standing incoming permissive trip” (incoming permissive trip asserted for more than 1 minute) alarm in numerical relays which were capable of performing this logic. Over the years, more and more items have been added, with the result that now we monitor standing permissive trip (on permissive schemes which still use tonegear), high levels of voltage or current imbalance, breaker or line current which disagrees with breaker or line disconnect status, as well as individual open poles in breakers (excessive 3I0 in the breaker with balanced currents in the line).
