UPRIVER DAM HYDROELECTRIC PROJECT:
FAILURE AND REHABILITATION

C. D. Robbins - Senior Member, IEEE
W. L. Shelton - Member, IEEE

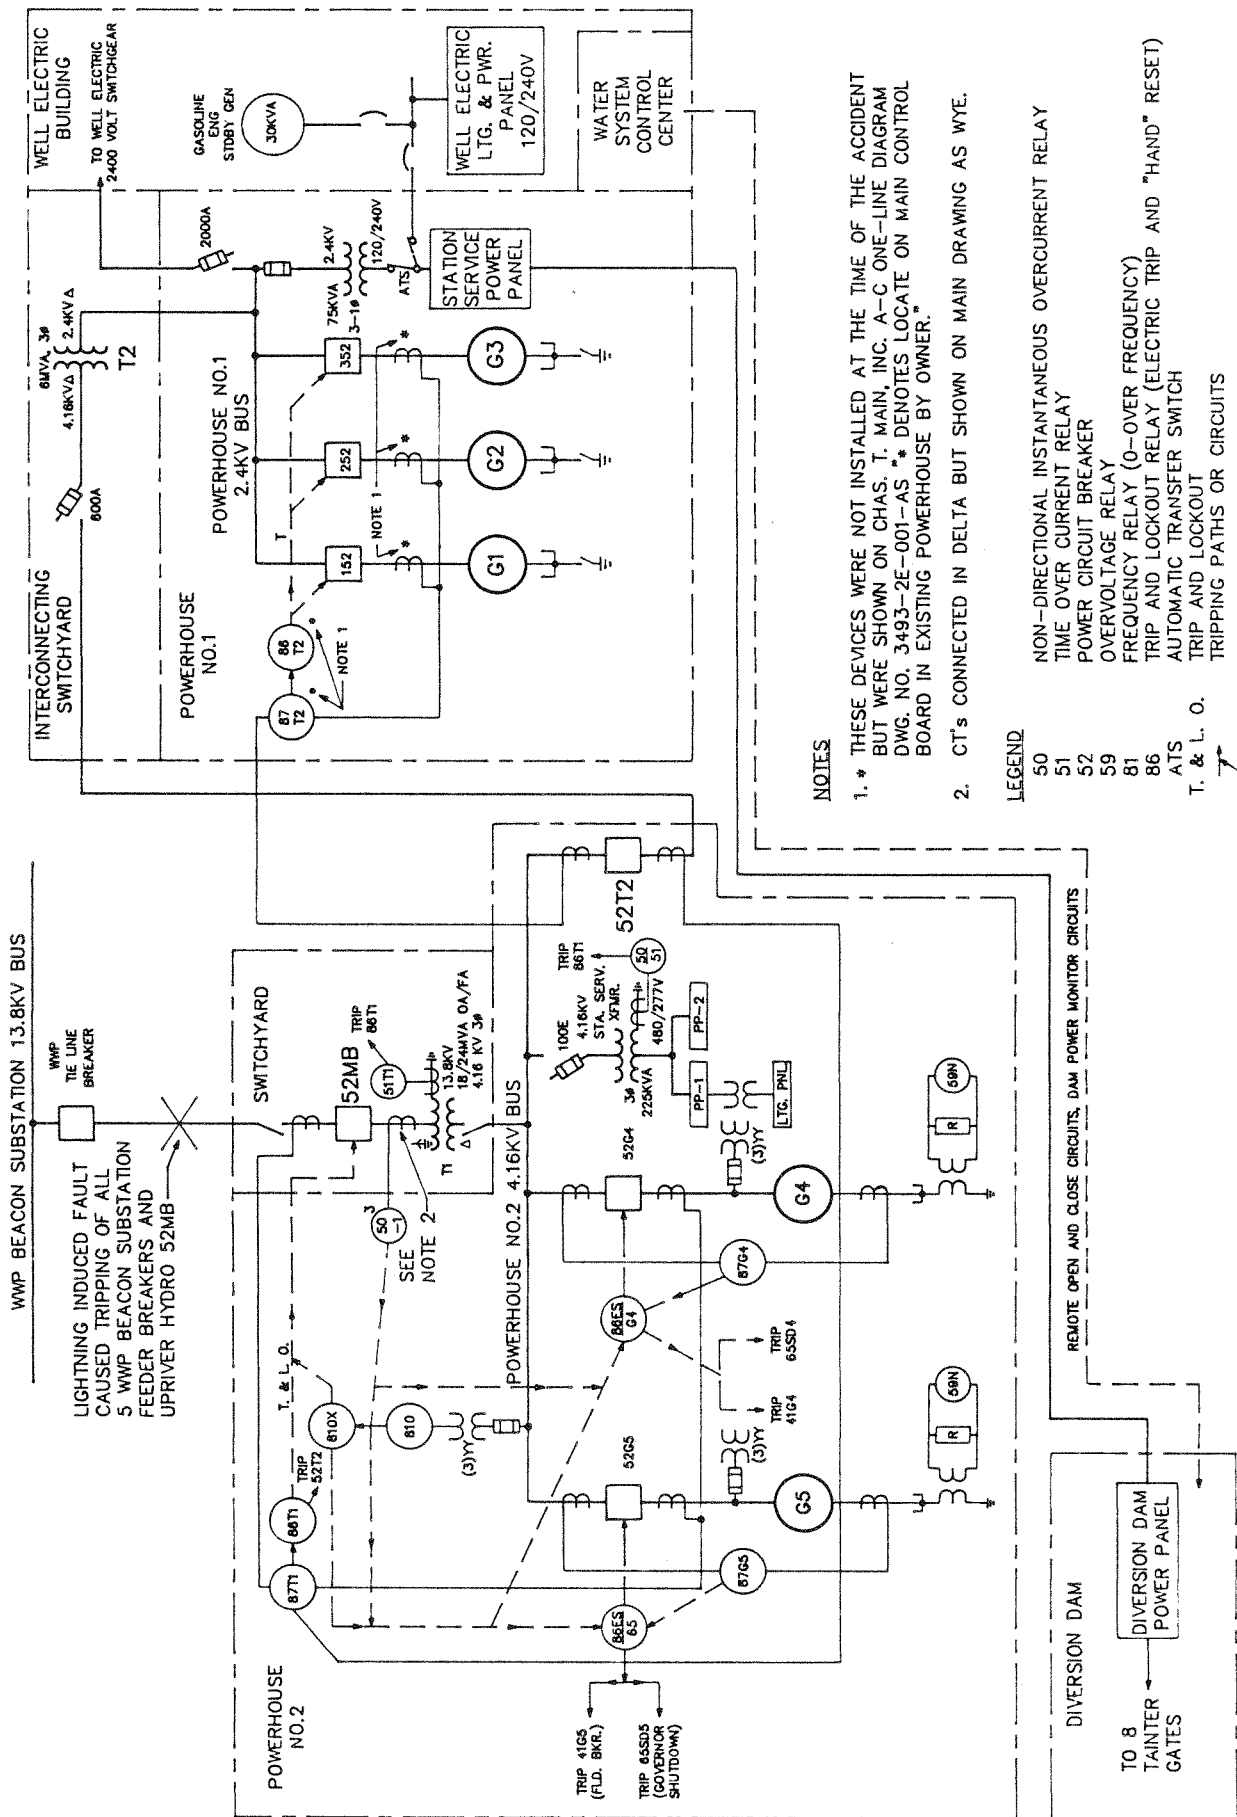
FIGURE 1 - PROJECT ONE-LINE DIAGRAM AS FOUND FOLLOWING FAILURE

A fault on the Washington Water Power (WWP) 13.8-kV interconnecting tie line to the Upriver Dam Hydroelectric Project caused the protective relaying to shut down and lock out all five generating units in the No. 1 and No. 2 Powerhouses. (See Figure 1.) This prevented operation of the spillway gates, leading to overtopping and breaching of abutments on both sides of the dam and closure embankments on both sides of No. 1 Powerhouse.

Preparation of the "Failure Investigation Report" and additional investigations revealed a number of irregular operating and protective relaying philosophies, the most significant of which was that the protective relaying scheme was designed to shut down and lock out all of the turbine-generator units for any fault in the vicinity of the Upriver hydro plants, including faults on the WWP system and the tie line to WWP. This, coupled with the lack of centralized control, the absence of a reliable standby power source to operate the dam gates and minimal freeboard for the forebay, was virtually a guarantee of the washout that occurred.

The problem of providing power to operate the dam gates was compounded by the requirement that the normal power for the gates came from the No. 1 Powerhouse station service bus, and the only tie to WWP was via the 13.8-kV line breaker at No. 2 Powerhouse. This breaker could only be closed at the breaker cabinet in the switchyard by placing the local-remote switch in "local" and operating the local control switch to "close" position. There were no interlocks or lockout contacts in this close circuit. After this breaker was closed to energize the plant, the 4,160-volt and No. 2 Powerhouse station service 480-volt buses and the No. 1 Powerhouse 2,400-volt and 240-volt buses had to be energized before normal power could be supplied to the dam gate hoist motors. This required closing of the tie between No. 1 and No. 2 Powerhouses via 52T2 and the 6 MVA, 4,160/2,400-volt transformer.

The line relaying was comprised of three instantaneous overcurrent relays, one in each phase. These relays were connected in the secondary of transformer bushing CT's. The existing three-line drawing showed these CT's connected in wye. During startup, when checking CT secondary currents, it was found that they were actually connected in delta. In the meantime, an overcurrent relay, which was connected in the station service transformer neutral, was removed from the station service neutral circuit and reconnected in the residual circuit of the line phase overcurrent relays. The transformer drawings showed all transformer CT's connected in delta, and it was found that the transformer drawings were correct. The

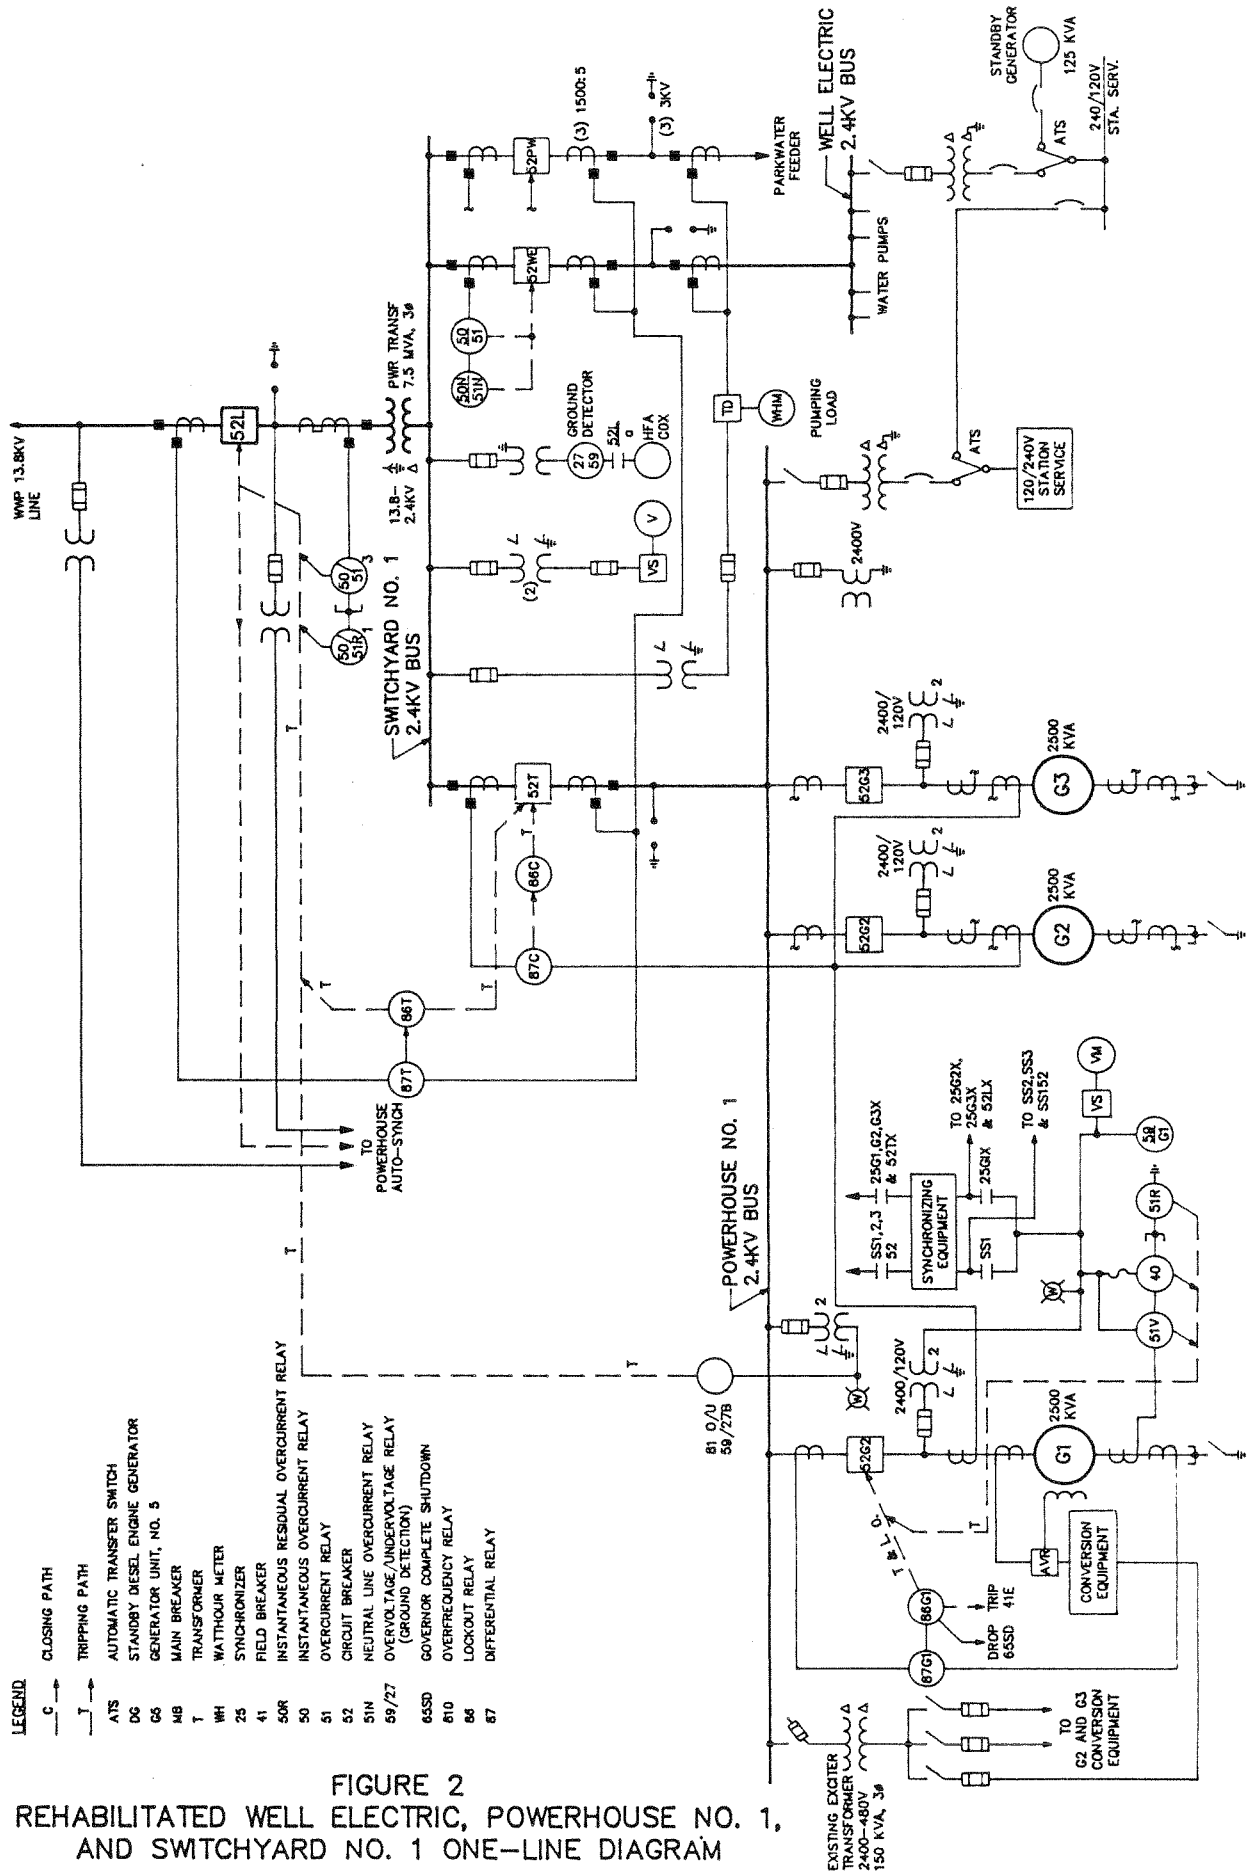
No. 1 Powerhouse underwent considerable automating and equipment upgrading. (See Figure 2.) The City took advantage of the opportunity by replacing 1936 vintage electrical and mechanical equipment with new state-of-the-art equipment. The three existing generator oil-circuit breakers were replaced with indoor metal-clad 5-kV switchgear with three 4.16-kV, 1,200-ampere air circuit breakers with 250-MVA short-circuit duty. The oil-filled station service transformer bank was replaced with a 75-kVA, 3-phase, 2,400-120/240-volt dry-type station service transformer and a 2,400-volt fused disconnect switch connected to the 2,400-volt generator bus. The existing transfer switch was replaced with a new automatic transfer switch. A new 240/120-volt, 3-phase station service switchboard and a new 125-volt dc panelboard were also installed. The following is a description of the rehabilitation.
