Forward to the Basics: Selected Topics in Distribution Protection

Lee Underwood and David Costello, *Schweitzer Engineering Laboratories, Inc.*

Abstract—Modern relays provide protection elements that were historically not used due to cost or panel space restrictions. These new elements can provide improved protection for the power system. However, protection engineers may be unfamiliar with the behavior of these elements and may make settings choices that lead to unintended consequences. At the same time, engineers must continue to properly employ good settings practices long established for more traditional elements.

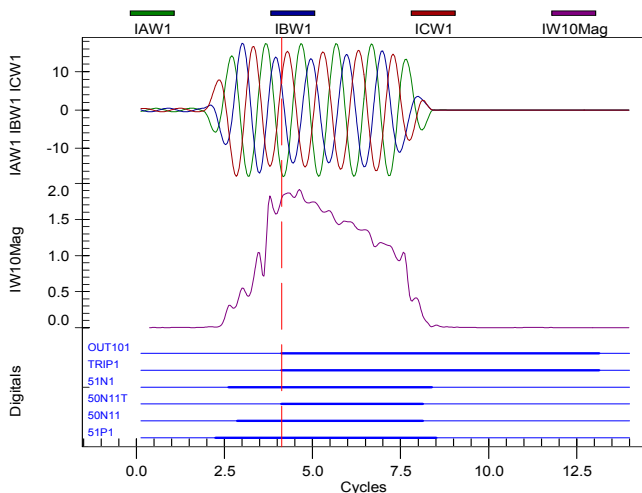
Fig. 2. Operation of Residual Overcurrent Element Due to Through Fault

Fig. 2 shows an event report captured by a transformer protection relay when a three-phase fault occurred on the low-voltage bus. The event report shows that a definite-time residual overcurrent element (50N11) on Winding 1 (the transformer high-voltage winding) asserted and tripped the breaker supplying the transformer approximately 2.5 cycles after fault inception.

This element, set to operate at 26.7 amperes primary with 1.25-cycle delay, was not intended to operate for a fault outside of the transformer zone. The value IW10Mag shows the magnitude of the zero-sequence current, I_0 , calculated by the relay. This current reached a maximum value of about 2 amperes secondary (160 amperes primary) and slowly decayed. This is false residual current that can be attributed to

dissimilar CT performance. Similar operations of very sensitive residual overcurrent elements have also been observed during transformer energization. Clearly, the possibility of poor CT performance was not considered when the setting for this element was calculated.

A conservative time delay for the residual element is determined by multiplying the expected decay time of the dc offset (3 to 5 time constants) by 1.5.

For example, if the X/R is 10, the minimum recommended time delay for a 60 Hz system would be 7 to 12 cycles.

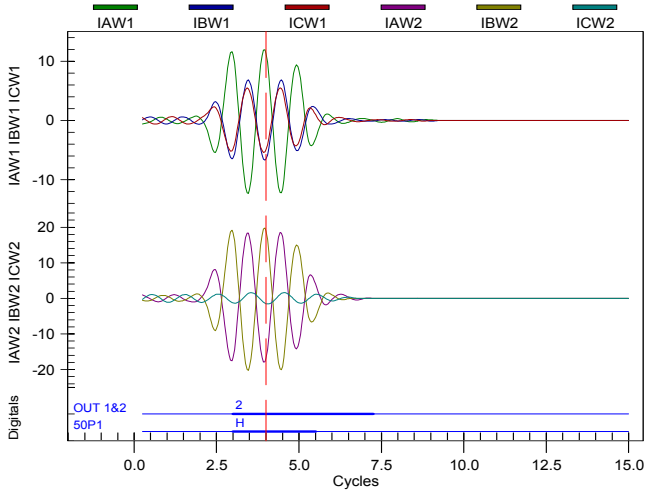
Fig. 4. Operation of Residual Overcurrent Element Due to Through Fault

Fig. 4 shows an event recorded by a transformer protection relay in a retail distribution substation. This event occurred when a tree caused a phase-to-phase fault one span out of the station on one of the 12.47 kV feeders. During this event, both the primary and backup transformer protection relays operated. In the primary relay, an instantaneous phase overcurrent element (50P1) had been set to operate without delay for 10 amperes CT secondary current on the high-voltage, delta-connected winding. The element operated because the relay current for this fault exceeded 12 amperes secondary.

It is obvious that some amount of 69 kV system impedance was considered when the pickup setting for the 50P1 element was established because the setting was below the fault current calculated in (3). The setting may have been appropriate for the assumed system impedance and would have provided better protection for the transformer than a higher setting. However, recall that this is a mobile transformer and, as such, is moved frequently to new locations. At different locations in the power system, the impedance of the source will vary.

In this case, the transformer was connected to the 69 kV system at a location with lower source impedance than was assumed when the setting was calculated. This increased the fault current available, and as a result, the 50P1 relay overreached and tripped improperly for a low-voltage line fault.

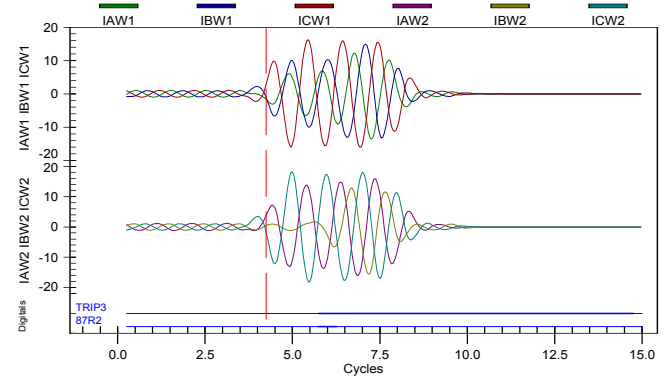
Fig. 5. Transformer Differential Relay Trips for an Out-of-Zone Fault

Fig. 5 shows an event captured upon the operation of a transformer differential element. This transformer is a delta-wye transformer in a retail distribution substation. As is typical for many such transformers, the neutral of the wye winding is effectively grounded. The presence of high Winding 2 current indicates that the fault is outside of the differential zone, as there is no significant source of current connected to the wye winding in this radial application.

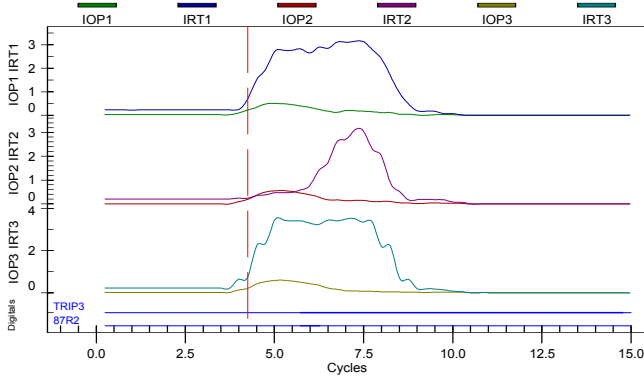
Fig. 6. Differential Relay Operate and Restraint Currents for Through Fault

Fig. 6 shows the operate (IOPn) and restraint (IRTn) currents calculated by the differential relay during the through fault. Note that when the differential element operated, as indicated by the 87R2 element plot, the operate current IOP2 exceeded the corresponding restraint current IRT2, allowing the relay to operate. Of course, the differential element was never intended to operate for a fault on a feeder breaker. What was the cause of this misoperation?

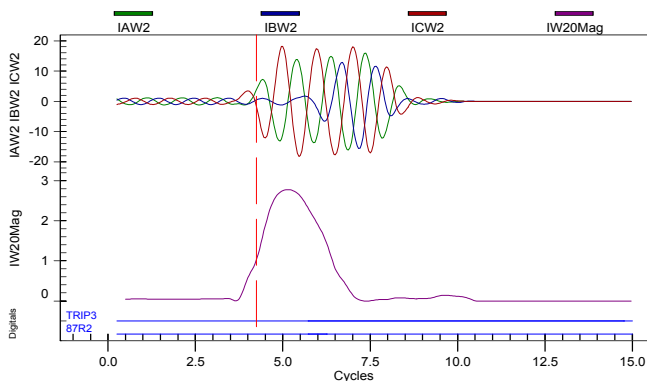
Fig. 8. Low-Voltage Winding and Zero-Sequence Currents for Through Fault

The relay settings for this application were correct to compensate the wye-winding currents for the 30-degree angle shift of the transformer. However, the settings did not correctly remove zero-sequence currents, as is required. Fig. 8 shows the low-voltage phase currents and the zero-sequence current on the low-voltage winding during the fault. Current magnitudes are shown on the CT secondary base. Although the phase currents indicate that the fault was initially phase-to-phase and evolved into a three-phase fault, the presence of zero-sequence current indicates ground involvement.

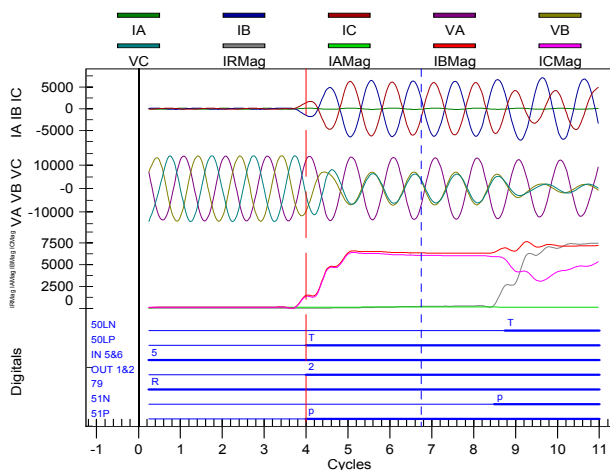
Fig. 11. Feeder Breaker Relay Response to Fault at Location F2

Fig. 11 shows an event report captured by a feeder relay when a fault occurred on the feeder. The fault started as a phase-to-phase fault but transitioned within five cycles to a phase-to-phase-to-ground fault. The event data show that a phase time-overcurrent element (51P) asserted, started timing to trip, and simultaneously closed the blocking output contact (OUT2) to prevent the main breaker relay from operating.

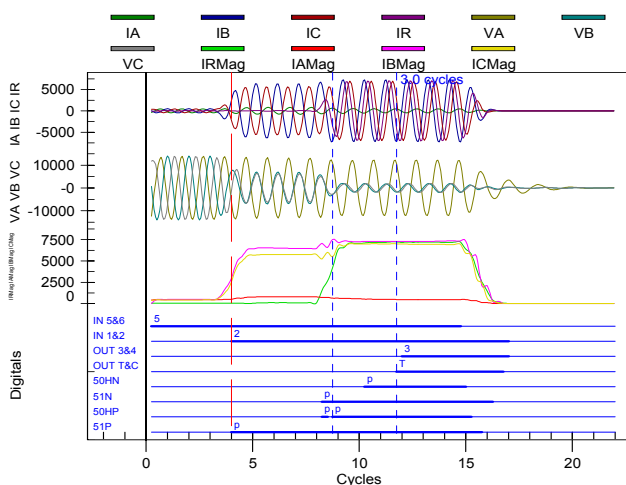
Fig. 12. Main Breaker Relay Response to a Fault at Location F2

Fig. 12 shows an event report captured by the main breaker relay for the same fault. At the beginning of the fault, Input 2 (IN2) asserted. As the fault transitioned, the bus protection elements (50HP and 50HN) asserted and began timing to trip. After a short three-cycle coordination delay, the 50HP element tripped the bus main breaker. This de-energized the faulted feeder in addition to several unfaulted feeders.

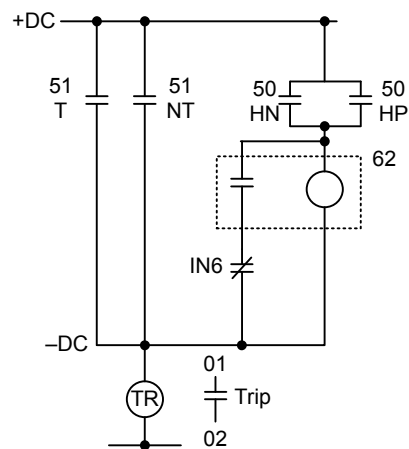
Fig. 13. Main Breaker Relay Trip Logic

Fig. 13 is a representation of the trip logic settings in the main breaker relay. The block signal, according to settings, was expected to be received on Input 6, IN6. Recall that the event data from Fig. 12 show that the blocking signal was actually received on Input 2, IN2.

We can say with confidence that this scheme was not fully tested during initial commissioning because this wiring error would have been found. We suspect that the lack of a logic diagram such as Fig. 13 contributed to the testing failure. We also suspect that the location of the feeder relays in the switchyard breaker cabinets and the bus main breaker relay inside the substation control building contributed to the testing failure. A valid test would have involved thoroughly testing the feeder relay and proving its output contacts worked. Then a jumper should have been applied to the blocking contact at the feeder relay, while performing current injection tests at the main breaker relay. If this had been performed, the improper tripping of the main breaker would have been observed. The wiring error would have been found before it led to a bus outage. A detailed logic diagram would have assisted in recognizing the need for, and the development of, a test procedure [4].

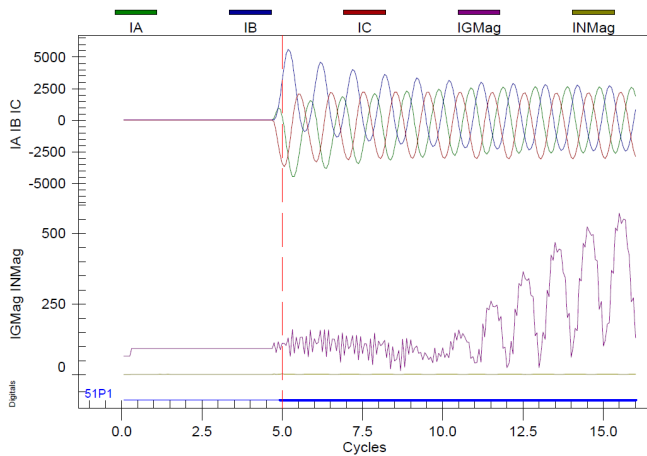
Fig. 14. Raw Microprocessor Relay Data from 15,000 HP Motor Start

In Fig. 14, raw or unfiltered data from the relay is shown. The 310 ground current calculated from the three-phase CTs is shown as IG. The measured ground current from the zero-

sequence CT is shown as IN. Phase current magnitude, asymmetry, unbalance, and the resulting CT saturation during the motor start are the causes of false IG residual current. Notice that IN remains at zero.

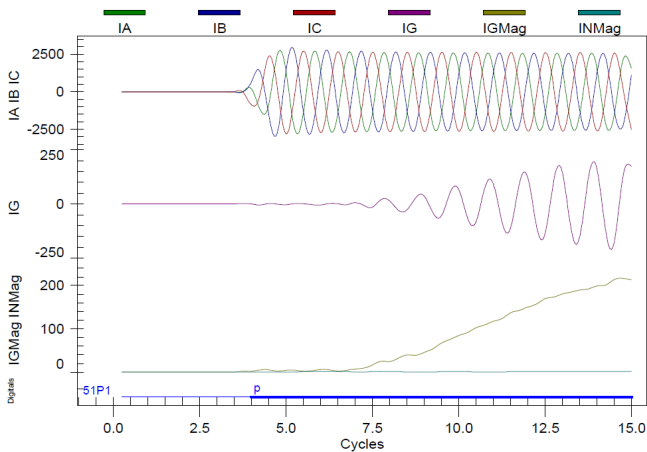
Fig. 15. Filtered Microprocessor Relay Data from 15,000 HP Motor Start

Fig. 15 shows the filtered currents from the same motor start. A 50G element, operating from the sum of the three-phase CTs, should be set no more sensitive than 1.5 amperes secondary [5]. From event data collected during motor starts, we observed that the CT unbalance subsides after about 30 cycles, or 0.5 seconds. Based on this, a 50G pickup of 2.0 amperes secondary with a time delay of 30 cycles was implemented, taking into account observed starting unbalance and observed starting times.

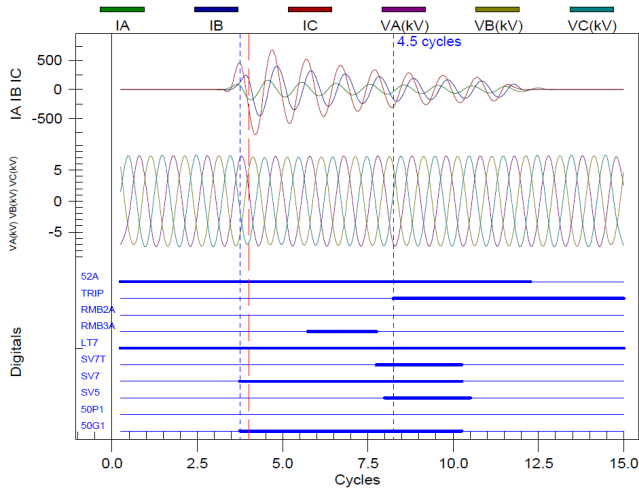
Fig. 17. Bus-Tie Breaker Relay Trips During Commissioning Tests

When the feeder breaker was closed, the bus-tie breaker tripped unexpectedly. Nothing else in the substation tripped. The event report data collected from the bus-tie breaker are shown in Fig. 17. The trip was generated by a ground overcurrent element, 50G1, after a four-cycle fast bus trip scheme delay. In this design, the blocking signals for the fast bus trip scheme are received via fiber-optic communications.

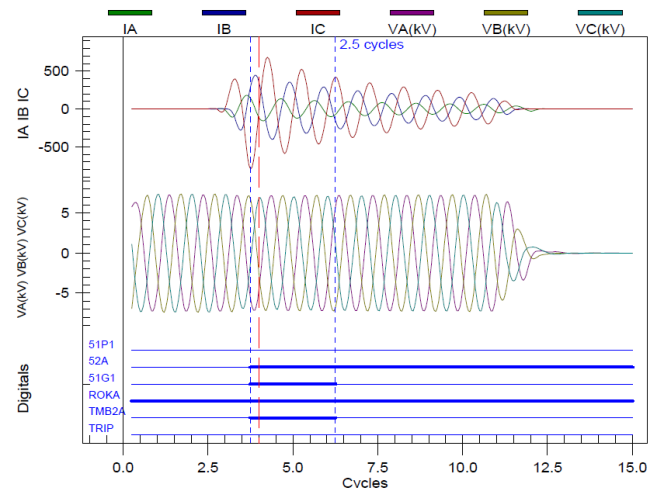
Fig. 18. Feeder Breaker Relay Data During Commissioning Tests

The feeder breaker relay did generate event data when it was closed, but it did not trip. From the data shown in Fig. 18, we verified that load current was picked up and that a blocking signal was sent for 2.5 cycles to the bus-tie breaker relay. Phase currents substantially lagged their respective phase voltages. Raw or unfiltered data show that the current was largely harmonic inrush, picking up downstream transformer loads. The ground current (calculated from the sum of the three-phase currents) was relatively low compared to the maximum phase current in the feeder.

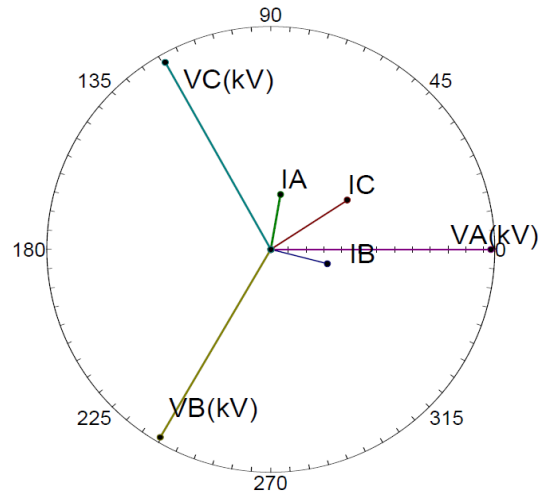
Fig. 19. Bus-Tie Breaker Relay Phasor Data During Commissioning Tests

When we look at the bus-tie relay's phasor data in Fig. 19, we notice first that the phase angles of IA and IB are 180 degrees out of phase with those recorded by the feeder relay. That is expected, in this case, due to the opposite polarity of the CTs for these relays. However, the C-phase polarity in the feeder and the bus-tie breaker relay match, indicating that we have a CT polarity problem in the bus-tie relay circuit.

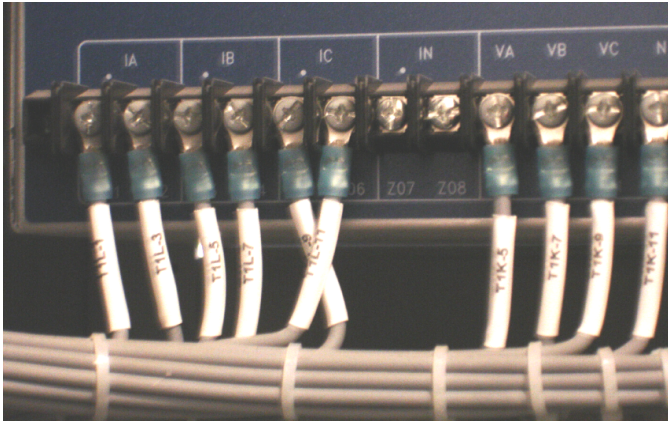
Fig. 20. CT Polarity Wiring Problem Found and Fixed

The photograph of the relay terminal block wiring, shown in Fig. 20, confirmed that the intent of engineering drawings and wire labels was correct. The wires for C-phase current were rolled at the panel shop during panel construction, and wiring tests did not find the error there.

Interestingly, the panels underwent a second round of testing at a drop-in control building manufacturer. The process of testing wiring was this: currents of 1 amperes, 2 amperes, and 3 amperes were injected from a test set into Ia, Ib, and Ic terminal block positions, respectively. All currents were injected at phase angle zero degrees. The current magnitudes were then read from a panel-mounted HMI (human-machine interface) screen, confirming that no phases were crossed. However, this test did not check for incorrect polarity. A balanced three-phase test was added to the standard test routine based on this lesson learned.

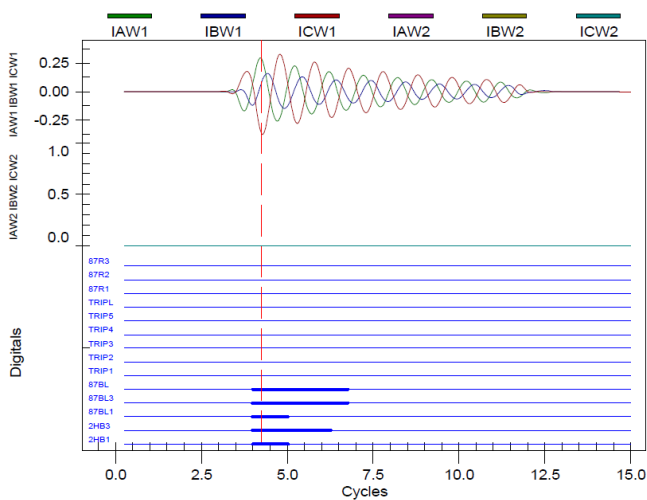
Fig. 21. CTs Shorted on Differential Relay Low-Side Winding

Recall that the purpose of this exercise was to commission the transformer differential relay. The data recorded by the transformer differential relay during the first close (and trip) operation are shown in Fig. 21. The differential relay did not trip, but event capture was triggered by the assertion of a harmonic restraint element, 87BL. However, one thing is clear; there are no low-side currents measured at the relay. In fact, the CTs on either side of the low-side main breaker were found to be shorted. This again speaks to the need for better commissioning tests, including primary injection tests, for checking out new transformer differential installations [7].

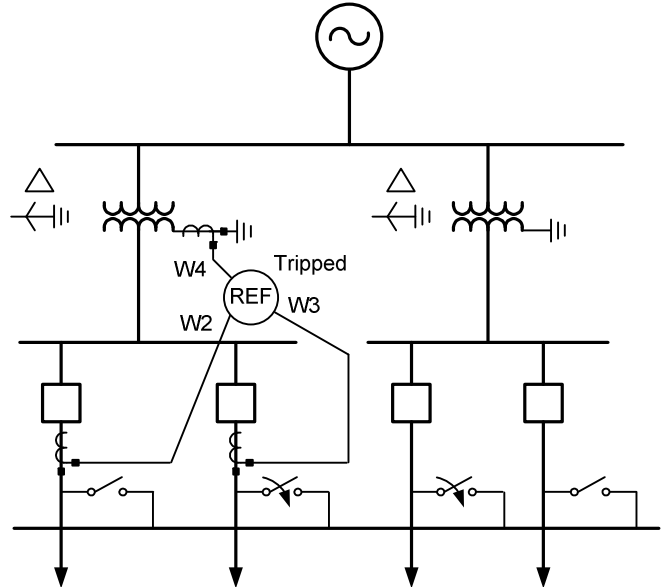
Fig. 22. Simplified One-Line Diagram of REF Operation

The REF installation shown in Fig. 22 tripped when load was picked up by closing a feeder tie switch. This meant that a wiring or setting problem might exist, or the transformer really had an internal ground fault.

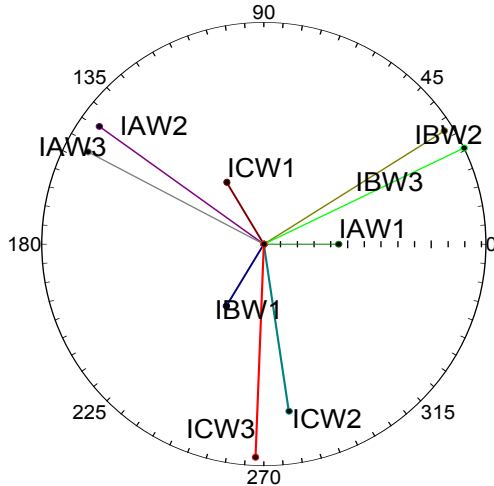
Fig. 23. Winding Currents From Differential Relay Match Expectations

Fig. 23 shows the high-side and low-side phase currents from the event data recorded by the relay. For an ANSI standard transformer with wye CTs, we expect the low-side CT secondary currents (W2 and W3) to lead the high-side CT secondary currents (W1) by 150 degrees. Fig. 23 matches expectations, so the terminal CTs used by the REF element are correct.

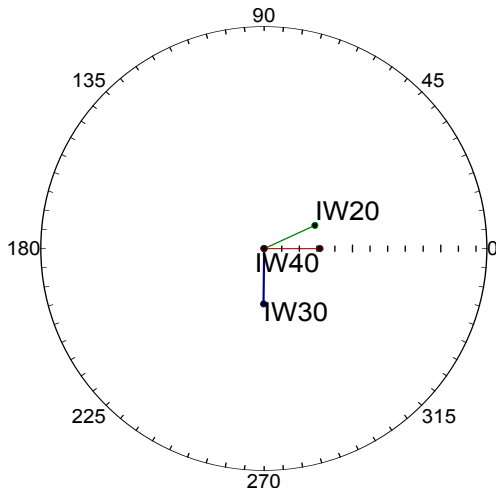
Fig. 24. REF Currents Do Not Match Expectations

The X0 bushing CT, however, needs to be checked. The zero-sequence reference current (IW40) and terminal currents (IW20 + IW30) are nearly in phase (Fig. 24). This indicates that either the X0 CT is connected with incorrect polarity or an internal ground fault exists.

We now must determine if the trip was due to an actual internal ground fault. During the trip, the two transformers were paralleled via the transfer bus. Therefore, W3 would have been a source of ground fault current for an internal winding fault. However, during another event report trigger, taken two weeks later, the two buses were not connected. In other words, W3 was a radial load and not a zero-sequence source, at that time. The zero-sequence phasors look identical to those in Fig. 24. Therefore, we can say with confidence that the reference CT, the X0 bushing single-phase CT, is connected with opposite (and incorrect) polarity. This was the root cause of the misoperation.

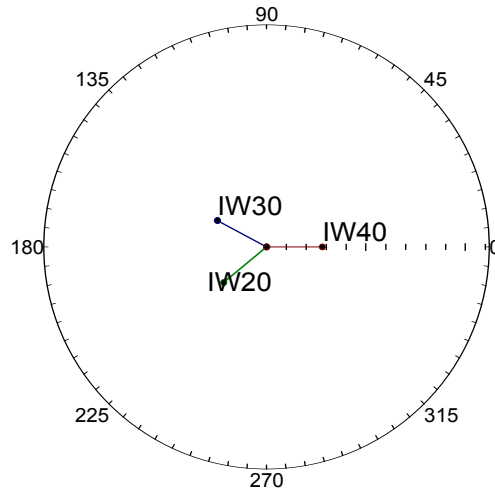
Fig. 25. REF Currents in Parallel Transformer During Normal Load

Consider the zero-sequence phasors shown in Fig. 25. These were recorded during normal load from the parallel transformer bank. The zero-sequence current is standing load unbalance on the distribution system and should therefore look like an external zero-sequence condition. It does; the reference (IW40) is nearly out of phase with the terminal currents (IW20 + IW30).
