Analysis of Mutual Coupling Effect on DCB Scheme Operation for an External Fault

By: Yujie Irene Lu, National Grid

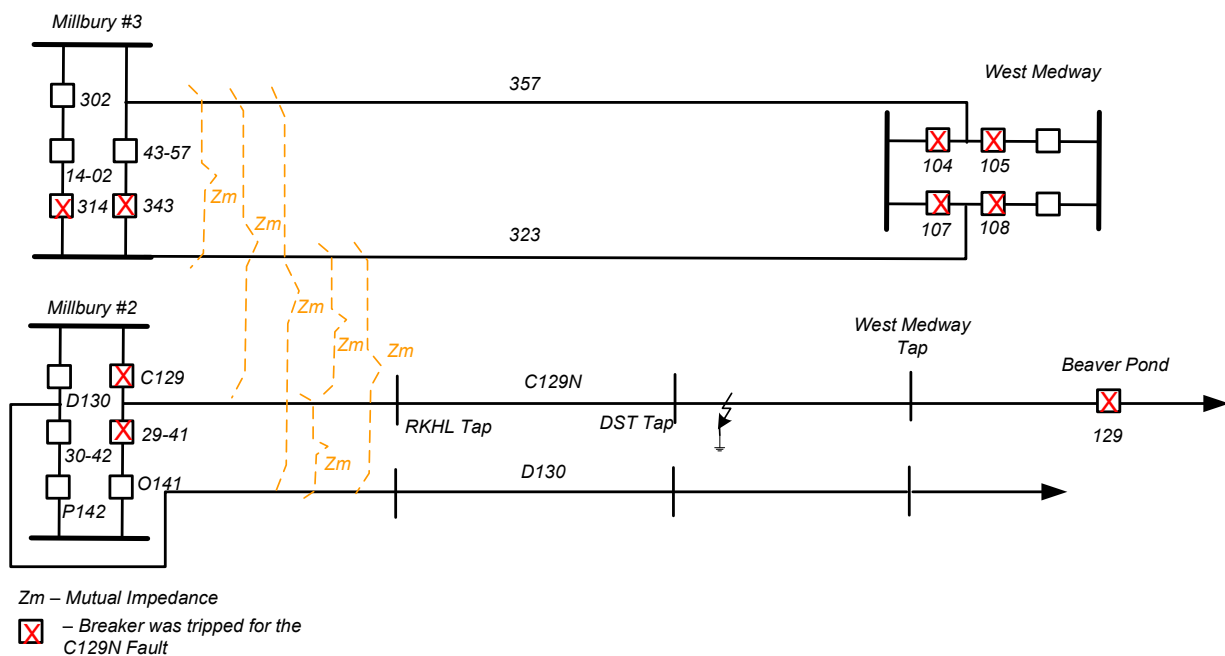
Figure 1. System One Line Diagram with the C129N Line Fault

Refer to the system one-line configuration (Figure 1), it is noted that the 115kV C129N and D130 lines are mutual coupled and tied together on the same bus at the Millbury #2 substation, and the 345kV 323 and 357 lines are mutual coupled and tied together on the same bus at both Millbury #3 and West Medway substations. However, the two pairs of the lines are not connected together through transformers, i.e. with zero sequence isolation, except mutual coupling. This fact implies that, during this fault, the directional ground relays on the 323 and 357 lines might challenger to sense direction correctly. Besides the possible directional sensing issue, it is believed that the increasing magnitude of ground fault current, i.e. 3I0, on the two 345kV lines contribute to the CDG false operations.

1. Due to the physical arrangement between the lines and the different voltage level of the lines (Figure 1), the mutual coupling effect was more significant on the 323 lines than on the 357 and D130 lines during the original C129N fault. In other words, the magnitude of the ground fault current 3I0 on the 323 Line increased more significantly than on the other two lines. In addition, the level of magnitude increase of 3I0 also depended on the fault locations. For the C129 faults located between the Rocky Hill (RKHL) tap and West Medway tap, the ground current 3I0 on the 323 Line might exceed the pickup setting of 360 amperes on the 323 CDG relays at the Millbury #3 and West Medway. See Table 2 in detail.

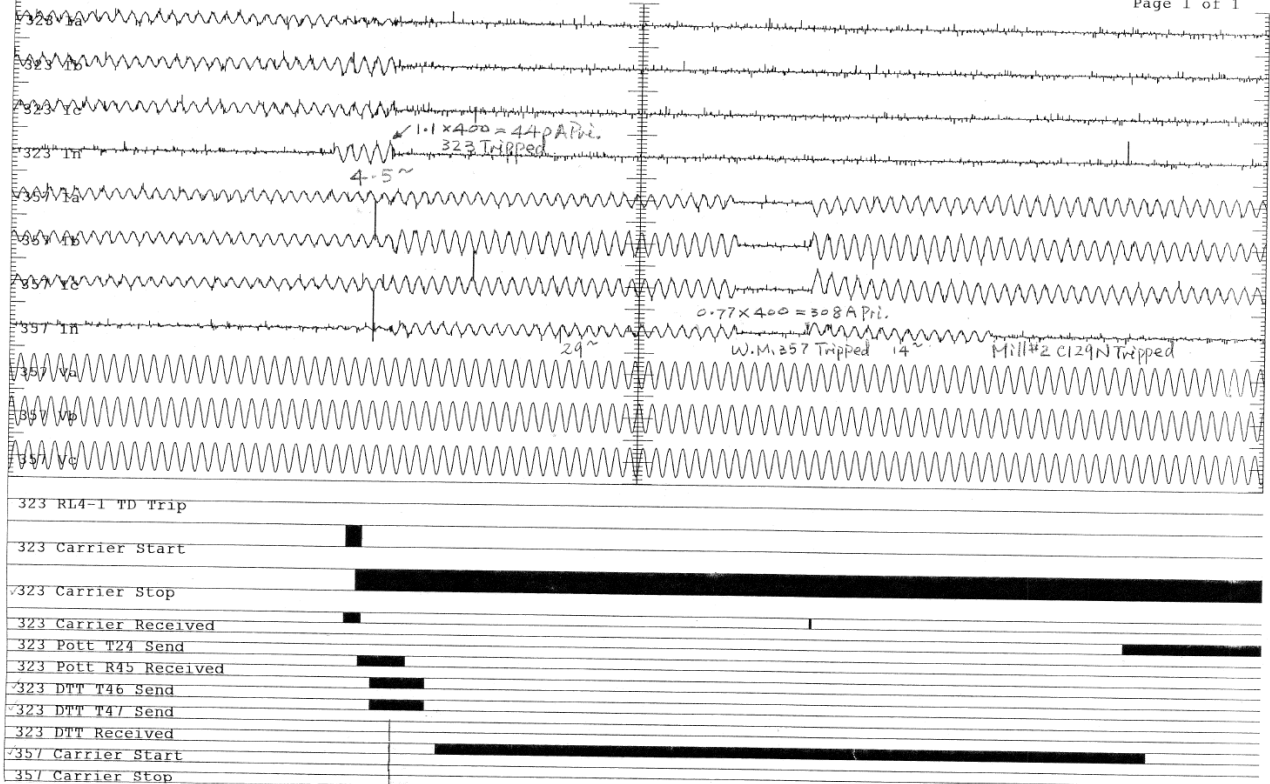
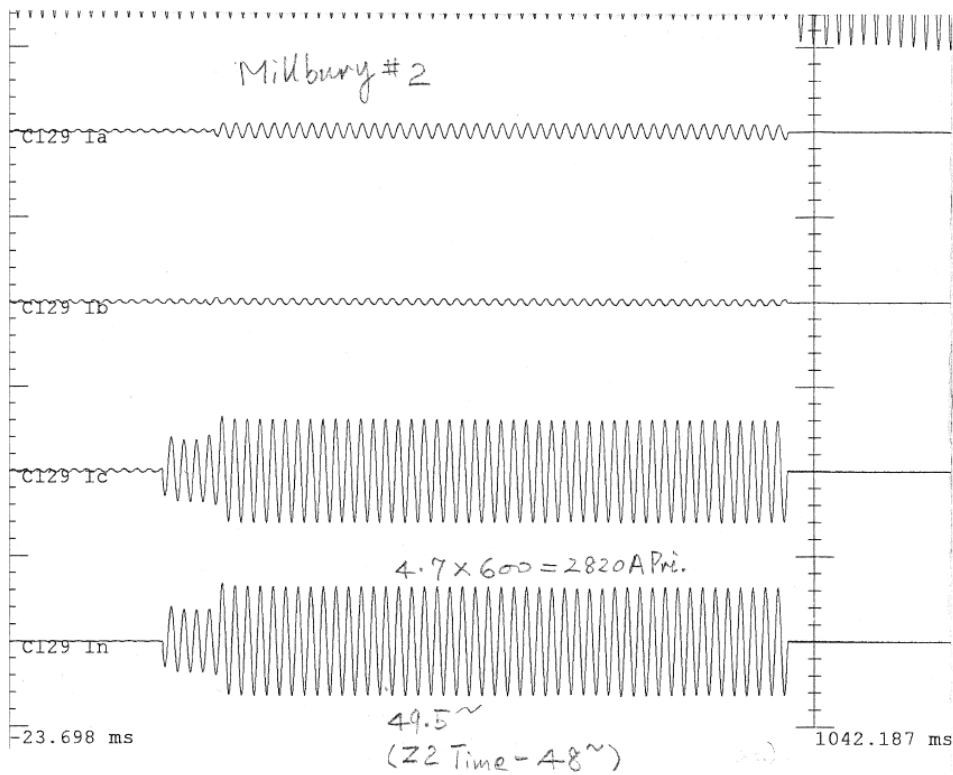
Figure 2. C129N, 323 and 357 Line DFR Records at Millbury Substation at 06:21:32:00

2. During the C129N fault, the 323 Line opened at both the Millbury #3 and West Medway (NStar) terminals. The line tripped at both terminals within 4.5 cycles. The current flow through 323 Line during the C129N fault for 3I0 was from the West Medway to Millbury #3. The 3I0 magnitude on the 323 Line at the Millbury #3 end was approximately 440 to 460 amperes, which is above the carrier directional ground trip (CDG) relay pickup of 360 ampere. (Note: The CDG function is a part of the 323 Carrier Comparison Blocking, DCB, scheme and the relay's directional control is zero-sequence voltage polarized.) As a fact, the 323 Line CDG relay at the Millbury #3 picked up and cleared the local terminal and sent a direct transfer tripping (DTT) signal to the West Medway resulting in the opening of the breakers 107 and 108 on the 323 Line. Since the breakers at the West Medway opened by the DTT, there was no auto-close on the 107 and 108 breakers at the time. It was most likely that the 323 CDG relay at the Millbury #3 misoperated due to the mutual coupling effects between the D130, C129N, 323 and 357 lines.

3. After the loss of the 323 Line and the Beaver Pond end of the C129N, the 357 Line became a main supply to the fault. It is important to keep in mind that the Millbury #2 end of the C129 Line had not yet cleared the fault. The 3I0 ground current, flowing from West Medway to Millbury, sensed by the 357 CDG start relay at the Millbury #3 was exceeded the pickup point of 200 amperes, therefore, the reverse-looking CDG start relay picked up and sent a carrier blocking signal to the West Medway. The 3I0 also exceeded the pickup setting of the 357 CDG trip relays at the West Medway. While, the 357 Line was correctly restrained from tripping due to the receipt of carrier blocking signal from the Millbury #3. As per further finding from NStar, for some unknown reason, approximately 29 cycles into the fault, there was a two (2) cycle interruption of the carrier blocking signal (i.e. a carrier hole) on the 357 Line at the West Medway terminal. This resulted in a single-end trip of the 357 Line at the West Medway only. It appeared that there were some problems on the 357 power line carrier system at this terminal.

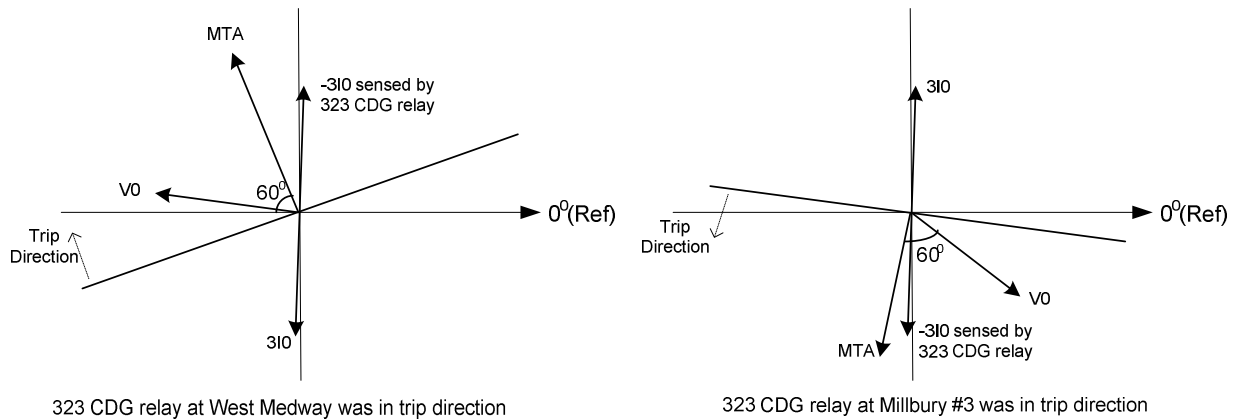
Figure 3. Characteristic of Directional Sensing on the 323 CDG Relays with the C129N Line Fault

2. Since the faulted C129N line is with zero sequence isolation, except mutual coupling, with the 323 and 357 lines, mutual inductance might cause incorrect directional sensing on the 323 line CDG relays for faults on the C129N Line between the Rocky Hill tap and West Medway tap. Therefore, the CDG relays at both terminals might see the C129N faults as internal faults. See Table 2 and Figure 3 in detail.

In additional, the fault simulation results quantitatively proved how the mutual coupling affected the directional sensing of the 323 CDG relays for this particular fault. The following sequence phasing diagrams (Figure 3) illustrate that the 323 CDG relays at both terminals were fooled into

Base on the above discovery, it was concluded that the root cause of the misoperation on the 323 and 357 CDG trip relay at the Millbury #3 and West Medway was due to mutual coupling effect between the four parallel lines.

In order to improve the security of the 323 and 357 DCB scheme, and, to prevent any parallel line fault from causing an unexpected operation on this scheme for external faults, the setting pickups for the 323 and 357 CDG trip and start relays at both Millbury #3 and West Medway were increased immediately after this fault occurred.

- Replace the existing 323 and 357 zero sequence polarized CDG trip and start relays with negative sequence polarized directional ground relays.
- Review pickup settings for those zero sequence polarized directional ground relays used on mutual coupled lines across the system. The determination was that the increase in ground current 3I0, due to mutual coupling effect, must be considered when setting zero sequence directional ground relays.

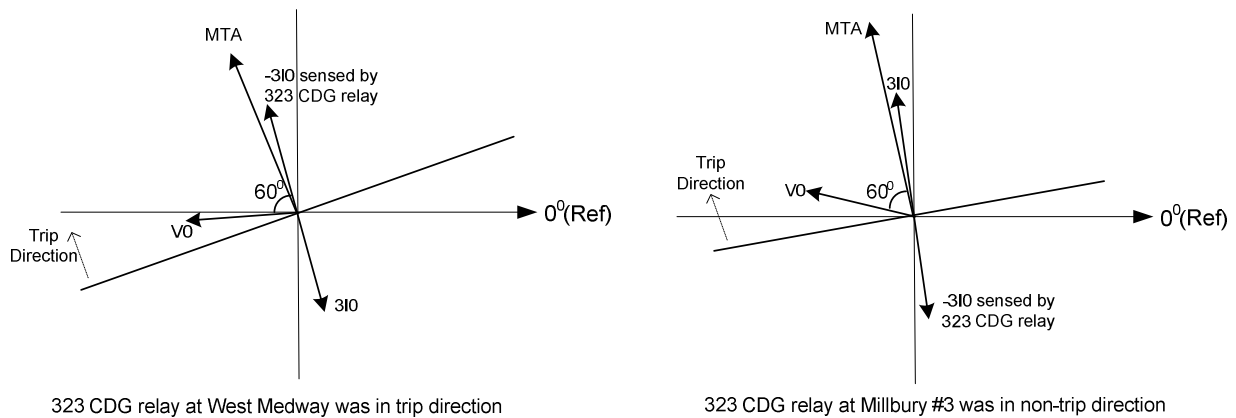
Figure 4. Characteristic of Directional Sensing on the 323 CDG Relays with a C129N Fault at 40% of Millbury #2 - RKHL

responding to this external C129N fault as an internal fault. However, the directional sensing would work as expected if the fault were located close to the Millbury #2 (Figure 4), which demonstrates how fault location is sensitive to directional sensing on ground relays with zero sequence polarized directional control for mutual coupled lines.
