# A Bus Cleared and a Hidden Breaker Insulation Failure Revealed

Robert Roman and Kevin Damron, *Avista Utilities*  
Emma Clawson, *Schweitzer Engineering Laboratories, Inc.*

**Abstract**—On June 27th, 2023, lightning struck a transmission line about one mile from a substation. Shortly after the first lightning strike, the high-impedance bus differential relay cleared the bus at the substation even though there was no apparent fault on the bus. About half an hour after these two events, the percentage-restrained bus differential relay attempted to trip the bus again, even though the bus was still de-energized from the initial events.

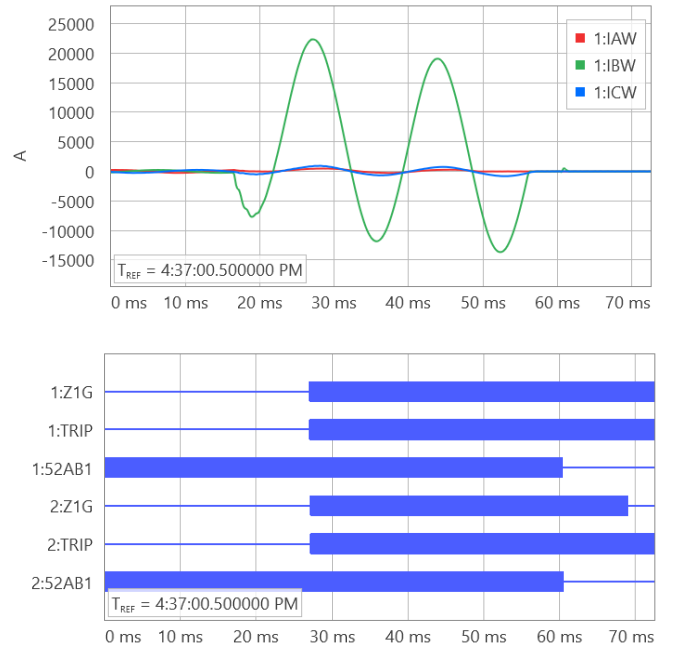
Fig. 9. Initial fault detected by the modern line relays protecting the Sub A–Sub B line.

At 16:37:00 a B-phase-to-ground fault occurred on the Sub A–Sub B transmission line. Both modern line relays at Sub A detected the fault and tripped on their Zone 1 distance element, Z1G. Bkr 3 opened within about two and a quarter cycles, opening the line from the Sub A end. Both relays showed the 52A contact from the breaker deasserting, which also indicated that the breaker opened. Fig. 9 shows the current and binary values from the modern line relays for the fault. The currents for both relays are nearly identical so only one set of currents is shown. The relay estimated the fault location to be 0.73 miles from the substation. This is very close to Sub A since the total line length was approximately 70 miles. The other end of the line at Sub B also tripped quickly due to the permissive overreaching transfer trip scheme and opened the remote breaker.

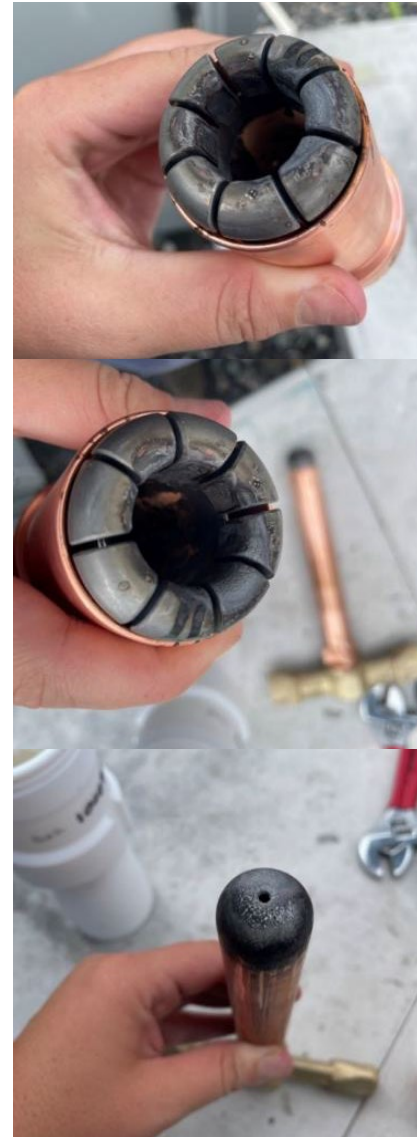
Fig. 15. Bkr 2 damage caused by lightning.

When Bkr 2 was removed from service and inspected, visible burn marks were observed on the breaker's C-phase contact, as shown in Fig. 15. The gas sample taken from this SF6 breaker indicated that the breaker was damaged. Unlike Bkr 3, Bkr 2 sustained not only the high-frequency current transients from the lightning strikes, but also five cycles of fundamental frequency fault current. This caused much more damage to Bkr 2 than the high-frequency current transients alone did to Bkr 3.

The breaker manufacturer was involved in the breaker failure analysis and recommended neither breaker be returned to service. Bkr 3 only experienced lightning flashover with no 60 Hz current reinforcing the breakdown to cause further damage to the breaker. Bkr 2 suffered lightning strikes as well as the internal fault for five cycles.

Prior to the event, the utility's standard practice was to not install lightning arresters on transmission lines due to the historically low total lightning density in their service territory. Based on this event, and the increasing lightning risk to the utility's 230 kV transmission system, a program was developed to install lightning arresters on breakers and to install shield wires on transmission lines.
