Ground Fault Neutralizer for Wildfire Mitigation in California

PACIFIC GAS & ELECTRIC CO.

SUMMARY

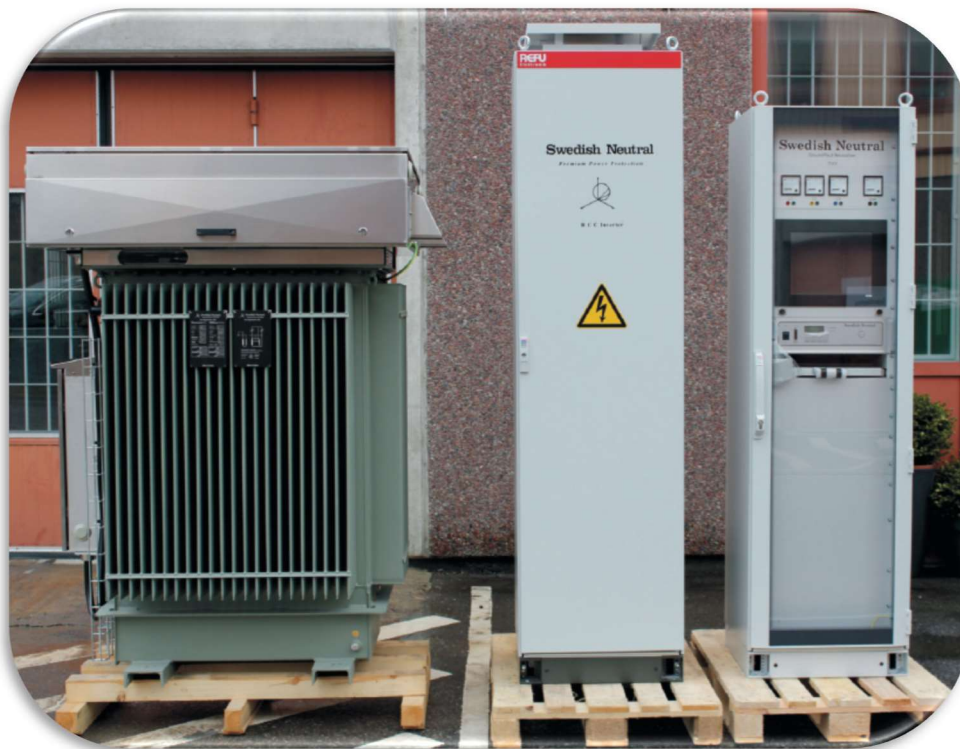
The GFN consists of an arc suppression coil (ASC), residual current compensator (RCC), and controllers (Figure 1) [3]. To package the GFN components more easily in a standard shipping container, a grounding transformer is connected to the substation 12 kV bus, creating an easily accessible neutral point for the ASC. The GFN detects a ground fault by measuring the zero sequence voltage, and once it exceeds a threshold, the RCC is activated to further increase the neutral voltage and reduce the faulted phase voltage, thus limiting the fault current to less than 1 Amp.

Figure 1 From left to right : ASC, RCC, Control Cabinet (Swedish Neutral AB)

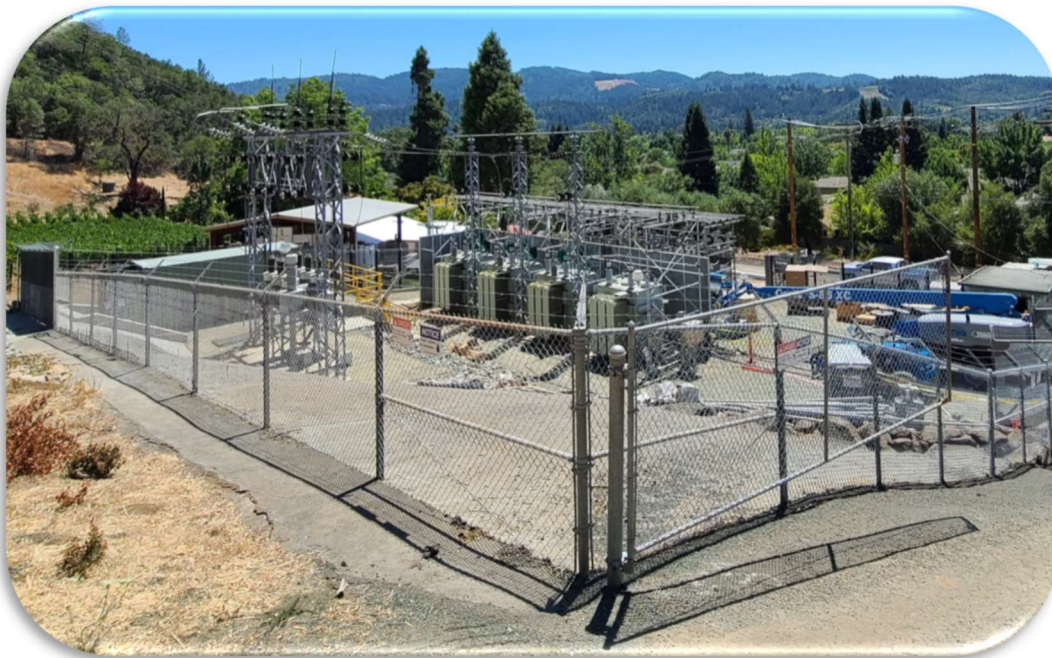
Figure 2 GFN pilot substation in Napa Valley California

The substation bank is changed from solid grounding to resonant grounding based on the position of the Neutral Grounding Recloser, which operates as a switch. With the GFN in-service, it protects 100% of the primary distribution networks connected to the substation transformer bank secondary.

For PG&E's demonstration GFN project, the following equipment had to be changed in the substation:

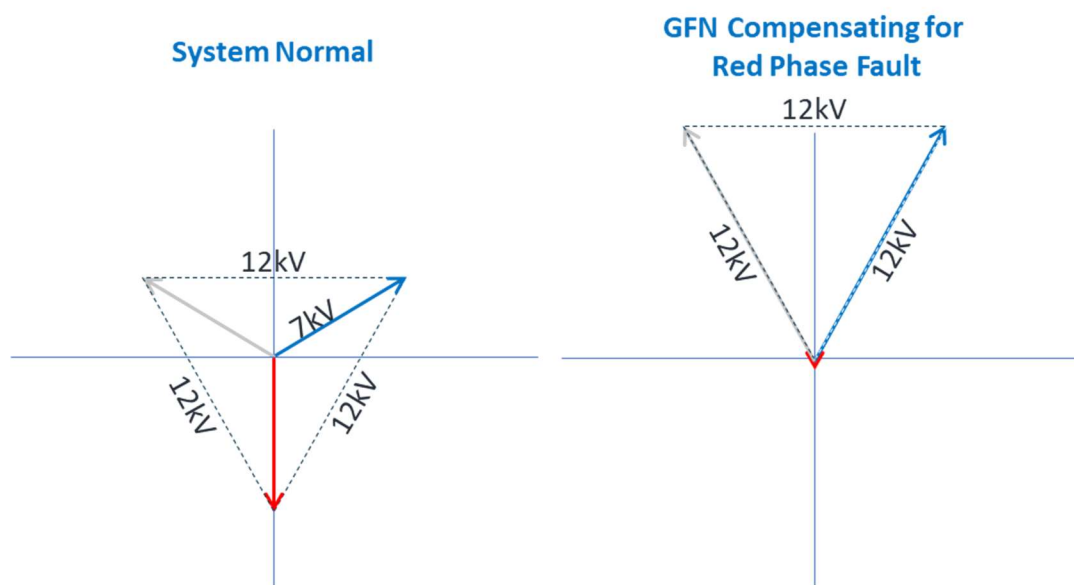
When a ground fault occurs with the GFN in-service, the neutral voltage passively increases and the GFN detects the fault once the voltage rises above the threshold setting. Within about 50 ms, the RCC activates to further increase the neutral voltage, which brings the faulted phase voltage typically below 250V primary. A side effect of this neutral shift is that the line to ground voltage of the two healthy phases increases to line-to-line magnitude as shown in Figure 3. The fault current follows Ohm's Law and is rapidly reduced as the faulted phase to ground voltage drops, limiting the current below 1 Amp. Note that the phase-to-phase voltage is maintained, customer's service voltages remain the same as the service transformers are all connected Phase to Phase.

Figure 3 The GFN shifts the neutral, reducing the line to ground voltage of the faulted phase

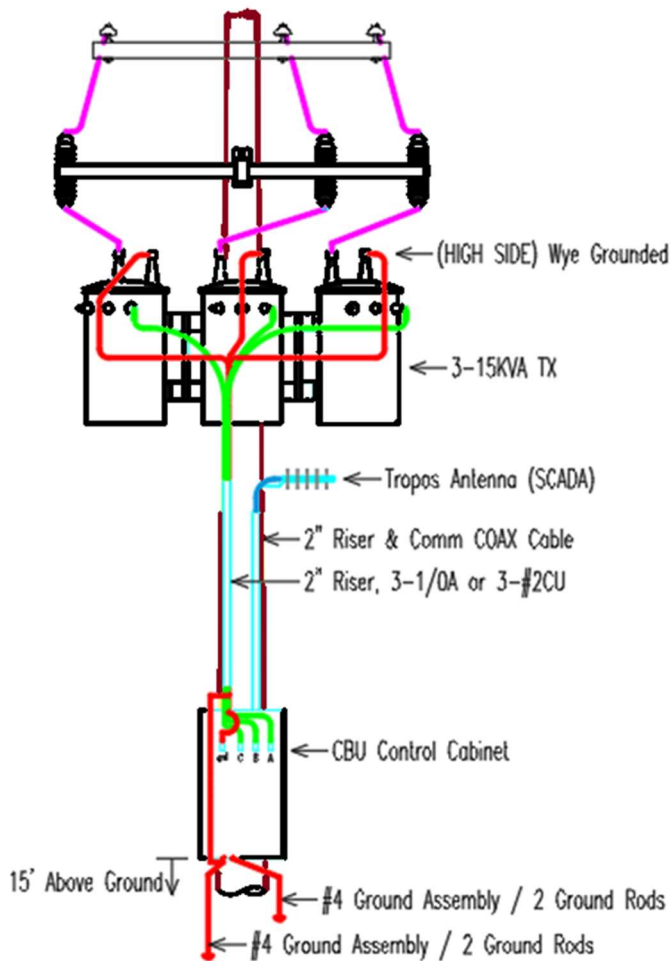
Balancing the charging currents to minimize the standing neutral voltage and maintain it is not a trivial task. In the USA, single phase – 2 wire laterals are commonly used on distribution circuits, especially on rural circuits where there are minimal 3 phase loads. To address long single phase laterals, phasing reconnection changes are performed for coarse balancing and a new type of equipment called a Capacitive Balancing Unit (CBU) is installed at major protection zones on the circuits to remotely inject ground current from each phase in 0.03 Amp increments, up to 0.5A maximum per phase (Figure 5). Single phase transformers or 5-limb three-phase transformers are to be used for the CBU so that the excitation of each phase is nearly identical [4]. To maintain balance, some single phase fuse locations need to be replaced with three-phase ganged protection to prevent false operation of the GFN in case of line-line faults [4].

Figure 5 Capacitive Balancing Unit

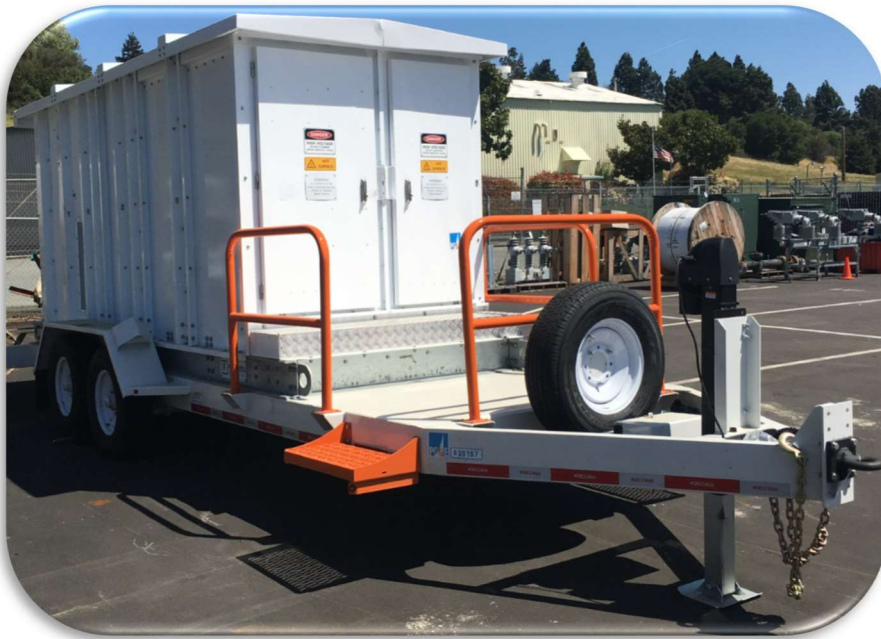
A specialty trailer with high voltage resistor bank was procured (Figure 6). This allowed for selecting different fault resistance to perform staged fault testing on the distribution primary to verify GFN performance and finalize settings of the controller.

Figure 6 Test trailer with high voltage resistor bank up to 25,400 ohms

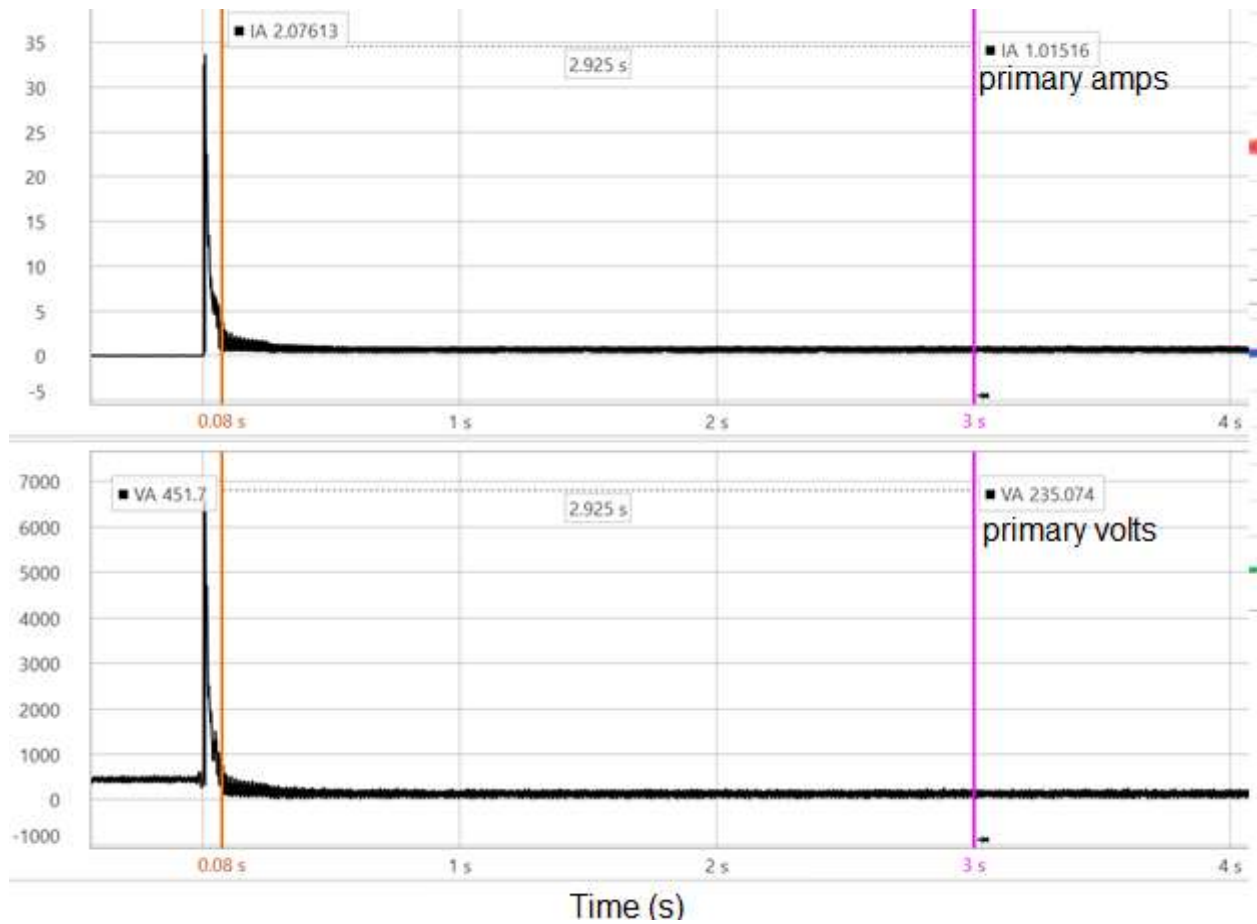
Low impedance faults were tested using a fault resistance of 200 ohms (Figure 9). The current initially reached the total charging current for the circuit, which was 34 Amps primary. Within 30 ms, the GFN RCC was active and driving the voltage down on the faulted phase, ultimately limiting the fault current to approximately 1 Amp primary. The GFN performed its soft fault confirmation after four seconds to identify the faulted feeder (not shown). In operation, this would result in tripping the faulted feeder within about ten seconds to isolate the fault. Different settings groups can be used to remove the time delay and trip the faulted circuit breaker as soon as fault confirmation is completed, one to two seconds after fault inception. The faster trip settings would be used during red flag warning conditions.

Figure 9 Measurements at fault site for 200 ohm fault with GFN operating

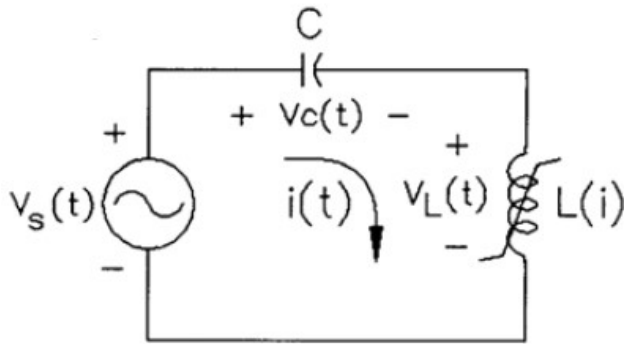
The substation went through some design iterations due to encountering unexpected ferro-resonance, which led to high voltages and damage to equipment. A circuit capable of ferro-resonance consists of a series capacitance with a saturable inductance, shown in Figure 11 [6].

Figure 11 A nonlinear L-C circuit capable of ferro-resonance [6]

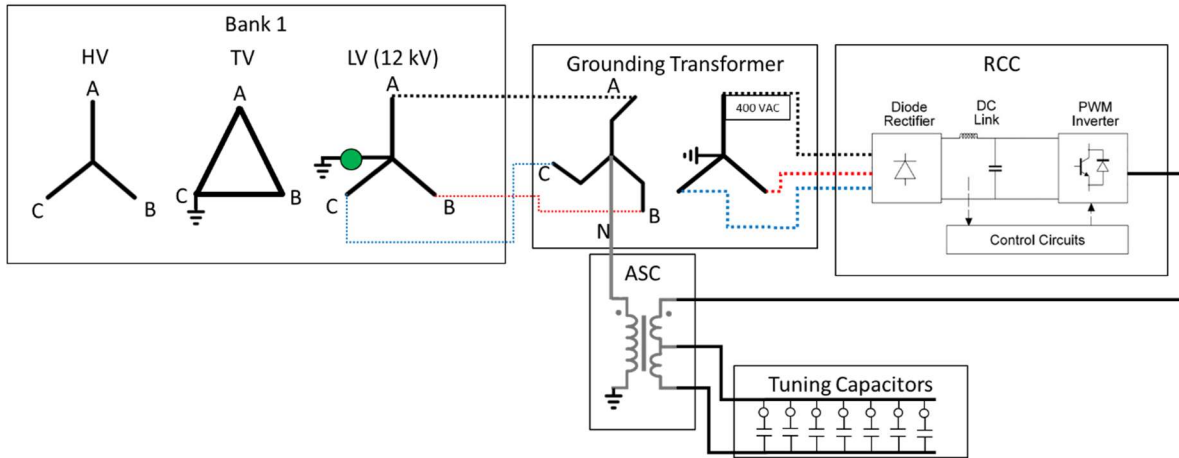
The supplier installed the GFN equipment in a standard seavan shipping container for international shipment. The service voltage of the GFN equipment was 400Y/230V, which is an uncommon voltage in North America. To simplify connections and service power, a zig zag grounding transformer was supplied to accept 3-phase 12 kV and create a neutral point and step down to the 400Y/230V service. The arc suppression coil was connected to this neutral point. The bank secondary neutral was kept separate and solidly grounded while the GFN was not in service (Figure 13).

Figure 13 GFN and Bank connections with Grounding Transformer

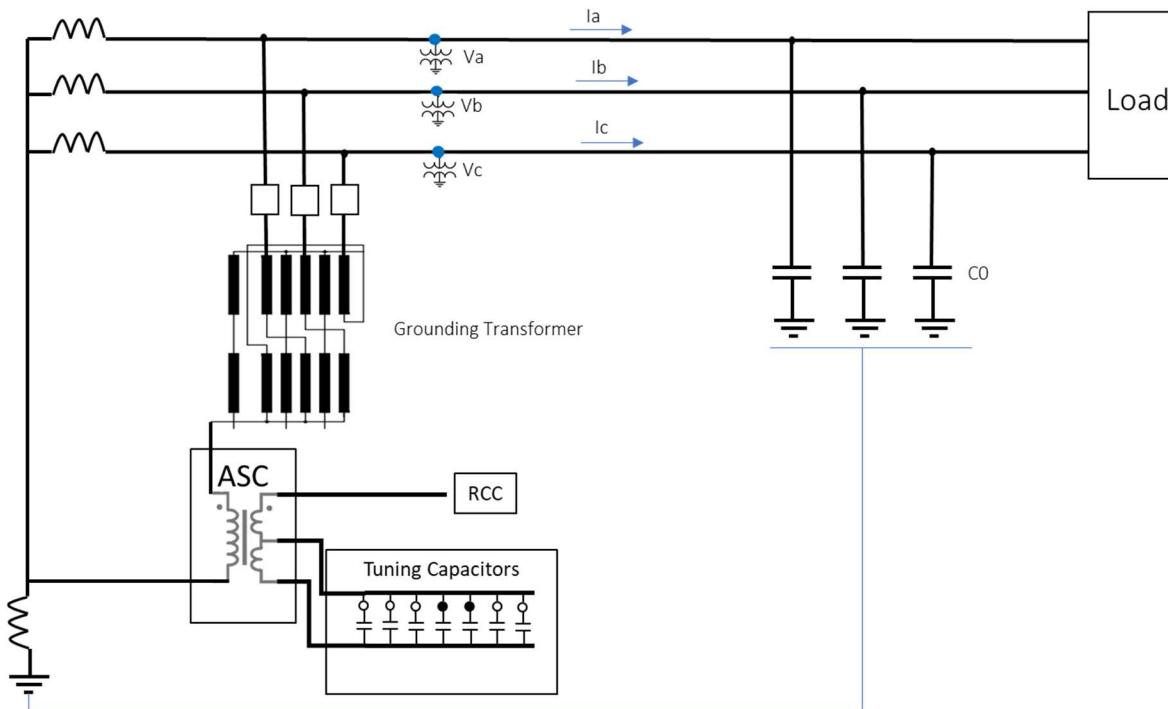
The connections with the grounding transformer and the bank neutral resulted in an equivalent circuit capable of ferro-resonance (Figure 14). The ASC was tuned to the previously determined resonant point of 76A to match the zero sequence capacitance of the distribution lines. The ASC was left at this position while the substation bank secondary neutral was solidly grounded. At some point while in this configuration, a single line to ground (SLG) fault on Phase A occurred. This caused the ferro-resonance operating point to change, and the grounding transformer saw high voltage on the other two phases. No load was on the grounding transformer when this occurred, so the peak voltage reached levels great enough to flash over between de-energized tap changer (DETC) leads on the grounding transformer high voltage side windings. No other primary equipment was damaged.

Figure 14 Equivalent circuit with grounding transformer capable of ferro-resonance

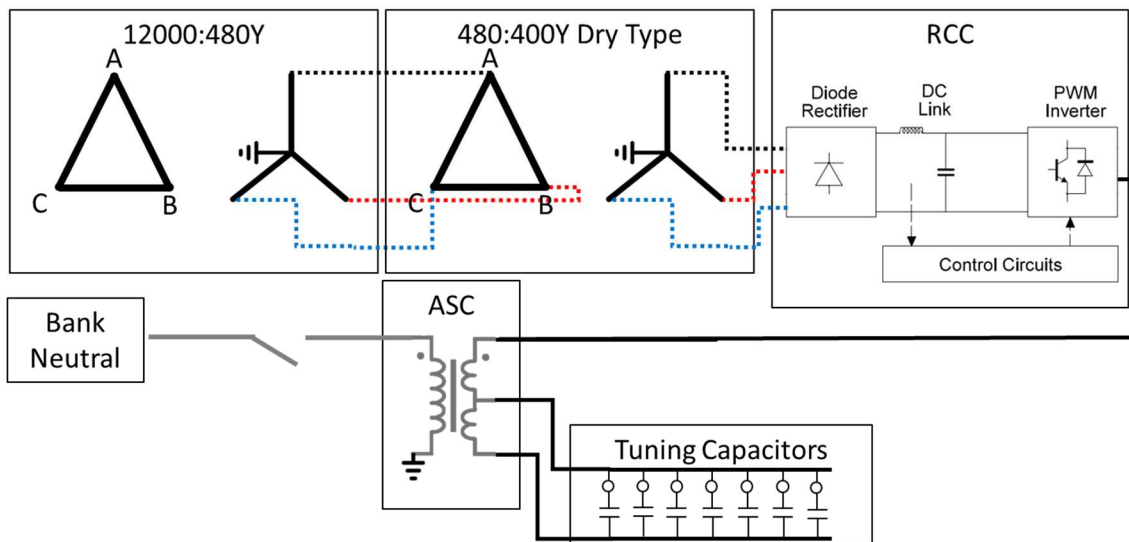
After determining ferro-resonance had occurred, corrective actions were taken to eliminate reoccurrence (Figure 15):

1. Eliminate grounding transformer from the design and install delta-wye 12 kV station service with 480:400Y V step down transformer
2. Install new neutral cable and disconnect switch between ASC and bank secondary neutral

Figure 15 Updated substation configuration with no grounding transformer

After taking these actions, no further ferro-resonance issues were observed.

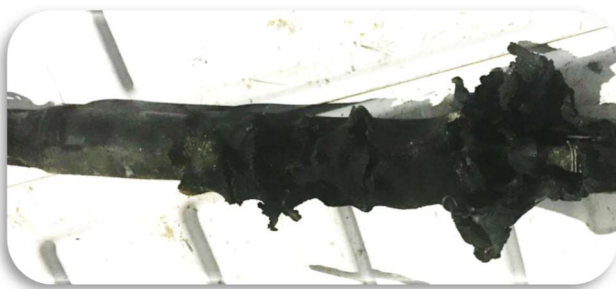
During GFN commissioning and staged fault testing, some equipment on the distribution circuits failed. These included a 10 KVA service transformer, underground cable connector, and underground cable splice (Figure 16). Due to the increased voltages during commissioning and testing, these failures were not unexpected, but they did cause delays in operationalizing the GFN.

Figure 16 Cable splice which failed during staged fault testing
