Protective Relays with Individual Breaker CT Inputs Help Detect Ring Bus Loose Connection Problems

Ding Lin, Protection Engineer
Manitoba Hydro
Winnipeg, Manitoba
CANADA, R3C 2P4

Abstract: This paper presents and discusses the benefits of connecting individual breaker CT inputs into the protective relays in a ring bus configuration. A real life case study of identifying loose or high impedance connections on a breaker disconnect in a ring bus configuration is presented. Furthermore, this paper also proposes a simple and novel ring bus open phase detection technique to prevent potentially expensive damage and outage to the high voltage equipment.

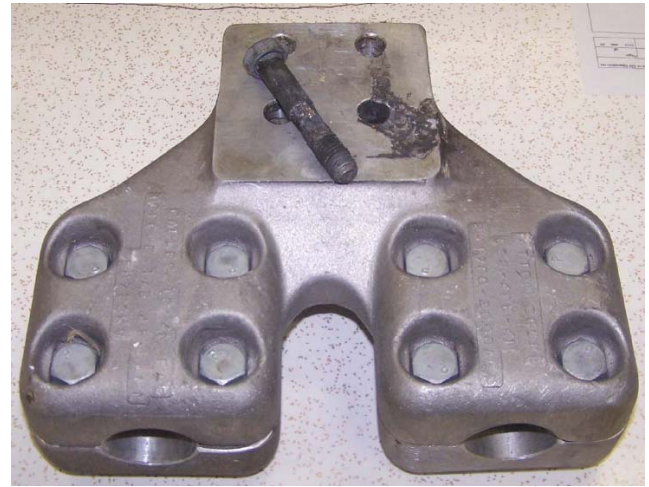
Figure 10 Damage to the Connector Due to Loose Connection

In this particular case, after the Thermography Inspection, the maintenance personnel quickly located two hot spots on the bus section and upon further investigation they found out that there were loose bolts on the connecting

plate of the breaker disconnect D2B. Figure 10 is a picture that shows that damage to the bolt and the plate due to the loose connection.

After the two loose connecting plates were replaced and the system was placed back into service, the current waveforms look perfectly normal again as shown in Figure 11. Problem solved!

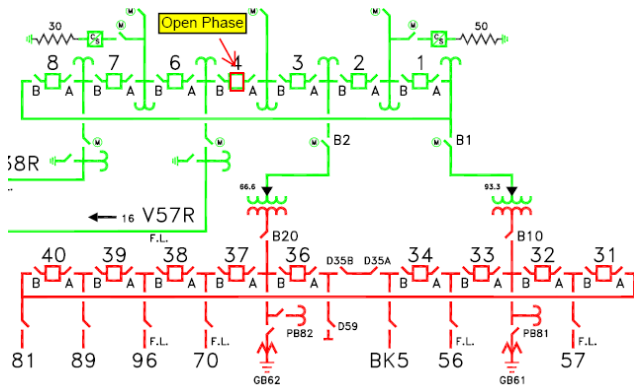
Figure 12 - Another Station Where Open Phase Occurred

As a specific example, a few years ago, in the process of clearing one of the two transformer banks in one of our substations as shown in Figure 12, the other bank tripped. This resulted in a major extended power outage to all the customers connected to the 66 kV lines from this substation.

It was later found out that one phase of breaker 4 had been open and undetected for an indeterminate time. As soon as the ring bus was opened by breakers 1 or 8, which were opened to clear bank 1, the unbalance current could no longer circulate in the ring and was forced to go through breaker 4. The unbalance current going through bank 2 neutral was high enough to cause the neutral overcurrent relay connected to the 230 kV neutral of transformer bank 2 to operate and trip the bank.
