Experience, Improvements in Operation, Limitations, and Successes of an Ungrounded Distribution Network Protection Scheme

Carlos Erroa, *ETESAL*
Miguel Cruz and Fernando Calero, *Schweitzer Engineering Laboratories, Inc.*

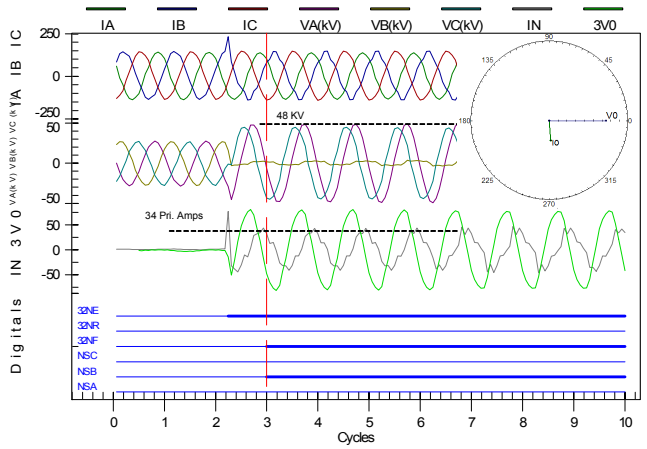
Fig. 14 and Fig. 15 illustrate the oscillographic information for a BG in feeder 34-4-82. Fig. 14 shows the waveforms corresponding to the faulted feeder (34-4-82) and Fig. 15 shows the waveforms for one of the healthy feeders (34-4-83). The waveforms from the other two healthy feeders are not shown but these waveforms showed similar behavior.

The faulted feeder shows the maximum capacitive fault current. Fig. 14 shows that the measurement is approximately 34 primary Amps. The prefault capacitive zero-sequence current in this feeder measures approximately 1.5 Amps primary, or 15 mA secondary. This is above any error caused by the CT arrangement, as discussed in the previous section, and can be attributed to the natural unbalance of the line. The forward and reverse sensitivities for the ground directional unit are set above the unbalance [6].

Fig. 14 Feeder 44-4-82 forward BG fault

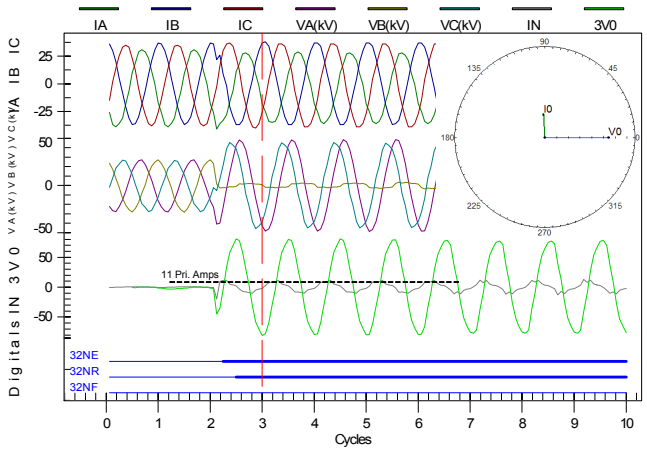
Fig. 15 Feeder 44-4-82 reverse BG fault

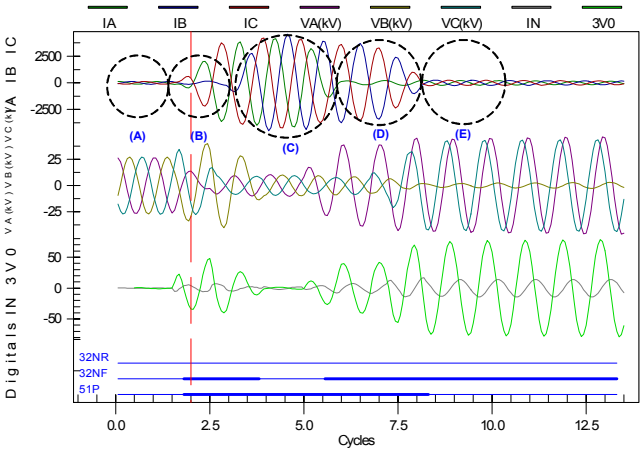
Fig. 17 Fault in the 44-4-82-Feeder

The event occurred during a storm. The prefault shows balanced load flow (A). The fault starts with the collapse of the phase-A voltage and almost immediately the phase-C voltage collapses. At the same time the A and C currents increase dramatically, effectively showing a CAG fault (B). In (C), the phase-B voltage also collapses, creating a three-phase fault in the feeder with very high current. In (D), phase-A voltage recovers and the fault is a BCG fault. After 2 cycles, the fault evolves into a permanent BG fault (E). This sequence of evolving faults is very peculiar; ETESAL has frequently observed faults evolving from one type to the other. During the trajectory, the phasing of the line is commuted, and each phase is in a different position, depending on the transposition. It is, therefore, possible to speculate the sequence of the fault evolution.

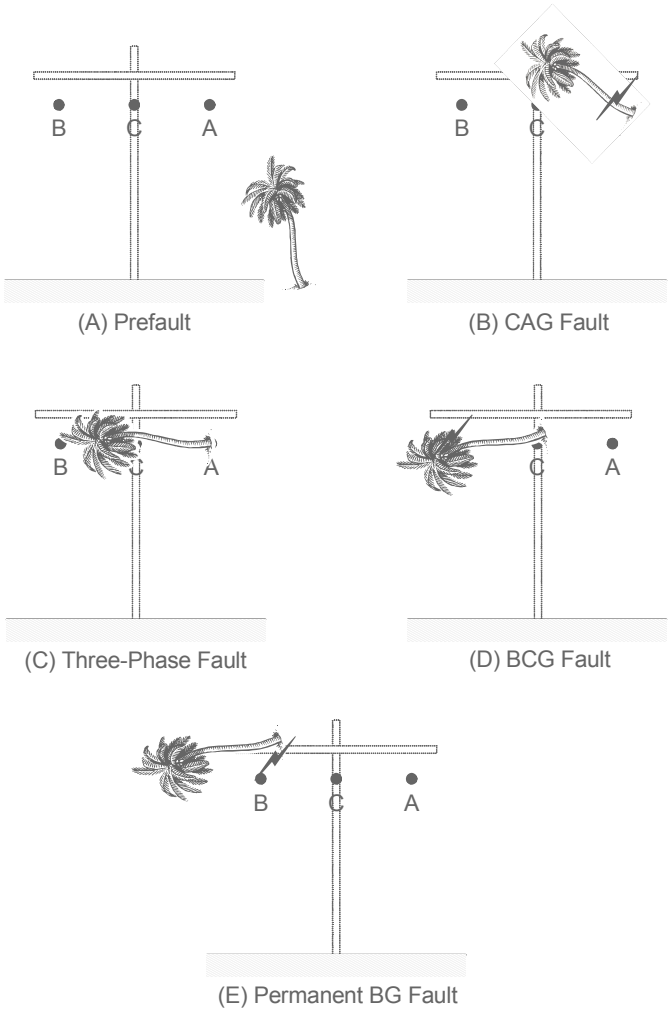
It is believed that during the storm, a tree branch being carried by the high winds made contact with ground and phase A first, then phase C. This is illustrated in Fig. 18(B). As the wind carried the tree branch, it also involved phase B, creating the three-phase fault, as shown in Fig. 18(C). Because of the high winds, phase A was released from the fault, yielding the BCG fault shown in Fig. 18(D). The wind force was also enough to release phase C, which finally created the BG fault. The phase-B insulator string may have stayed flashed-over, creating the permanent BG fault in Fig. 18(E).

Fig. 18 Possible fault sequence for the fault

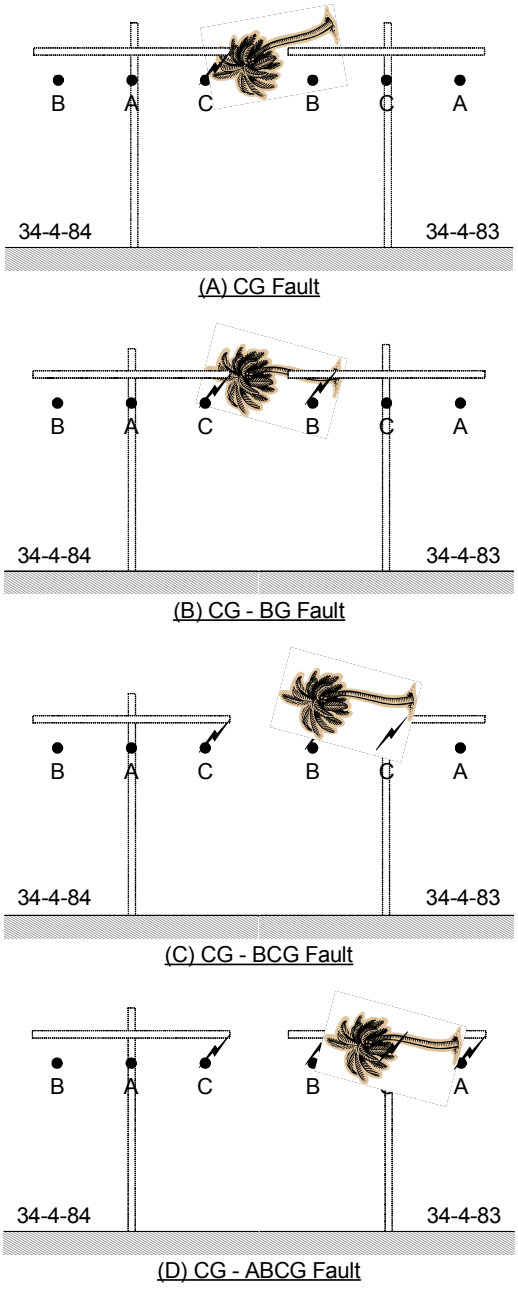
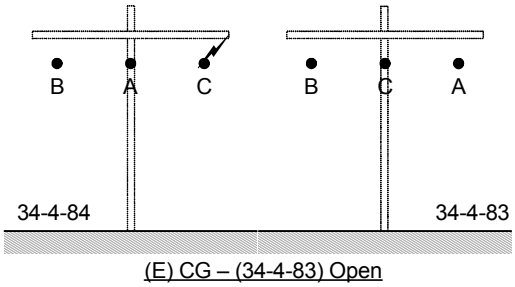
Fig. 19 illustrates the assumed fault sequence. The fault starts in feeder 34-4-84 as a CG fault (Fig. 19[A]). The fault was identified by the relay in the 34-4-84-feeder as an internal fault, and the other relays in the other feeders reported the fault as reverse.

Fig. 19 Assumed fault sequence

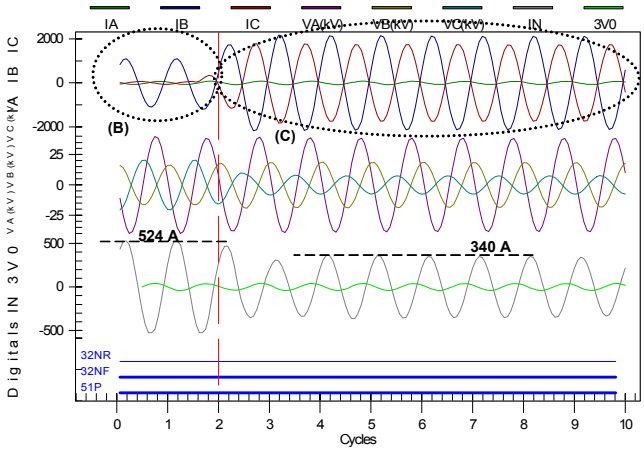
The waveform recorder did not capture the whole sequence, but sometime in the sequence there is a simultaneous fault (cross-country) in both feeders, as illustrated in Fig. 19(B). Fig. 20 shows the simultaneous fault, (B). Fig. 20 also shows the transition in Feeder 34-4-83 from a BG fault to a BCG fault in (C). Both simultaneous faults create significant zero-sequence current and phase current. The phase element properly detects the overcurrent condition (51P).

Fig. 20 Feeder 34-4-83 BG to BCG transition (Fig. 19(B) and Fig. 19(C))

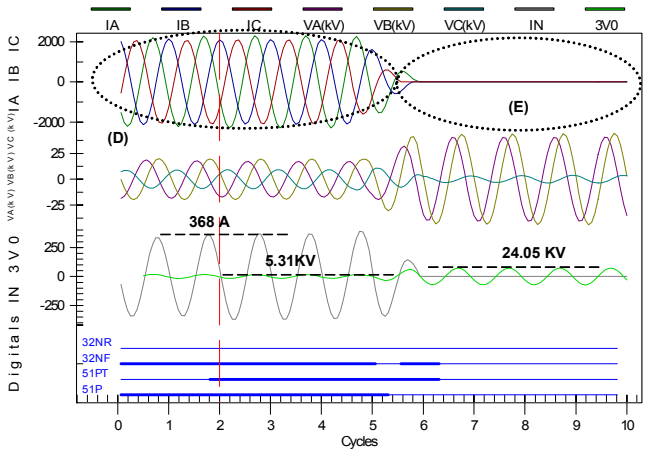
Fig. 21 illustrates the three-phase fault in the 34-4-83 feeder. Fig. 21(D) shows the high current in the three phases and at the same time the unbalance in the zero-sequence quantities caused by the ground fault in the parallel feeder. Fig. 21(E) shows the opening of the feeder 34-4-83, which corresponds to the transition from the simultaneous fault to the CG fault in feeder 34-4-84.

Fig. 21 Three-phase fault and opening of the 34-4-83-feeder

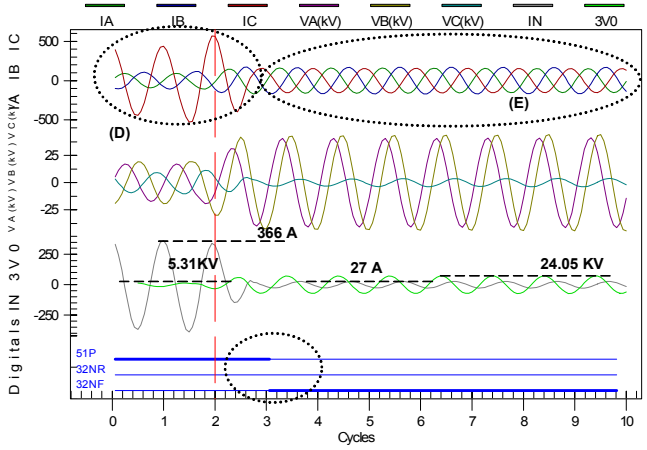
Fig. 22 illustrates the transition from the high fault-current magnitude simultaneous CG fault to the single-occurrence CG fault after the parallel breaker opens, corresponding to Feeder 34-4-84. The unfortunate situation illustrated in Fig. 22 is that the phase element resets (51P) because the parallel line trips and the ground element regains the proper directionality (32N) once the breaker opens.

Fig. 22 End of the simultaneous fault in Feeder 34-4-84
