COMPARING GROUND DIRECTIONAL ELEMENT PERFORMANCE USING FIELD DATA

KARL ZIMMERMAN
SCHWEITZER ENGINEERING LABORATORIES, INC.
BELLEVILLE, ILLINOIS

20th ANNUAL
WESTERN PROTECTIVE RELAY CONFERENCE
SPOKANE, WASHINGTON
OCTOBER 19 - 21, 1993

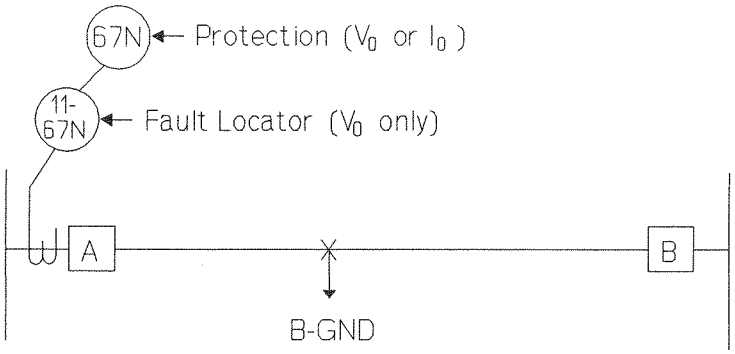
Figure 8: Example I - One Line Diagram

A ground fault (B-phase to ground) occurred on the line which was correctly detected by the dual-polarized relay. The fault locator, however, did not pick up for the initial fault and triggered an event report only when a Zone 3 phase-phase element picked up as the breaker opened. The fault locator indicated a negative distance to fault, which was investigated.

Since the event report was triggered after all of the currents and voltages dropped out, the fault location is based on invalid data, and is therefore, discarded. Also, since the fault had already occurred prior to the event report being triggered, the portion of the event report which is usually the "pre-fault" data (the first 4 cycles), is, in fact, the "fault" data. A portion of the event report is shown in Figure 9. The question is: why didn't the ground directional element of **11-67N** pick up at fault inception?

1. Even when relays are applied as fault locators, set the relays as if to trip. In this example, the relays were set correctly and would have produced the correct results if not for the vt neutral shift.

3. Check for ungrounded or multiple grounded vts!

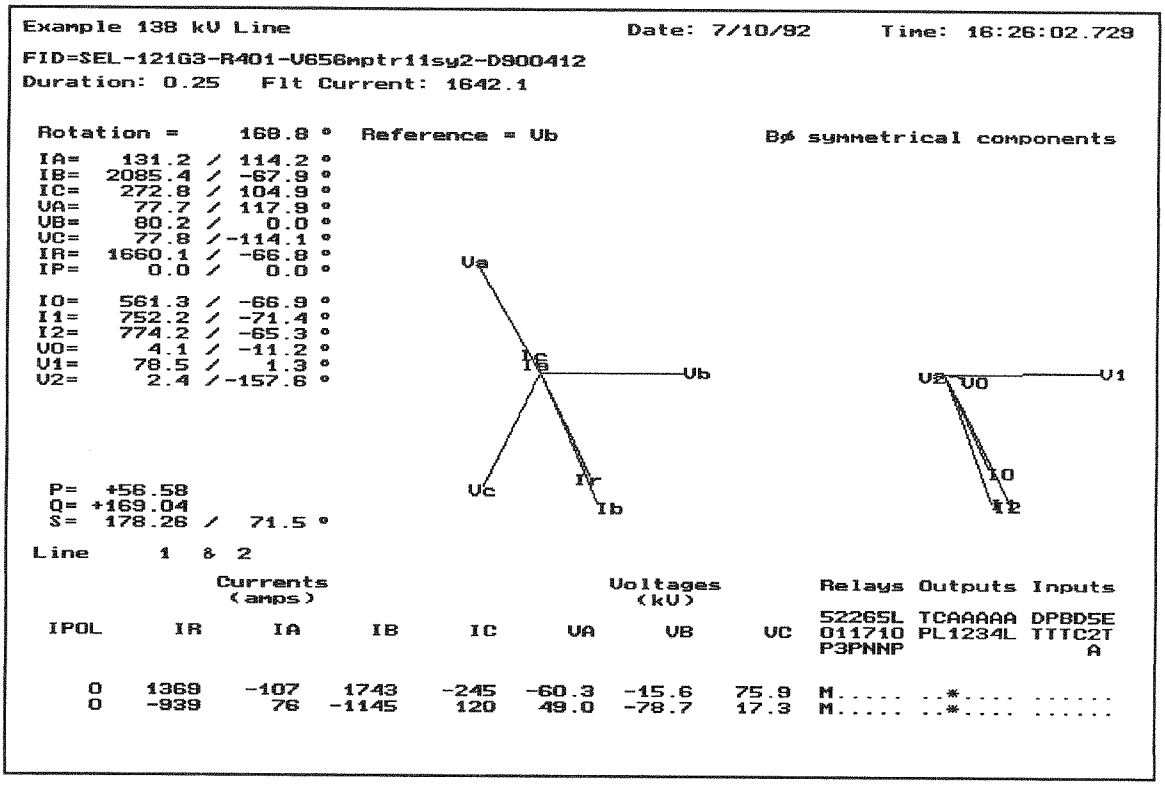
Figure 10: Example I - Phasors as illustrated in VIEW Program

If we examine the phasor quantities more closely, the faulted phase (B-phase) voltage magnitude is greater than the non-faulted phase voltages (80.2 kV vs. 77.8 kV). This indicates that the neutral reference of the phase voltages is shifted from the center position. Consequently, the reason the zero-sequence voltage polarized element sensed a reverse fault is due to a neutral shift of the input voltages to the relay. This is probably the result of ungrounded or multiple grounds on the supplying vts. Also, the dual-polarized relay that operated correctly did so due to its current polarized directional element.

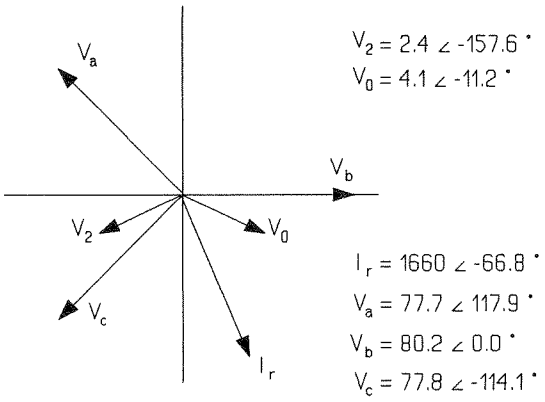
Figure 11: Phase and Sequence V and I

Besides the magnitude of the phase voltages, another characteristic of neutral shift is that the angle between the non-faulted phase voltages (V_B and V_C) increases. For an actual ground fault, this angle decreases. Figure 11 illustrates the phase and sequence voltages and currents. Since the phasors V_2 and V_0 are nearly in opposite directions, we see that the zero-sequence voltage polarized element responds the opposite of the negative-sequence polarized element.

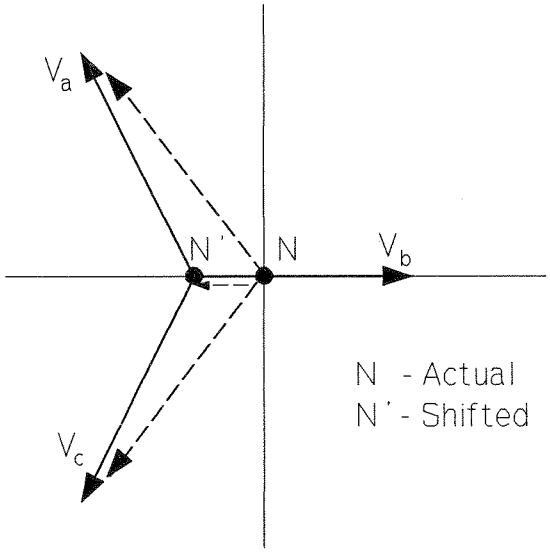
Figure 12: Neutral; Actual and Shifted

A graphical representation of the neutral shift is shown in Figure 12.

2. Negative-sequence polarization is relatively immune to neutral shift compared to zero-sequence voltage polarization.

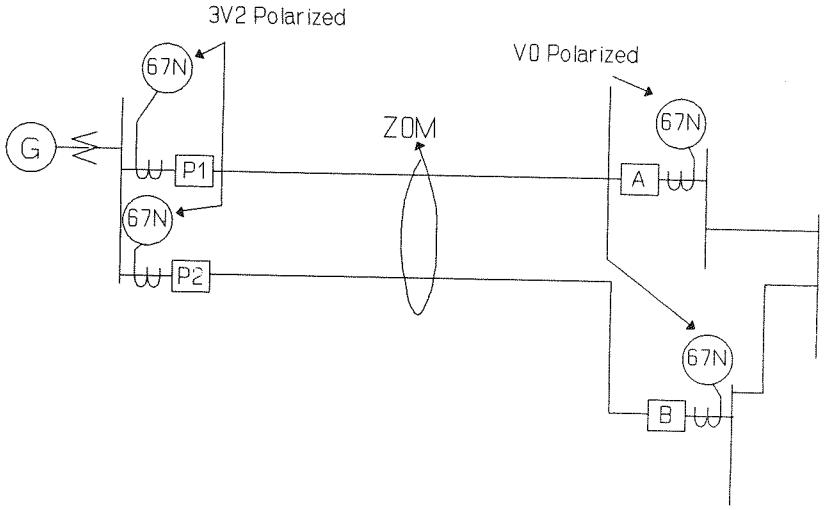
Figure 14: Example II - Pre-Fault Conditions

A B-phase to ground fault occurred on line P2-B near breaker B which resulted in correct tripping of the faulted line, but also resulted in an incorrect trip of the parallel line. Why did the non-faulted line trip incorrectly?

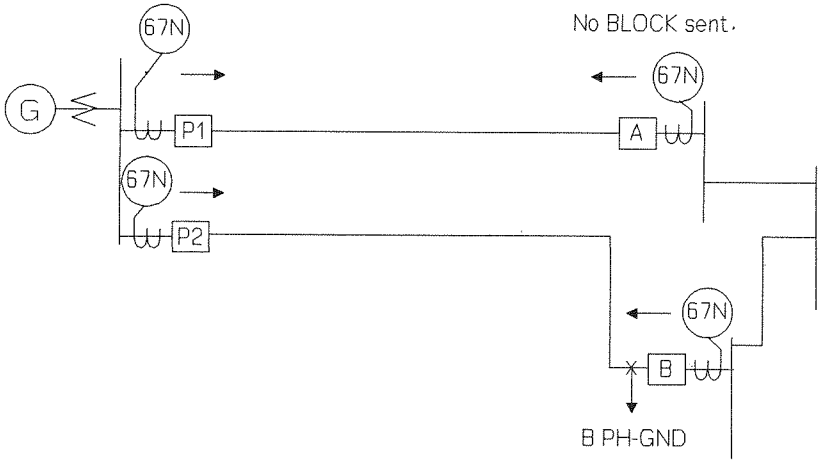
Figure 15: Example II - Initial Fault Inception

At fault inception, the negative-sequence directional element at P1 (**32QT**) senses a forward fault, which is delayed 0.75 cycles to allow arrival of the block signal from the remote terminal (BKR A). However, the block signal is never received, resulting in a trip at P1. BKR A tripped by its local 67N relay sensing a forward fault and no block received from BKR P1. In Figure 15, the arrows indicate the direction of the current as calculated from the directional overcurrent elements and confirmed by targets from the BKR A relay.

The 32V element at P1 produces a negative torque (reverse fault), opposite the 32Q element. This is probably due to mutual coupling caused by the parallel line configuration. It also explains why breakers P1 & A tripped: the BKR A relay determines the fault is in the forward direction thus tripping its own breaker and squelching the block signal to the remote (P1) breaker.

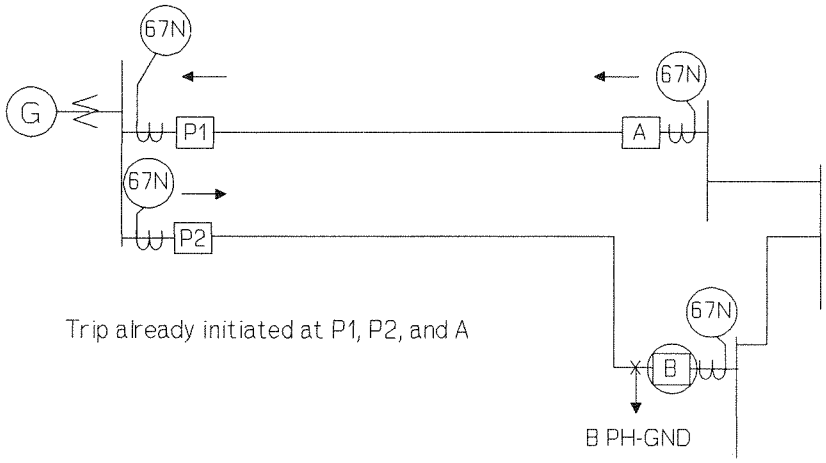
Figure 16: Example II - Fault Conditions After BKR B Opens

After BKR B tripped (correctly), the directional element (32QT) reversed. However, the trip signal had already been applied to the breaker (BKR P1). Thus, the non-faulted parallel line tripped for an out-of-section fault due to the misbehavior of the ground directional element at BKR A.

Since directional elements polarized by negative-sequence are immune to zero-sequence mutual coupling affects, negative-sequence polarization is recommended for all parallel line applications.

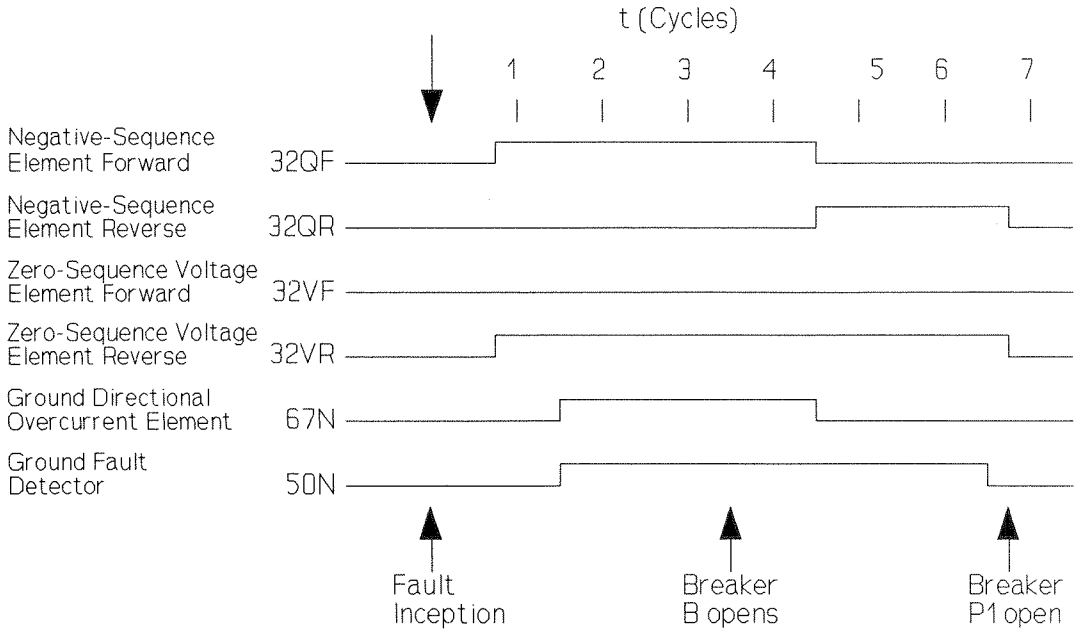
Figure 18: Time-Line of Elements at P1 end of P1-A Line

The elements at the P1 end are shown in a time-line of the event in Figure 18. **67N** picks up after **32QF** and **50N** assert. **67N** drops out after **32Q** reverses (**32QR** asserts). **32V** was picked up in the reverse direction (**32VR** asserted) from fault inception.

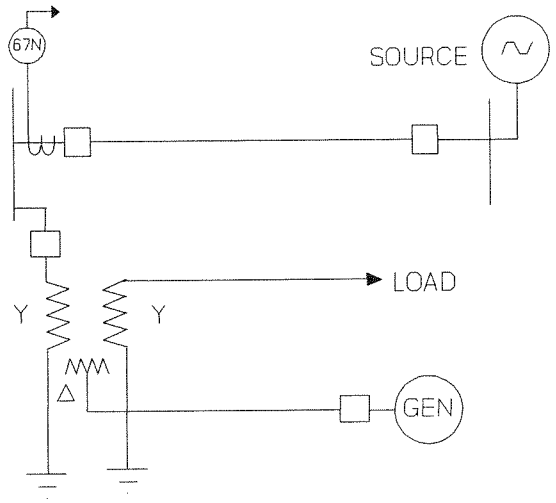
Figure 19: Example III - One-Line Diagram

The ground directional overcurrent element (**67N**) is set for negative-sequence polarization. Under normal operating conditions, the relay has a source of positive-sequence and negative-sequence current (generator **GEN**) and a source of zero-sequence current (the wye-grounded transformer). In this example, the generator is out of service. (See Figure 20.)

However, since the generator is out of service, there is no positive-sequence or negative-sequence source behind the relay. Consequently, the V_2 produced by the fault causes only a small amount of I_2 to flow (limited primarily by the high impedance of motor loads on the feeder). Since the only source is the back EMF created by the motors on the feeder, it is too weak to provide an adequate directional source. It is simply good fortune that the directional element happened to see forward initially.

About one and one-half cycles later, the negative-sequence element reverses due to inadequate polarizing quantities. The zero-sequence element solidly indicated a forward fault.

The V_0 produced by the fault forces an I_0 to flow, limited only by the leakage reactance of the transformer and the line impedance. Consequently, zero-sequence voltage polarization is a much better choice for this application. Note that V_0 polarization is reliable with or without the generator in service.

2. Select the polarizing method that has adequate operating quantities for all system conditions. In this case, select 32V (zero-sequence voltage polarization) over 32Q (negative-sequence polarization).

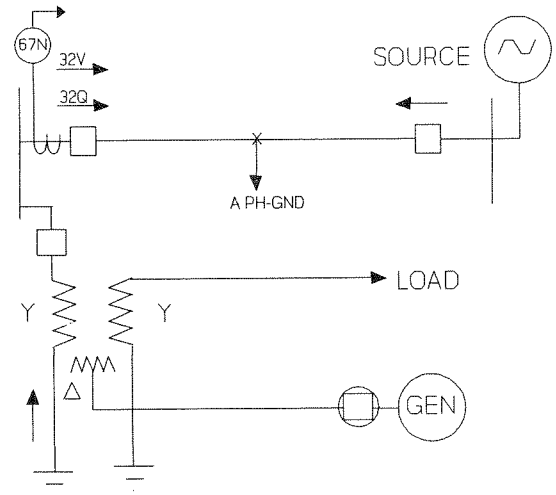
Figure 20: Example III - Initial Fault Conditions

The Zone 1 directional element is set to detect faults in the forward direction, the Zone 3 element is set for the reverse direction. A forward A-phase to ground fault occurred on the protected line. The relay initially senses a forward fault, then switches direction and detects a reverse fault. There were no other operations on the system. Why did this happen and what can we learn from this event?

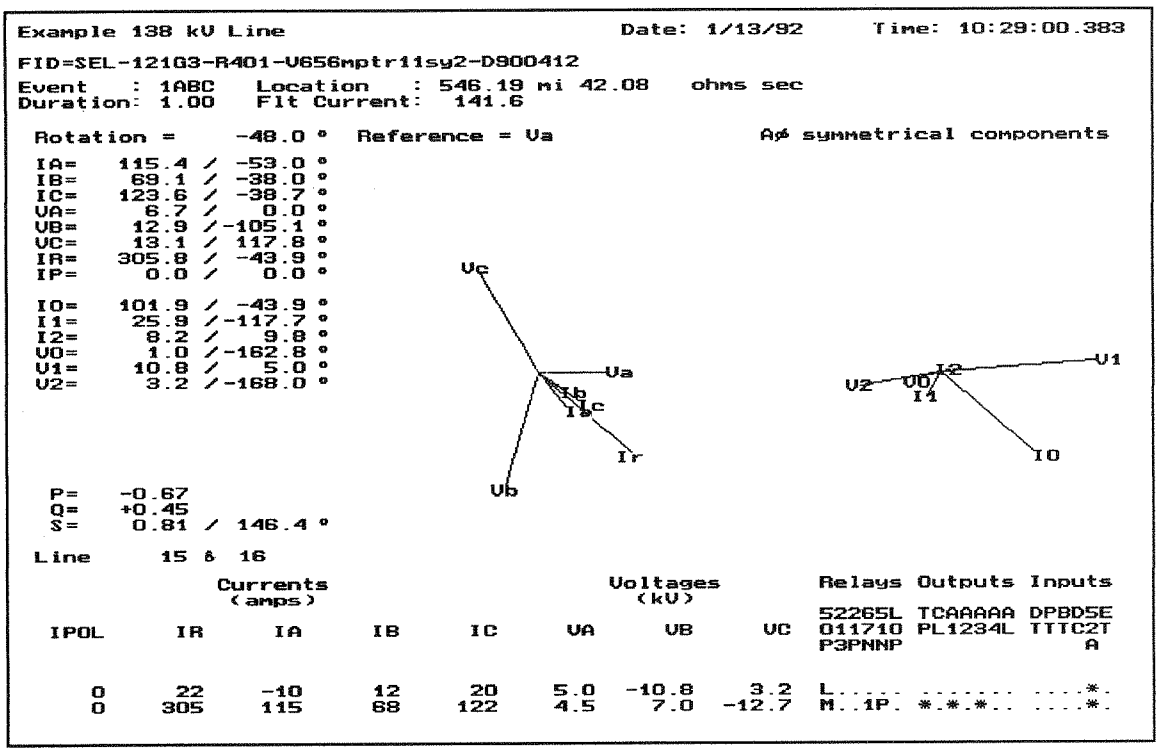
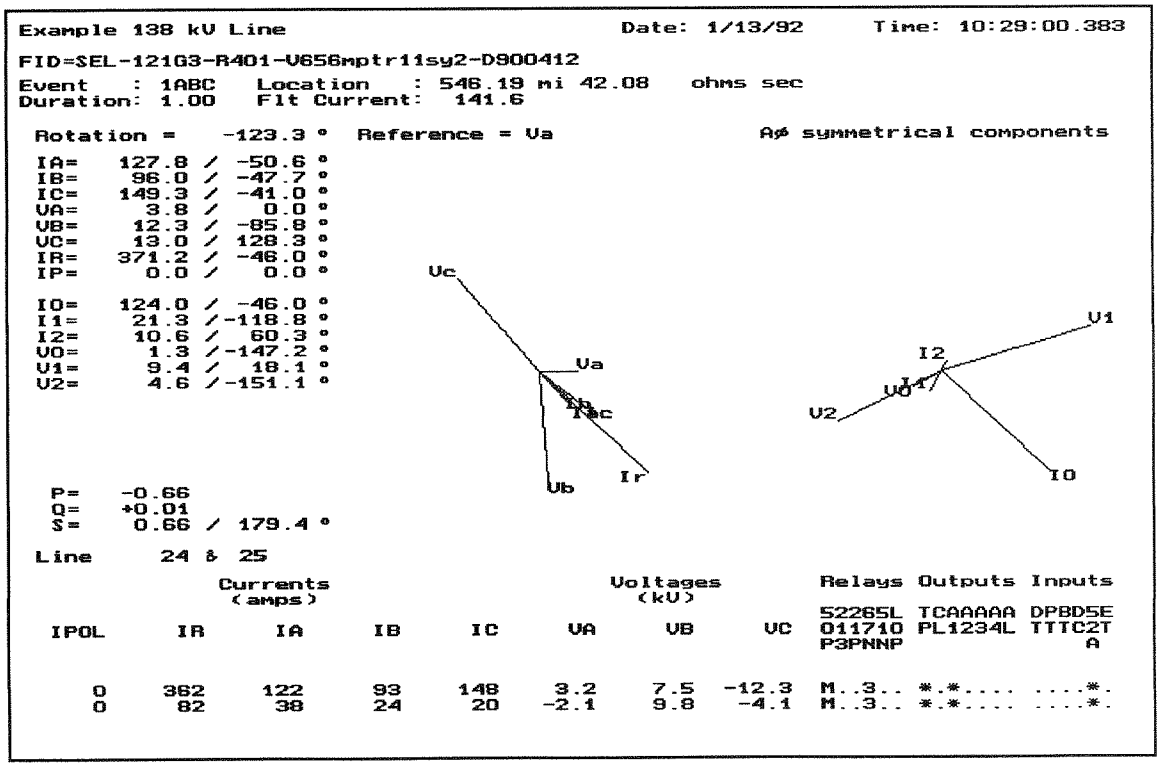
Using VIEW, we examine the event report for rows 15 & 16, where the fault is sensed in the forward direction and again for rows 24 & 25, where the fault is sensed in the reverse direction.

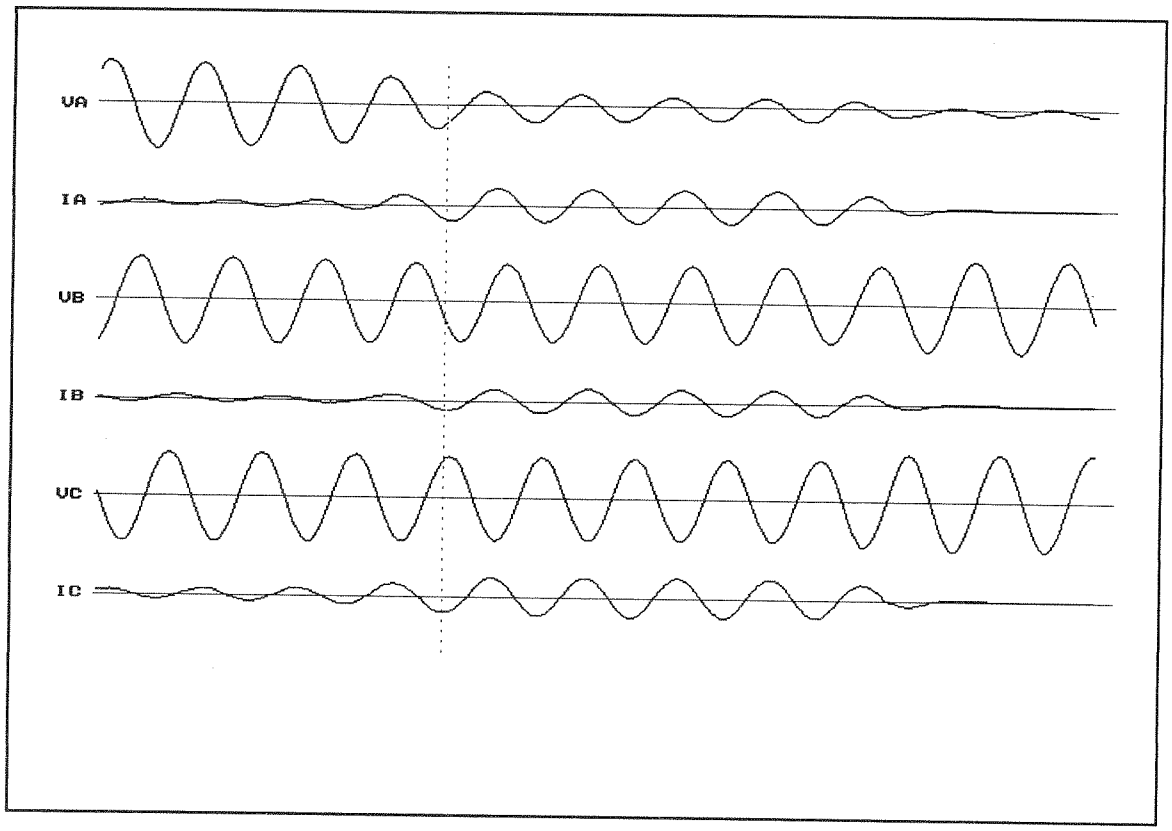
Figure 24: Oscillograph Plot for Event Report

Using the oscillographic plot from VIEW, the three-phase voltages and currents are plotted, with the trip condition marked by the vertical line.

In this example, negative-sequence polarization is a poor choice since it is unreliable when the generator is out of service.
