# Clocks Trust: An investigation of recent 500KV line operations

Galina S. Antonova and Tommy Jansson, Hitachi Energy  
Tom Roseburg and Steve Laslo, Bonneville Power Administration

## Abstract

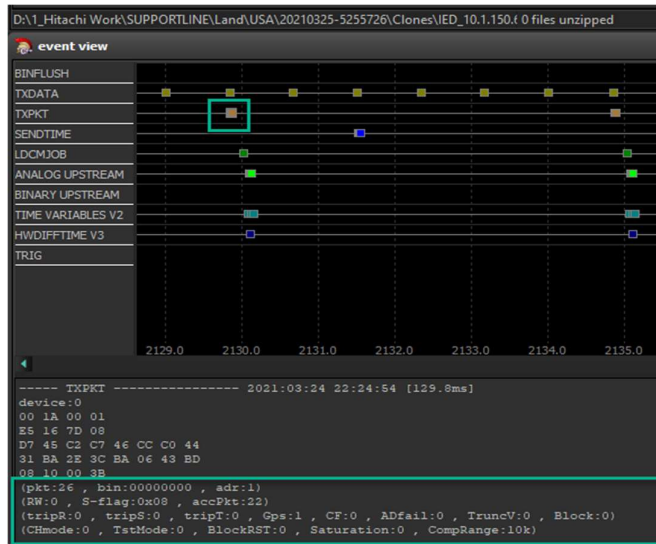
Figure 17. Details of message 22 at the transmitting end

Following this analysis of received messages, message 22 was examined at the transmitting end. Figure 17 captures details of the healthy status of message 22 at the transmitting end.

Based on the above information it was concluded that the glitch in analog data was caused by lost data samples due to corrupted relay-to-relay communication message which had a CRC error. The source of the CRC error was concluded to be outside for the relays, inside BPA test setup which includes communication channel emulator and channel bank.
