Open-Circuited CT Misoperation and Investigation

David Costello, *Schweitzer Engineering Laboratories, Inc.*

Abstract—A wire crimping error caused a current transformer (CT) to become open-circuited under load, a relay to operate, and an industrial plant outage. The wiring error was corrected, and the relay, internally damaged by severe overvoltage, was put back into service. Root cause analysis predicted and exposed the damage and led to corrective actions. This paper revisits the IEEE dielectric strength standard, safe design and work procedures regarding CTs, and what happens when a CT is open-circuited under load. The case study emphasizes the critical importance of commissioning tests and root cause analysis to power system reliability.

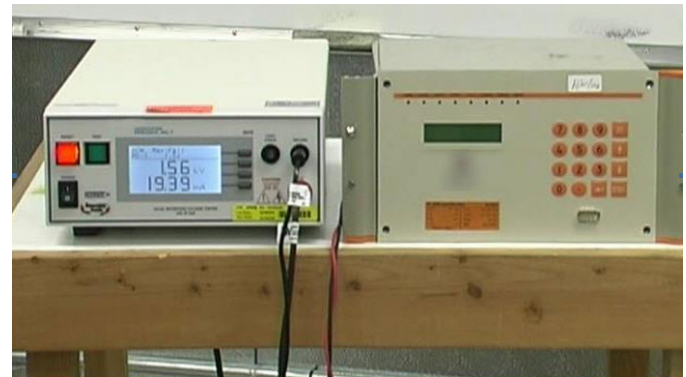
Fig. 7. Dielectric Strength Type Testing

A dielectric test is quite simple to perform with the correct equipment. Fig. 7 is a screen capture from a video taken during dielectric strength, or HiPot, type testing of Relays A and B.

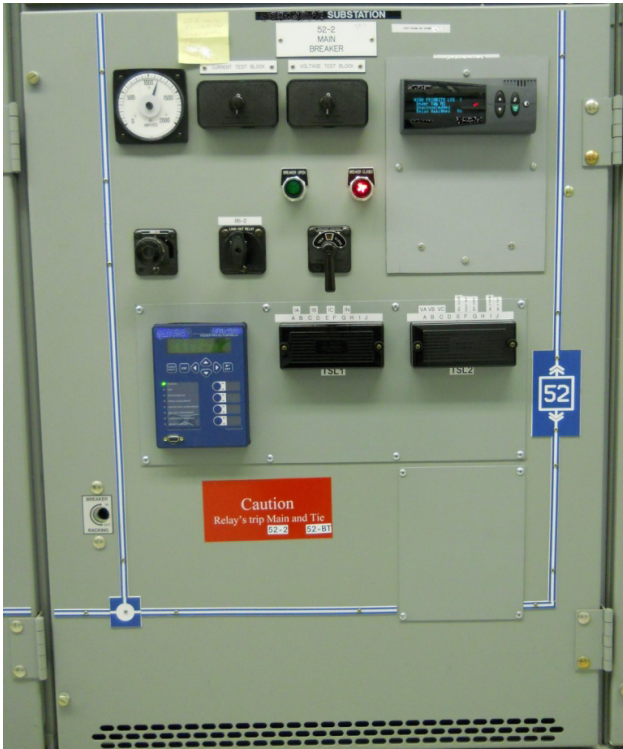
Fig. 9. Switchgear Breaker, Relay, and Controls

The application under study in this paper is a microprocessor-based overcurrent relay installed in switchgear in an industrial plant (see Fig. 9). CTs from the main and bus tie breakers are paralleled and wired to the relay. One breaker is normally closed while the other breaker is normally open.

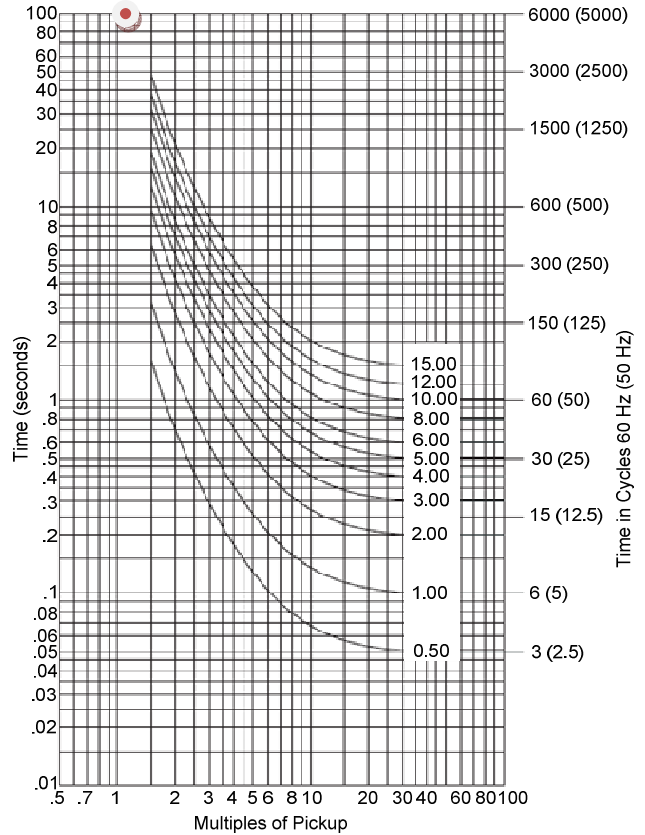
Fig. 15. IEEE Very Inverse Curve

When 51N1P finally asserted continuously, IN was equal to 817 A primary, just above pickup. At this current level and with an IEEE very inverse curve and a time dial setting of 5, the 51N element would take over 7.5 minutes to trip (see Fig. 15). Load current continued to increase, however, and IN increased in magnitude to over 900 A primary at the time of the trip. This sped up the trip time.

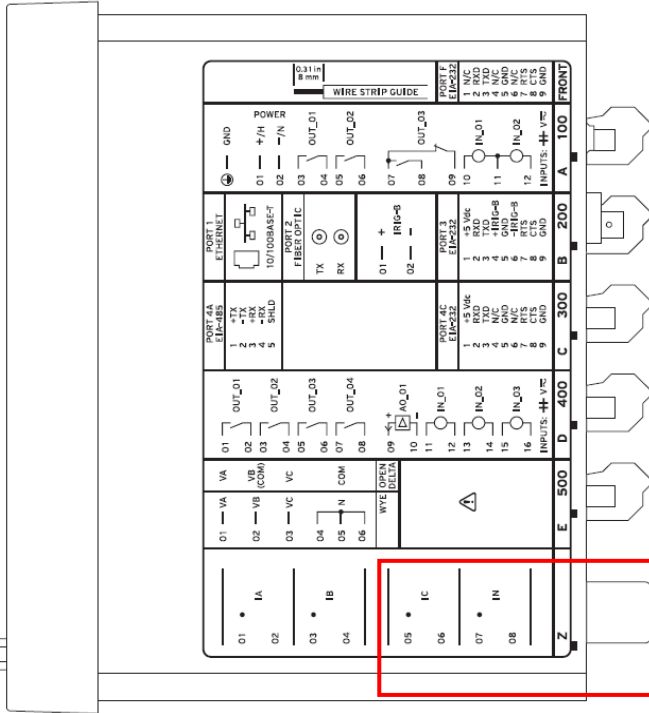
Fig. 23. Profile of Relay Hardware

The relay current terminals are shown in more detail in the next few figures. Fig. 23 is a profile view of the relay hardware. The bottom terminal block is for the current connections. The diagram or sticker on the side of the relay simply explains the connections and terminal numbering. Terminal Z05 is C-phase polarity. Terminal Z06 is C-phase nonpolarity. Recall in this application that Z06 is the terminal that was open-circuited.

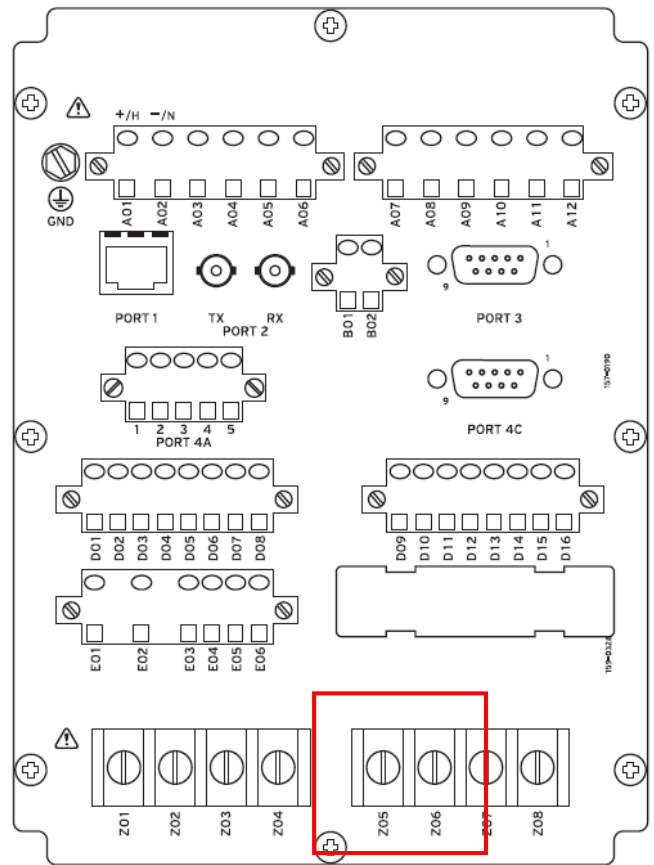
Fig. 24. Rear-Panel Layout of Relay Hardware

Fig. 24 is a view of the relay rear-panel layout. The CT connections are made to the Z terminal block on the bottom. Terminal Z05 is the fourth screw from the right, and terminal Z06 is the third screw from the right.

With a theory and a dielectric test on a like make and model relay in hand, the industrial plant was advised that they had a damaged relay in service that needed to be removed from service and repaired immediately. After switching loads to an alternate source, the breaker and relay were removed from service for thorough inspection.
