When Is Compensation A Bad Thing?

Problems In Applying Wye Connected Transformers With Delta
Tertiary Windings On Distribution Feeders

Steve Gooding

Georgia Power Company

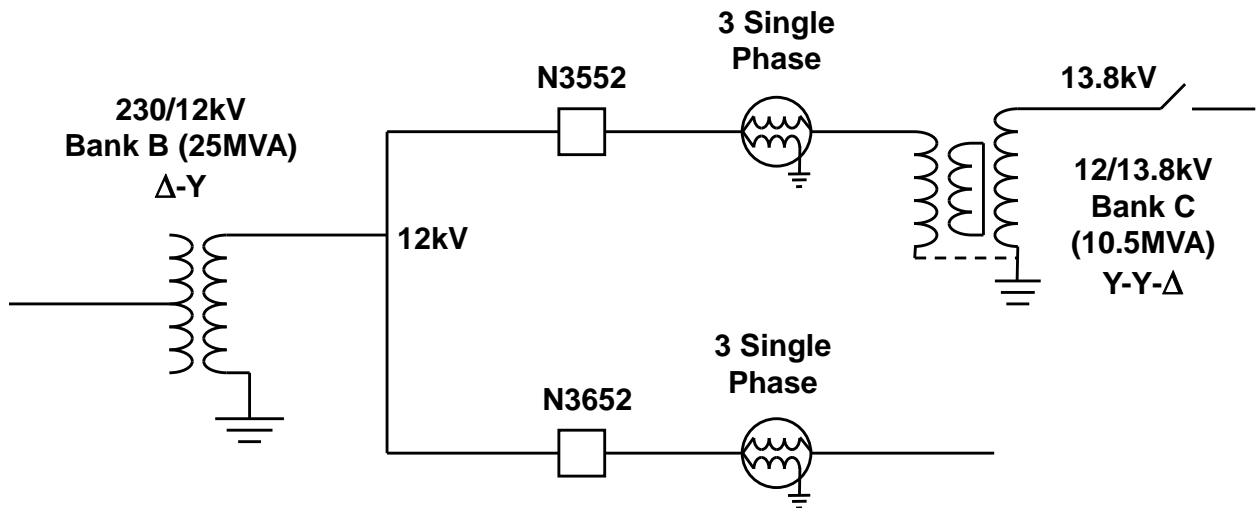
Peach Orchard Station Bank B Arrangement

Peach Orchard - Initial Problem

- 13.8kV Feeder N3552 locked out from a ground trip.
- The line side disconnect was opened, N3552 was closed and immediately tripped again.
- The regulators and 12/13.8kV transformer were tested and no problems were found.
- Several of these trips occurred and it was found that they all coincided with a regulator “running away”.

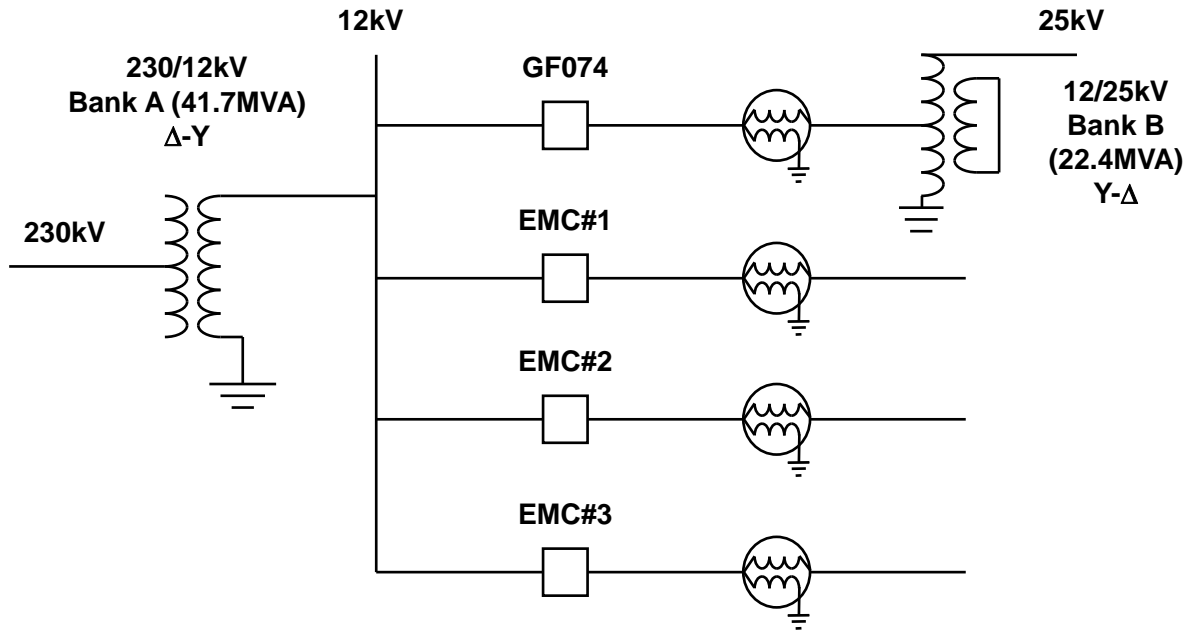
Busbee Parkway is a station owned by one of our ITS partners. There are three feeders supplying EMC load at 12kV and a fourth feeder supplying Georgia Power load through a 12/25kV autotransformer with a delta tertiary. As was the case at the Peach Orchard station, all the voltage regulators are single phase.

- The 25kV feeder current was checked with a clamp-on ammeter and 18 amps was found in 2 phases, no current in the third phase.
- Reading current in the breaker relay showed 52 amps in each of 2 phases, 76 amps in the third phase, and 170 amps of residual current.

- One of the regulators was found to be locked out for reverse power.
- The investigation was hampered by the fact that in this substation, the differential currents on the main transformer and the autobank were wired in delta making it harder to compare currents between CT circuits.

Looking at the 12/25kV transformer nameplate it was noted that just like Peach Orchard, this transformer had a delta tertiary winding. This transformer is an autotransformer where Peach Orchard was wye-wye but the problem is exactly the same. When a single phase voltage regulator tries to change the voltage the delta tertiary tries to rebalance the voltage causing current to circulate in the tertiary and this circulating current is then reflected back into the source side of the transformer.

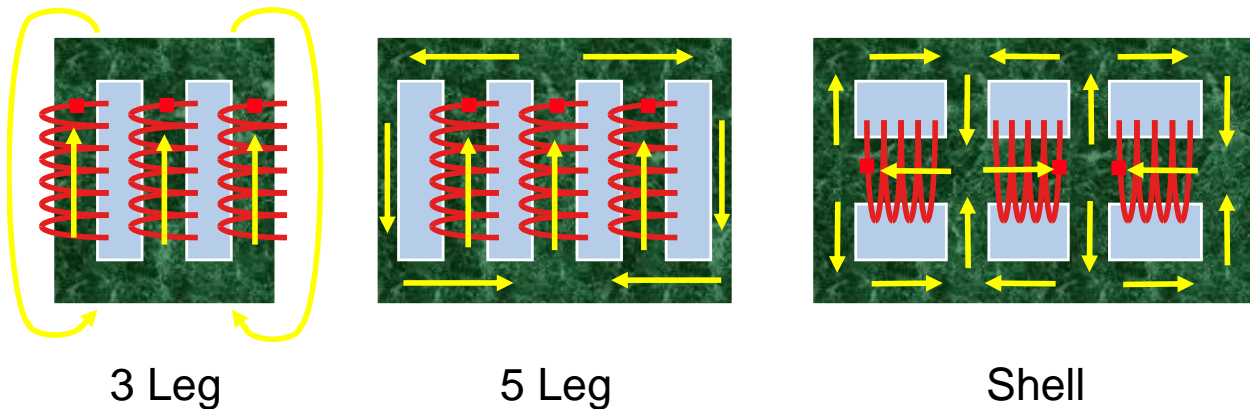
Common Transformer Core Designs

It turns out that breaking the delta tertiary winding does not necessary eliminate the ability of the transformer to supply zero sequence current. In the three legged core design the magnetic circuit is open to all zero sequence current flows. This has the effect of reducing the zero sequence shunt impedance, commonly known as the “phantom tertiary” effect. In other words, even with the tertiary opened up or not even installed on a three legged core transformer, the transformer is still able to supply some zero-sequence current to a fault or unbalanced load.

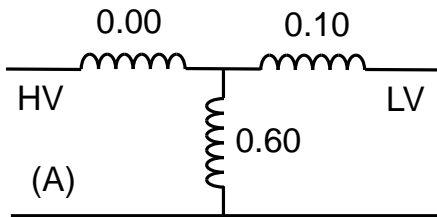
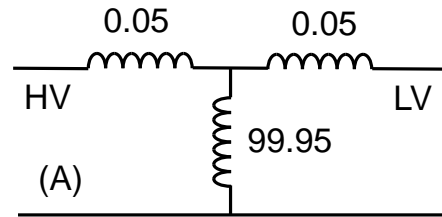
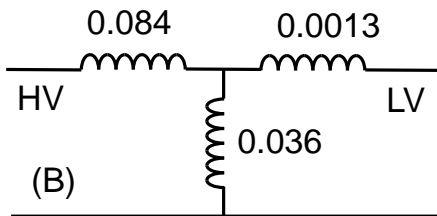
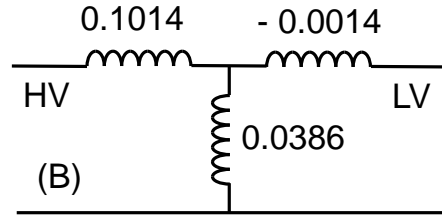
Zero Sequence Networks

In looking at the above impedances measured by B. A. Cogbill, the zero sequence branch for core 3 legged core form transformers without a delta tertiary appears to be much lower than a shell form transformer without a delta tertiary. However, under heavy fault conditions the zero sequence branch impedance may drop. Whether this is a problem most likely will depend on application.
