A Tale of Two Out-of-Phase Synchronizing Events at BC Hydro

Mukesh Nagpal and Lesley Gu, *BC Hydro*
 Ralph Barone, *Barone Technical Consulting Services Ltd*
 Ritwik Chowdhury and Michael Thompson, *Schweitzer Engineering Laboratories, Inc.*

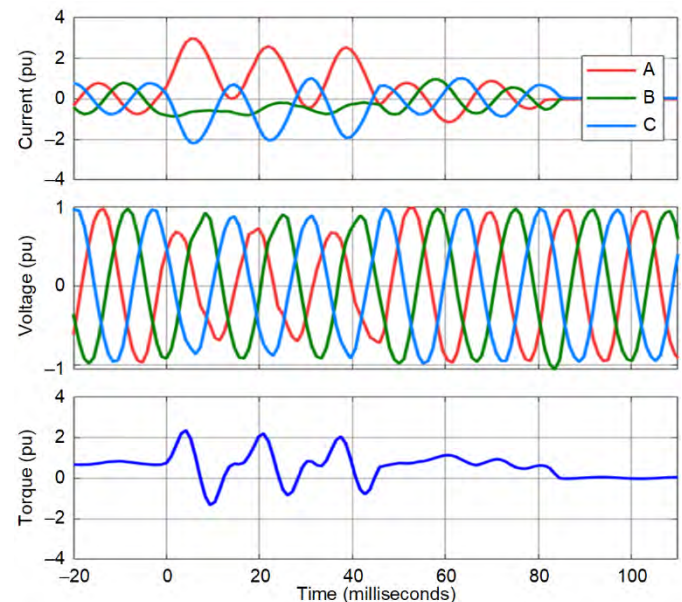
Fig. 10. External CAG fault that occurred 91 kilometers (56.5 miles) from the generating plant.

An important and relevant characteristic of the fault shown in Fig. 10 is that, unlike most faults (which occur near a voltage peak), this fault occurred near a zero-crossing of the fault loop voltage, V_{CA} . Because of the point-on-wave of fault inception, the faulted phase currents had a very high dc offset. This high dc can contribute to delayed zero-crossings and is a much more important consideration for OOPS events. This is discussed further in Section IV.

The near loss of zero-crossings on the faulted phases and the actual loss of zero-crossings on the unfaulted phase was also evident from the field event of the external CAG fault (Fig. 10) that had significant dc offset in the currents. The point-on-wave of fault inception made it so that the dc offset of the A-phase fault current had the same polarity as the load. That fault was 91 kilometers (56.5 miles) away, which reduced the X/R ratio and the dc time constant of the fault current. If the fault were closer, it is possible that the current could have had delayed zero-crossings.

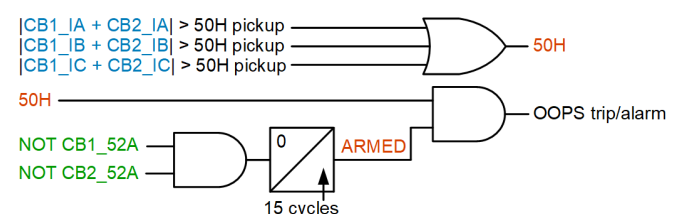
One reason that the OOPS scheme of Fig. 18 was not applied to the 500 kV breaker was because of the high bus current ratings and the possibility of closing either of the ring-bus breakers, 5CB6 or 5CB7, to synchronize the generator. For example, if 5CB6 is already closed and 5CB7 is subsequently closed, a high current could flow through the breaker that closed second, thus jeopardizing the security of the OOPS protection scheme shown in Fig. 18.

Fig. 19. OOPS element for HV synchronizing breakers in dual-breaker configuration.

An alternative to the scheme of Fig. 18 for dual-breaker configurations is shown in Fig. 19. If either breaker is closed, the scheme is disarmed and remains secure. The overcurrent element operates on the partial differential current of the two breakers. For the system shown in Fig. 1, this current corresponds to the generator current and can, therefore, be set in a similar manner as the scheme of Fig. 18 [3]. The phasor sum of the two currents can be obtained by paralleling the CTs externally, using a relay designed for two breaker applications that internally sums the current, or by using programmable math in a digital relay.

Once the scheme operates, to avoid the problem of delayed zero-crossings on the 500 kV breakers, the unit generator breakers connected to the bus can be tripped. For example, if the scheme operates on the relay measuring currents from 5CB6 and 5CB7 of Fig. 1, then G3 and G4 can be tripped. This works because the only scenario where a generator is being synchronized using the 500 kV breaker instead of the generator breaker is when the other generator is out of service. Tripping both breakers trips the closed one that is involved in the OOPS event and a breaker that is already open because the generator is not in service.

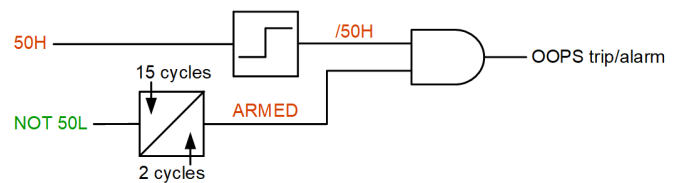
Fig. 21. OOPS scheme without reliance on breaker status.

An alternative to the OOPS scheme of Fig. 18 is shown in Fig. 21; it does not rely on breaker status. The arming path uses a 50L element that picks up for all loading scenarios but not GSU magnetizing current. A 50L pickup of 0.5 to 3 percent is adequate for most applications. The 50H has an additional rising edge to the AND gate to improve security. The dropout timer of the arming path is shortened to two cycles to accommodate timing differences associated with 50H, 50L, and the rising-edge trigger. This scheme looks for a high step change in current to declare an OOPS condition.

For generator relays that do not support a low pickup value for the 50L element, a sensitively set reverse power level can be used to supplement the arming logic. For the system under study, the magnetizing current was less than 0.3 percent.

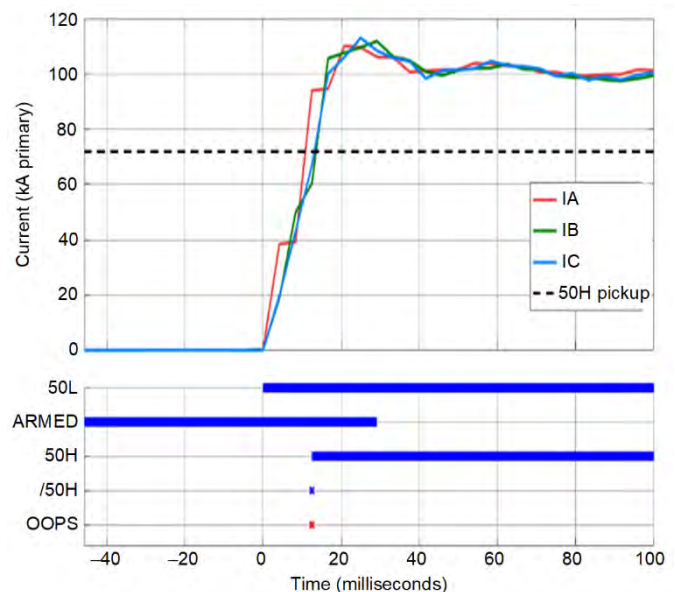
The dependability of the scheme of Fig. 21 for the second OOPS event is shown in Fig. 22. The 50L pickup is set to 1 percent of the generator rated current and the 50H pickup is set to 120 percent of the generator contribution to a three-phase fault on the high-side of the GSU, which is 70 kV (equal to $1.2 \cdot 3.06 \cdot 19$ kA). It is clear that the element is dependable for the 180-degree OOPS event and, based on the analysis from Section III.A, it would remain dependable for events with a synchronizing angle greater than 80 degrees.

Fig. 22. Dependability of OOPS scheme for 180-degree OOPS event.

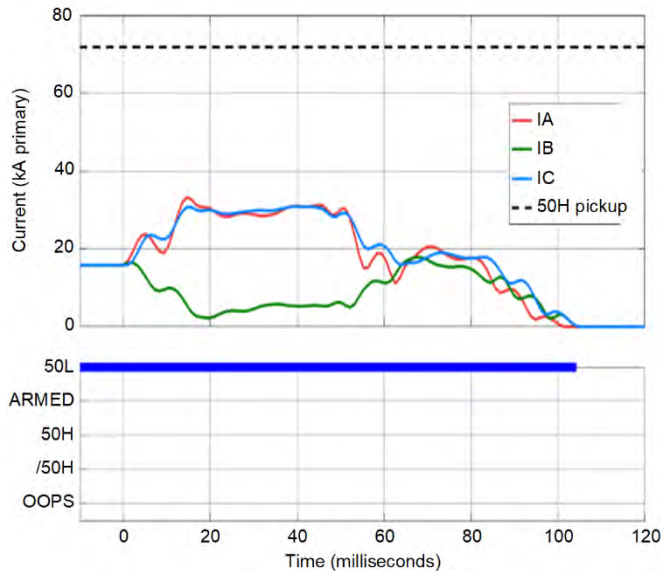
The security of the scheme for the external multiphase fault of Fig. 10 is shown in Fig. 23. The element does not remain armed because of the load current asserting 50L. Even if the element were armed, the fault current is not high enough to assert 50H, which is set to remain secure for a bolted three-phase fault at the GSU 500 kV terminals. Infeed and fault resistance further reduce the fault current so that the element is at no risk of a misoperation.

Fig. 23. Security of OOPS scheme for external multiphase fault.
