Western Protective Relay Conference 2022

Power Plant Protection Event Analysis and Condition Monitoring

Steven Turner

Senior Engineer – Arizona Public Service (APS)

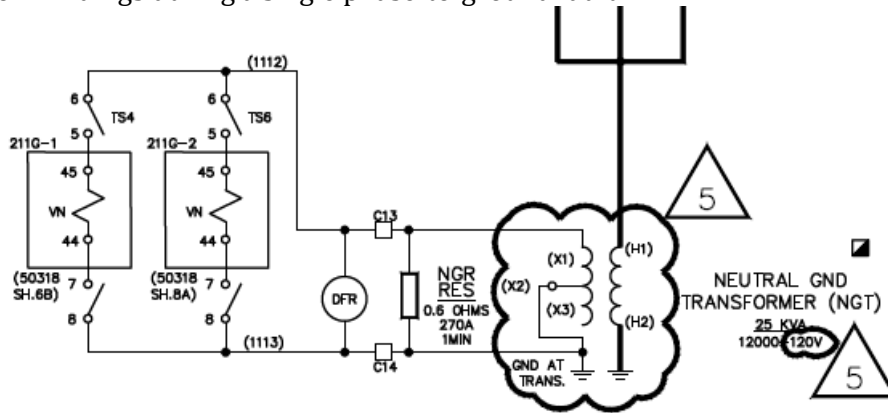
FIGURE 6. Grounding Transformer Connections

The generator is rated 13.8 kV line-to-line. The phase VT ratio is 120 and the grounding transformer turns ratio is 100. Figure 6 below illustrates the connections for the grounding transformer. The generator is high impedance grounded through a neutral resistor across the secondary of the grounding transformer. The generator is high impedance grounded through a neutral resistor across the secondary of the grounding transformer to limit the magnitude of fault current flowing in the stator windings during a single phase-to-ground fault.

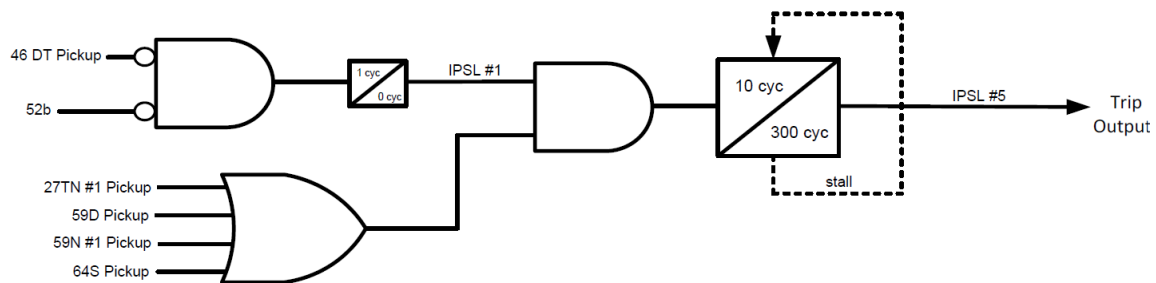
FIGURE 9. Intermittent Arcing Accelerated Tripping Logic

The logic can be initiated by any ground fault protection function that is being used (for example, 59N, 27TN, 59D, and 64S). The integrated stall timer consists of both the pickup and reset timers shown in Figure 8. A pickup time of 10 cycles is used for this application, with a reset time of 300 cycles, that is, if there is an arcing fault with an accumulated 10 cycles worth of arcing with the time between arcs less than 5 seconds, then this scheme will trip:

The logic NOT 46DT AND NOT 52b is ANDed with the ground pickups to improve the security of this intermittent arcing protection by ensuring it does not falsely assert due to a phase-to-ground fault on the high side of the GSU. 46DT is a definite time negative-sequence overcurrent element.

An integrated stall timer that incorporates memory of recent previous arcing events provides fast tripping during intermittent arcing. Timer memory is accomplished by stalling timing of the 59N pickup timer when the initiating function pickup intermittently drops out, as is the case for arcing faults.

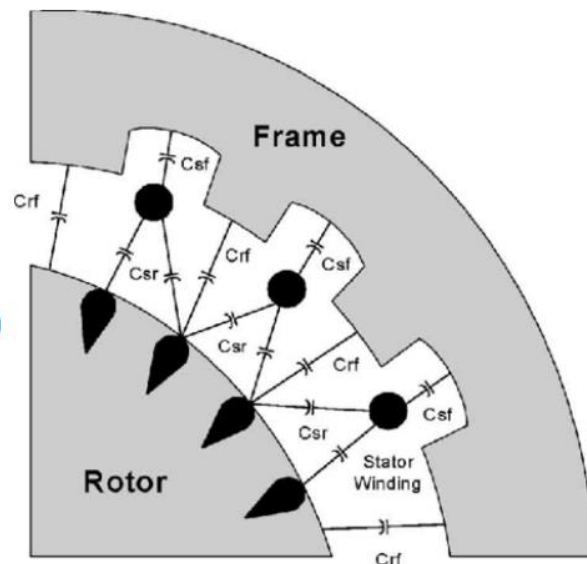
FIGURE 14 - Stator Winding Capacitance-to-Ground

The second to last section of the paper demonstrates how to use a numerical generator protection relay profile capability to measure the stator ground capacitance of a large combustion turbine generator. The measurements are taken when the generator is online and running at full speed while the generator breaker is open (that is, no load), then during startup as the exported power increases. The stator capacitance-to-ground is indicative of conductive moisture and dirt in and around the stator insulation system. The apparent conductive surface area of winding insulation grows as contaminants build up. The value of the variable “plate” can be measured and trended over time as the change in stator capacitance-to-ground (C_g). *Compare the initial (baseline) measurement to future recorded values. A significant rise in magnitude may indicate one of the following conditions exist:*

- Internal contamination
- Moisture infiltration
- Problem with the circuit cables connected to the machine

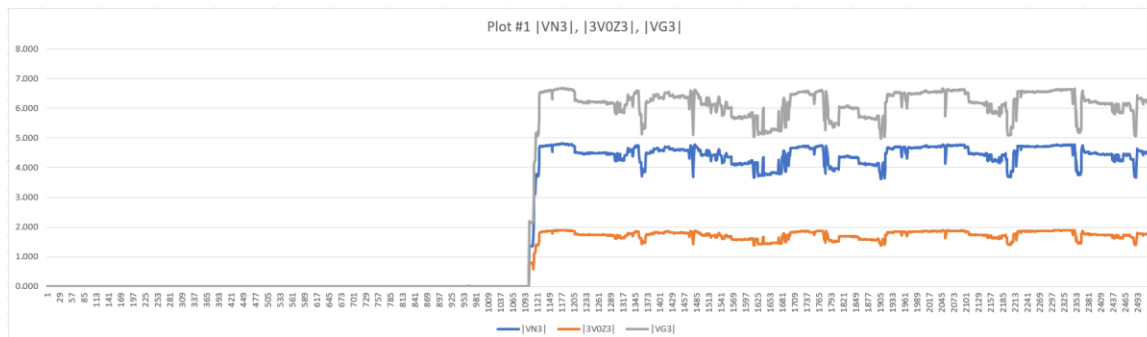
FIGURE 16 – Third Harmonic Voltage Profile Captured during Startup

Figure 16 below shows the third harmonic voltage profile captured by the generator protection relay during startup:
