Finding Common Ground: A Case Study of Phantom Currents and Ground Loops

Matthew Boecker and Genardo Corpuz
Lower Colorado River Authority

Jared Candelaria and Ariana Hargrave
Schweitzer Engineering Laboratories, Inc.

Presented at the
47th Annual Western Protective Relay Conference
Virtual Format
October 20–22, 2020

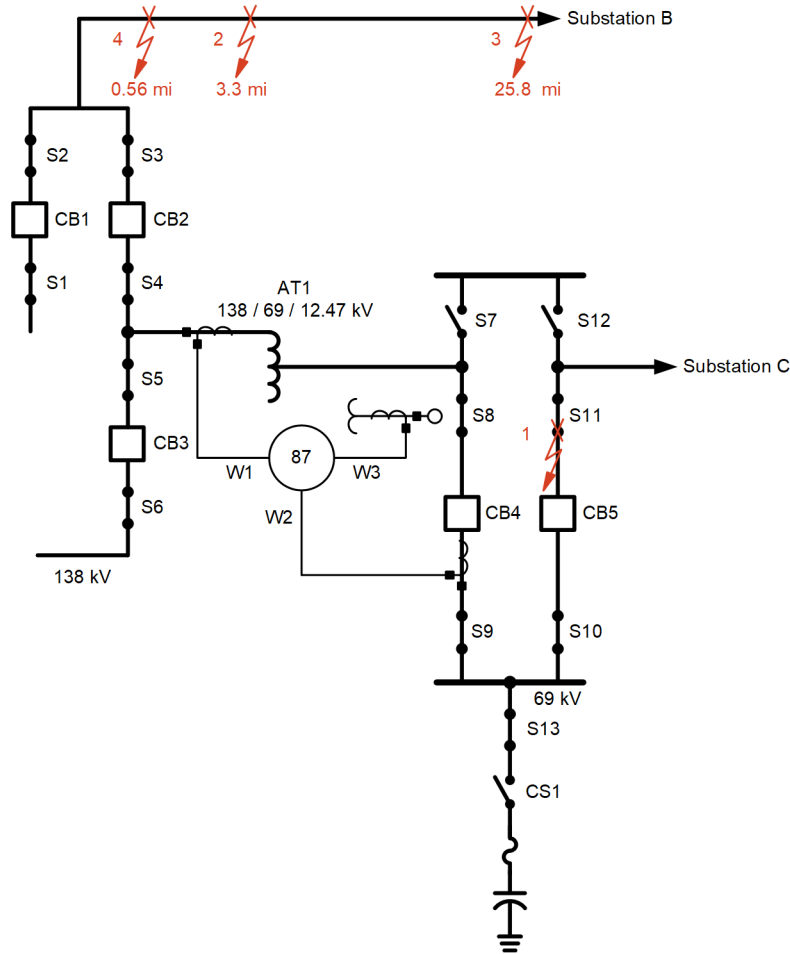
Fig. 4. One-line diagram of Substation A

The one-line diagram of Substation A and the system configuration at the time of the event are shown in Fig. 4. The transformer shown is a 138 kV/69 kV/12.47 kV wye-wye-delta (YYD) grounded autotransformer, with the delta tertiary used for station service. Circuit Breaker CB5, Circuit Switcher CS1, and Switches S7 and S12 were all open, effectively open-circuiting the load side of the transformer. A microprocessor-based current differential relay was protecting the transformer.

The first fault occurred on February 14 at 3:34 a.m. It was an AG fault on Switch S11 on the side of the open circuit breaker, CB5. Fig. 5 shows the switch, where a flashover to the structure caused the switch to break away from the insulator. The location on the system is shown as Fault Location 1 in Fig. 4. Even though this fault was clearly not in the transformer relay's zone of protection, the relay tripped on the C-phase percentage-restrained differential element. The 138 kV circuit breakers (CB2 and CB3) and the 69 kV circuit breaker (CB4) opened in response.

The second thing of note is that W2 measured current on the C-phase. This was not expected. With the 69 kV side of the transformer isolated, as shown in Fig. 4, no current should flow on W2. The events also show that the current on C-phase W2 is arcing. This arcing continued even after the transformer tripped. The length of this arcing time was due to the remote electromechanical ground time-overcurrent relay taking 34 cycles to clear the fault.

One week later, on February 20 at 11:55 p.m., a BG fault occurred on the 138 kV transmission line going to Substation B, 3.3 miles from Substation A. Operations noted that the probable cause of the event was the presence of lightning storms in the area. Crews inspected the line and found no evidence of a fault. The system configuration at this time was the same as it had been when the first fault occurred, as shown in Fig. 4. The second fault was located at Fault Location 2. The transformer relay again tripped on the C-phase percentage-restrained differential element.

Before any testing could be performed, the power system delivered another surprise. The next day, on February 21 at 9:56 a.m., a CG fault occurred on the 138 kV transmission line going to Substation B, 25.8 miles from Substation A. This is shown as Fault Location 3 in Fig. 4. This time, the transformer was completely isolated from the system with Breakers CB2, CB3, CB4, and CB5 all open. Operations again attributed the fault to lightning in the area, since no physical evidence of a fault was found. Although the line relay operated for this fault, the transformer relay did not trip.

Later that same day, at 12:58 p.m., a CAG fault occurred on the 138 kV transmission line going to Substation B, 0.56 miles from Substation A. This fault was also attributed to lightning in the area and is shown as Fault Location 4 in Fig. 4. The A-, B-, and C-phase differential elements all asserted and caused the transformer relay to trip.

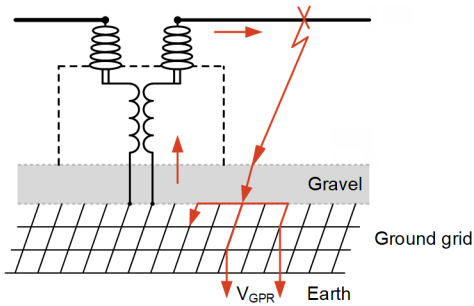
Fig. 9. Ground current flow during a ground fault causes GPR at a substation

When ground faults occur, the zero-sequence current returns to the source through the earth, as well as through other paths such as neutral conductors, overhead ground wires, and cable shields. The total zero-sequence current splits between the earth and these alternate paths [3] [4]. When a fault occurs near a substation, a large amount of current flows through the station ground grid. Because the ground grid has some impedance, the zero-sequence current flowing through it causes a voltage to develop across the grid. This is known as ground potential rise (GPR) and is illustrated in Fig. 9. IEEE 80 defines GPR as:

The GPR voltage only defines the maximum voltage possible. The voltage will drop across the substation ground grid, resulting in a gradient of different voltages at different points on the grid, as illustrated in Fig. 9.
