Event Investigation of 69 kV Double-Circuit Faults

Ahsan Mirza, Christopher Bolton, Girolamo Rosselli, and Sergio Flores
San Diego Gas & Electric

Presented at the
47th Annual Western Protective Relay Conference
Virtual Format
October 20–22, 2020

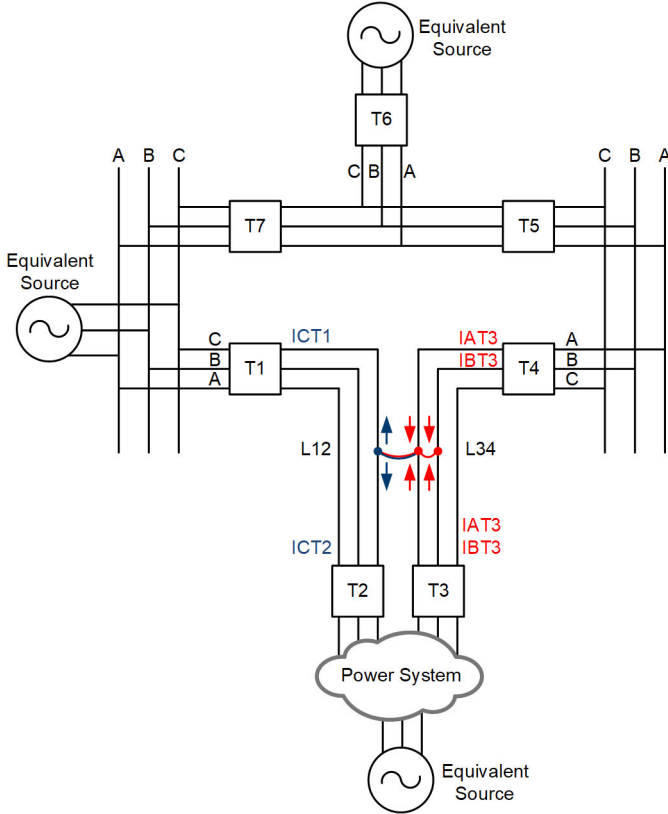
Fig. 9. Intercircuit Fault Illustration

To start, we transform the one-line diagram of Fig. 1 into its three-phase view and place a short between C-phase of L12 and A-phase and B-phase of L34, as shown in Fig. 9.

To find out if this is an intercircuit fault, we take the Kirchhoff's Current Law (KCL) approach. If it is indeed a case of an intercircuit fault with no ground involved, then adding all the current flows into the fault point should give us a value of zero in accordance with KCL. If the currents add up to a significant non-zero value, then that non-zero value represents the ground current, and it is instead a case of a double-circuit fault involving ground.

The currents to add up are C-phase currents at T1 and T2 (shown as ICT1 and ICT2 in Fig. 9), and IA and IB pairs at T3 and T4 (shown as IAT3, IBT3, IAT4, and IBT4, respectively, in Fig. 9). To add the currents, we simply combine the event reports from the T1, T2, T3, and T4 relays and perform custom calculations in the event viewer software to obtain the KCL summation in (1).

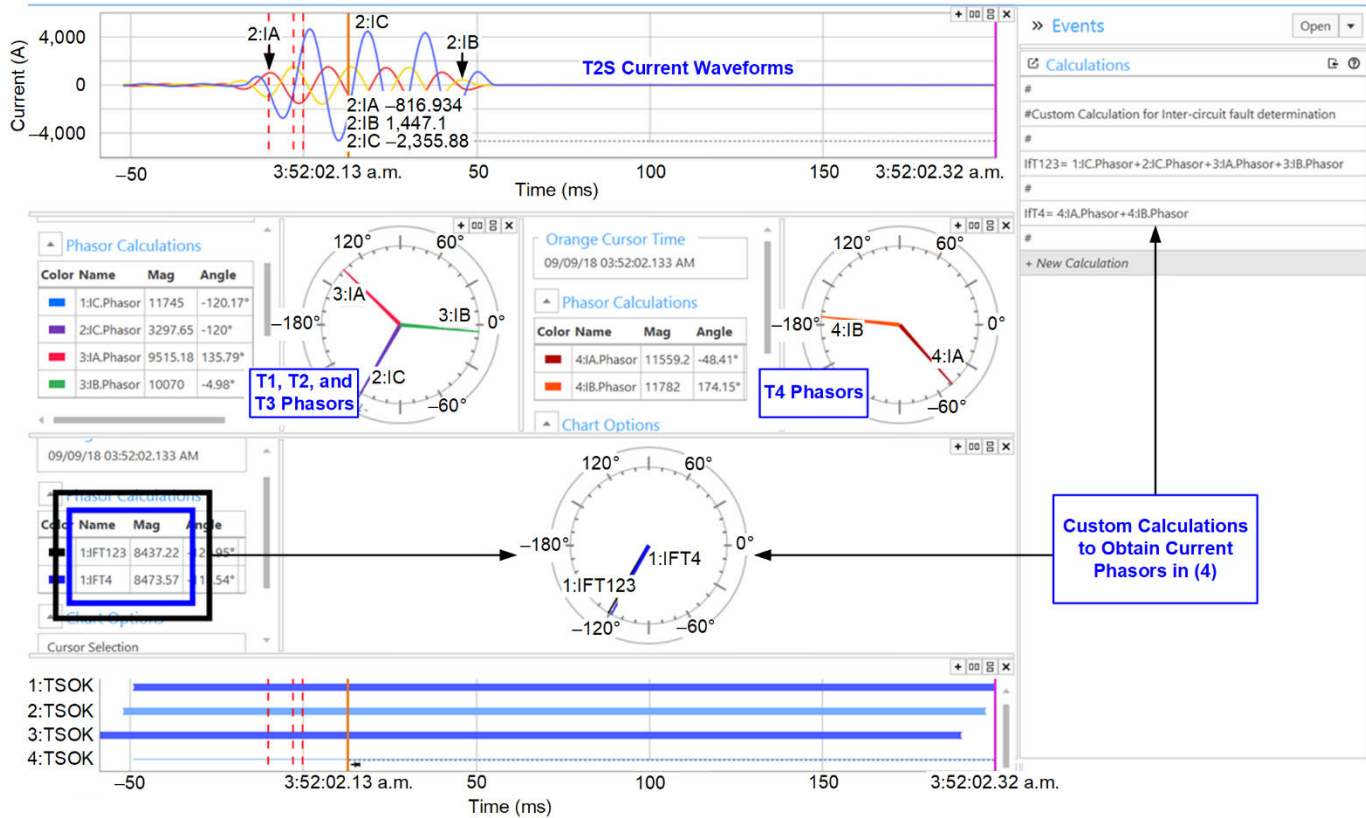
Fig. 11. Combined Event Reports to Form (4)

We proceed further and combine all four event reports from T1S, T2S, T3S, and T4S in the event viewer software and perform custom calculations to form (4). Fig. 11 shows the result of the two phasors (IfT123 and IfT4). The two current magnitudes are quite close to each other at 8,437 A for IfT123 and 8,473 A for IfT4. Such close magnitudes indicate that ground was possibly not involved, and the fault was instead a phase-only intercircuit fault between C-phase of L12 and A-phase and B-phase of L34.

Not surprisingly, we still have roughly the same magnitudes of 8,453 and 8,454 A of IfT123 and IfT4, respectively, just like we saw in Fig. 11. But now we know their respective angles (now that all the event reports have been time-aligned) as well. IfT123 and IfT4 are roughly 170 degrees apart from each other, The 10-degree difference (180–170 degrees) is enough to reveal the existence of ground current of ~1,423 A.
