Protection Engineer Campfire Tales

Presented to
Western Protective Relay Conference
Oct 2009
Spokane, Washington, USA

Prepared by
Ralph Barone, PEng
Senior Protection Planner
BC Hydro

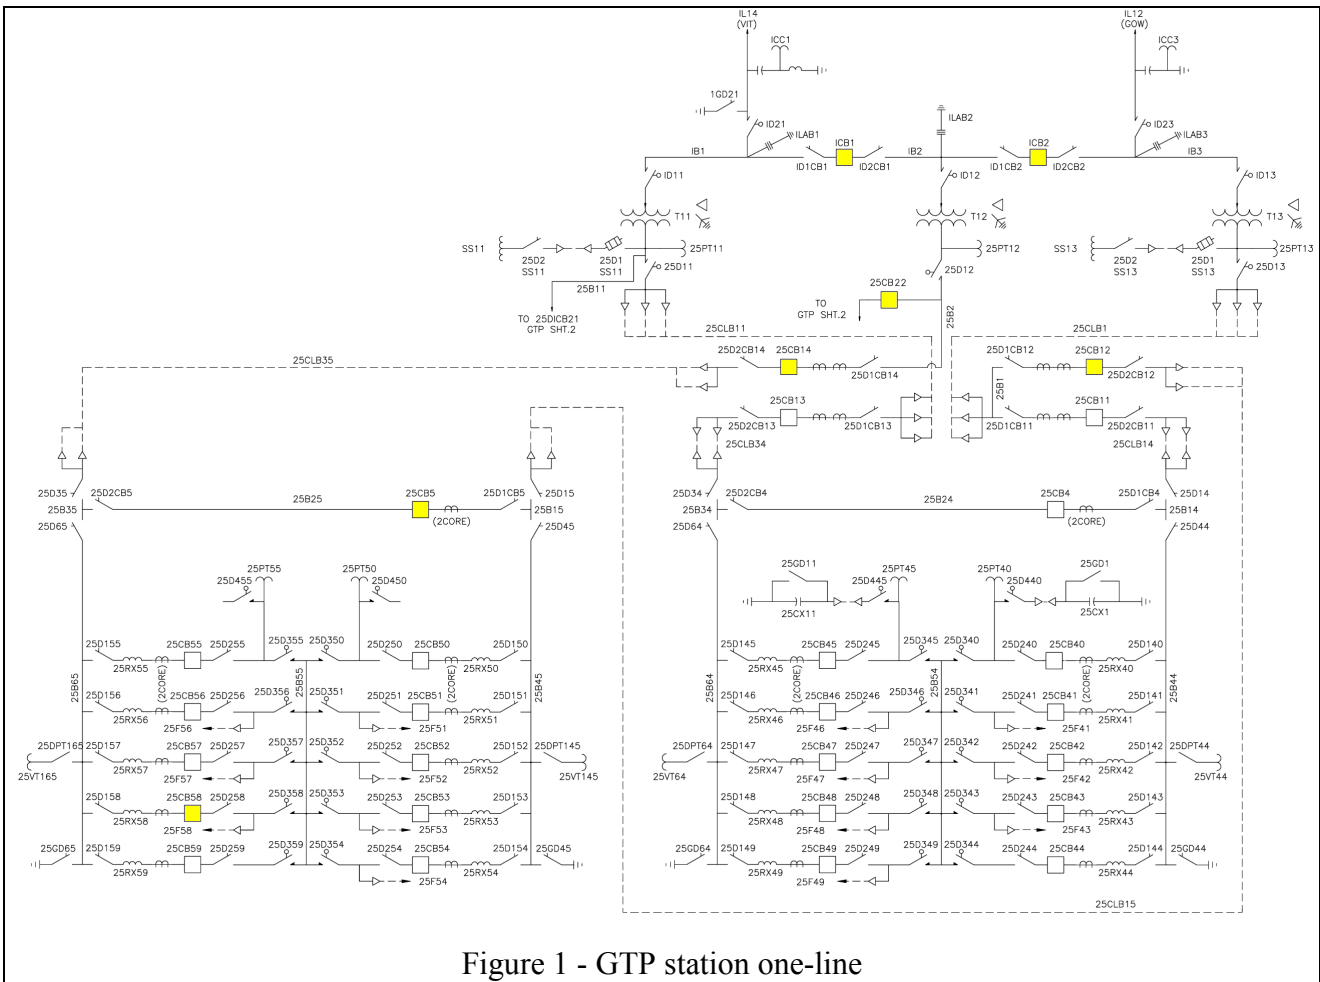
Figure 1 - GTP station one-line

At GTP substation (the first disturbance), a fault on feeder 25F58 was the initiating incident. Breaker 25CB58 failed to open before its breaker failure protection tripped into 25B65 protection², which sent trips to 25CB5 and 25CB14. Both 25CB5 and 25CB14 failed to open in time, and their respective breaker failure protections then operated. The 25CB5 breaker failure protection tripped into 25B45 protection, which tripped 25CB12. 25CB14 breaker failure protection tripped into T12 protection, which tripped 25CB22, 1CB1 and 1CB2. All breakers eventually opened, except for 25CB14.

Timing tests performed on the breakers after these incidents showed very interesting behaviour. The first test trip operation of the breaker would be very slow (up to ½ second)³. However, subsequent trip commands would be processed faster, until by the second or third operation, the breaker would be operating at nameplate speed. Inspection of the breakers showed that improper maintenance procedures had been used, including the use of a non-recommended grease. This grease had thickened with age, causing sticking between two plates in the mechanism, which the low powered trip coil could not overcome.

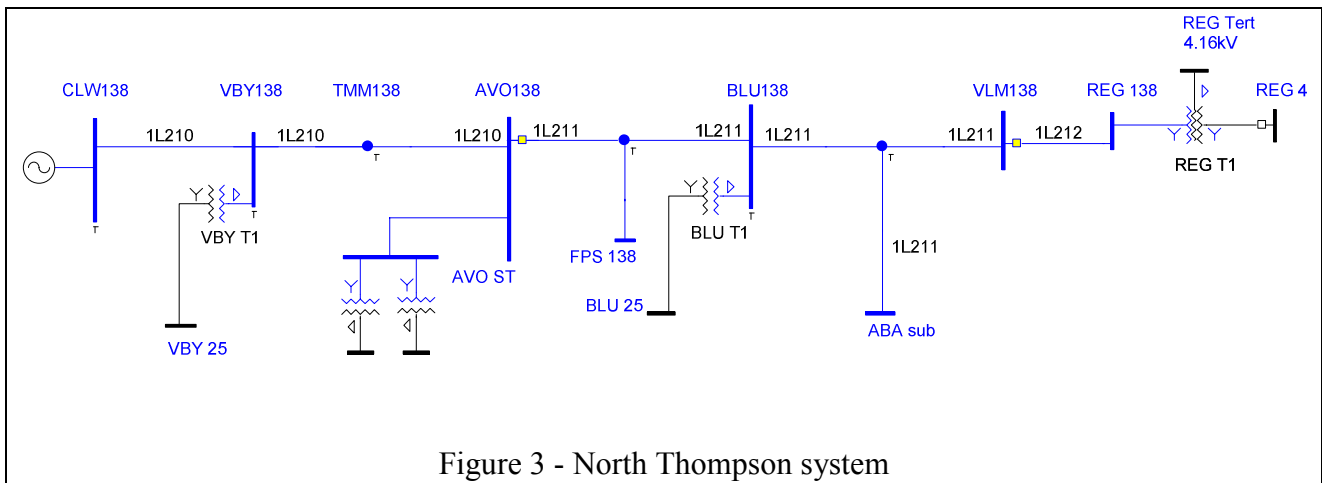
Figure 3 - North Thompson system

On 2007-06-18, existing AVO 1L211 line protection operated twice, isolating customer load at BLU and VLM, as well as the industrial load at FPS, ABA and REG. A line patrol failed to find any faults on 1L211. After sectionalizing at VLM, the line was successfully reenergized, however it tripped off again after 1L212 was reenergized. A line patrol of 1L212 found a broken cross-arm, one conductor hanging a foot above the sandy soil, and two dead bears near the conductor.

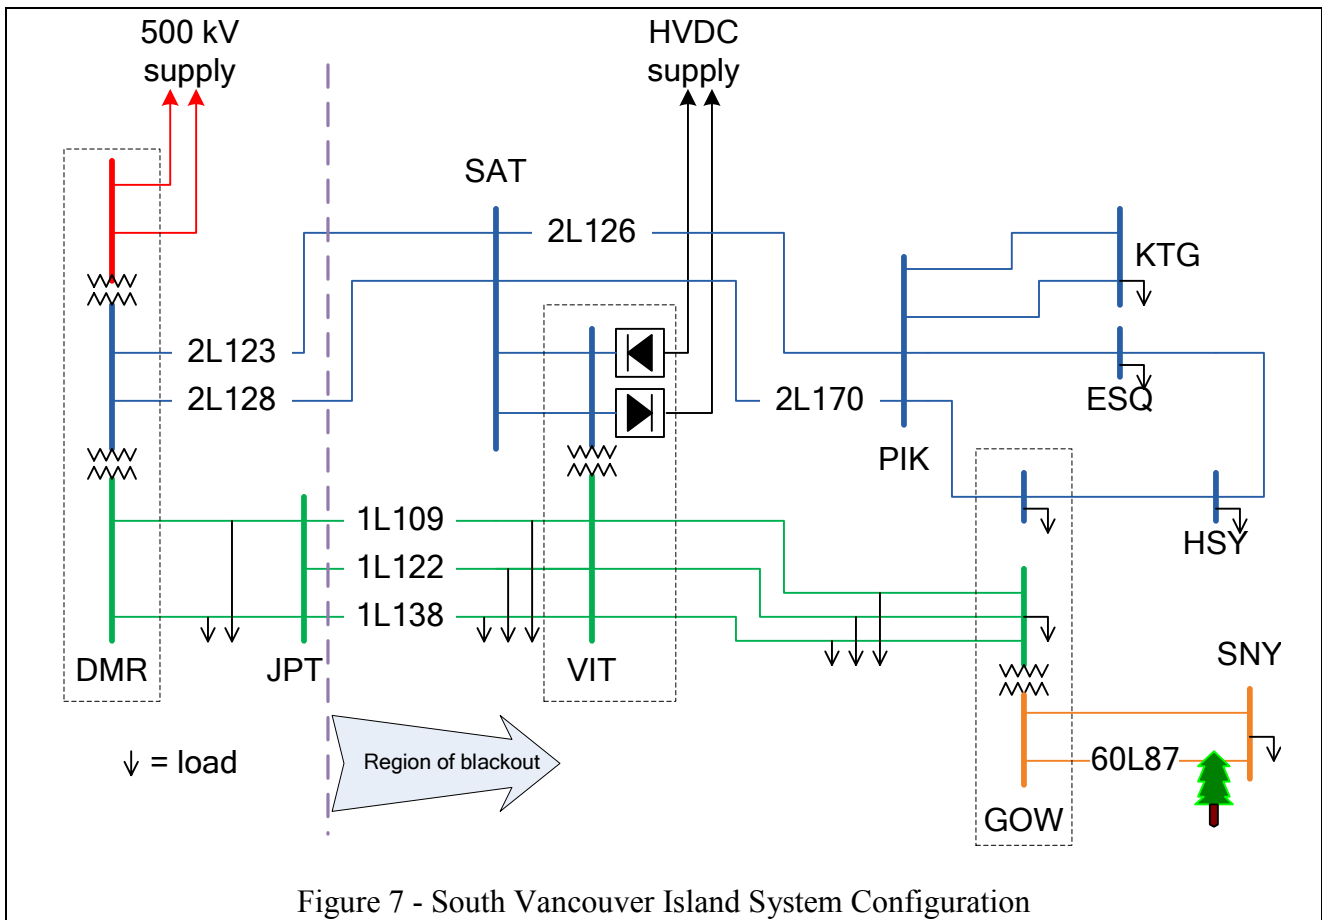
Figure 7 - South Vancouver Island System Configuration

On Oct 12, 2008, all load to the right of the dashed purple line (approx 700 MW) was lost as a result of cascading transmission outages caused by two protection misoperations in the 230 kV system triggered by a tree branch falling on circuit 60L87 [2].

The root cause for the escalation of this disturbance into a wide area outage was the unexpected misoperation of two critical protection systems on the two transmission lines (2L123 and 2L128) that form the backbone 230 kV supply to the SVI area. These two permissive overreaching transfer

2L128 tripped first. This was caused by a setting error which resulted in incomplete coordination between the forward looking elements at DMR with the reverse looking elements at SAT.

When 2L128 tripped off line, 2L123 became more heavily loaded than it had ever been before (though still within rated capacity). Even though the protection on 2L123 was correctly set in accordance with our guidelines at the time, the unbalance in circuit 2L123 (caused by lack of transpositions combined with heavy load) resulted in an negative sequence voltages and currents that were sufficient to cause the sensitive forward looking directional elements at both terminals of the line to declare an internal fault and trip.

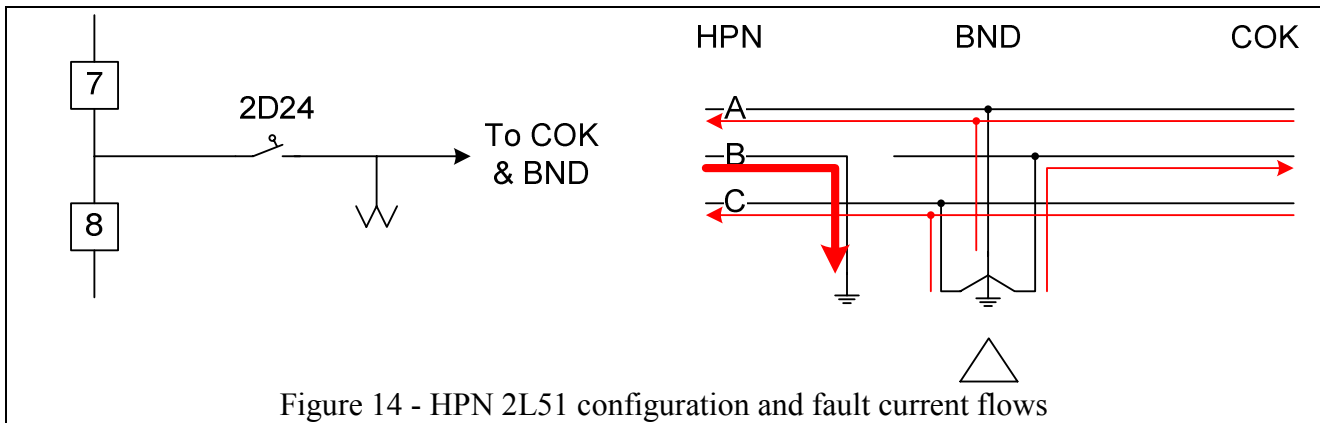
As part of the switching sequence, 2L51 was energized from the COK side, then line disconnect 2D24 at HPN substation was closed remotely. When the disconnect was closed, B phase of the disconnect broke at the hinge end and dropped into the grounded support structure. This did not cause an immediate fault, as the circuit was open on the energized side, and not yet energized on the faulted side. When the first circuit breaker at HPN was closed to put the line in service, it resulted in a bolted B phase to ground fault.

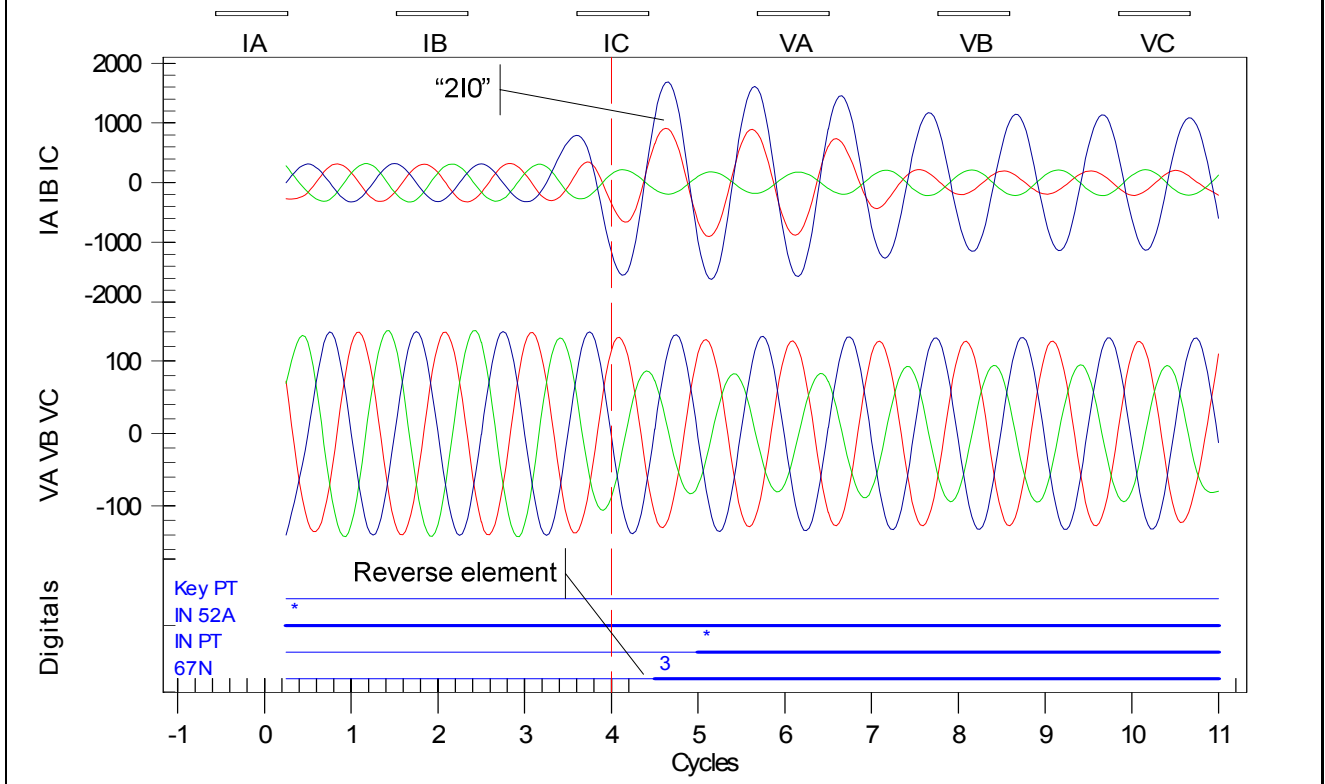
Figure 16 - COK 2L51 Event Record

The initial fault record from HPN is shown in Figure 15. The nature of this fault (combination of open phase plus short circuit on a line with tapped load which was energized from the remote end) acted to allow this fault to go undetected by many of the standard schemes that protection engineers apply. A high set ground instantaneous overcurrent trip was not applied at HPN due to coordination difficulties (being a fairly short cable circuit, the fault levels do not change much over the length of the line) and ground mho elements were not applied since that vintage of relay did not have those elements. Since the fault was undetected by local protection schemes, it would have been expected that the permissive scheme would quickly clear the fault. However, due to the open circuit on B phase at HPN and infeed via a tapped station on 2L51 (BND), the negative sequence directional element on the COK end of the line saw the fault in the reverse direction (ref Figure 17) and blocked operation of the permissive scheme.

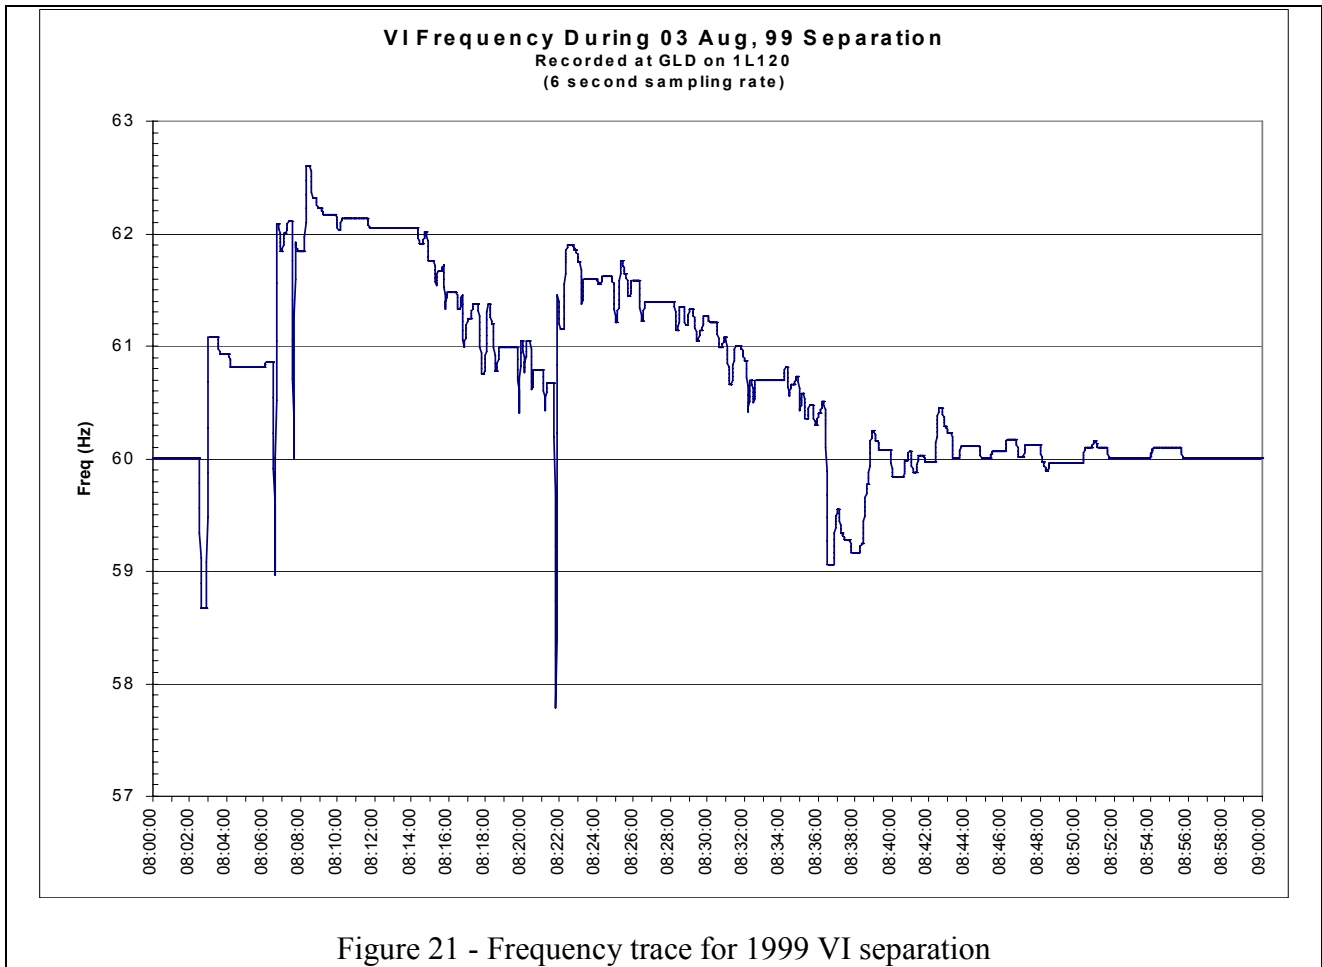
Figure 21 - Frequency trace for 1999 VI separation

the line itself. Since both parallel circuits had tripped 3-pole⁷ simultaneously, the two systems (Vancouver Island and the mainland) were out of synchronism and a reclose was impossible (loss of 248 MW). Due to the extreme voltage dip caused by the initial fault on 5L32, both HVDC converters blocked for 300 ms before restarting (loss of an additional 542 MW).

With the loss of the tie to the mainland and the HVDC temporarily out of service, we were left with 1068 MW of load connected to 278 MW of hydro generation. The frequency on the island began to drop at approx 4.9 Hz/sec and dropped to 57.7 Hz 6 cycles after the HVDC restarted. By this point, underfrequency load shedding had shed more than 248 MW (the generation deficit from 5L30/32), so at this point, the frequency began rising. Once the frequency hit 65 Hz, half of the HVDC and two synchronous condensers at VIT were tripped on overfrequency. The reduction of import power, resulted in the frequency stabilizing near 61 Hz. At 8:06, a fault on the AC system in the lower mainland near the HVDC rectifier terminal resulted in the temporary blocking of the other half of the HVDC and more underfrequency load shedding. When the HVDC restarted, the frequency rose up above 66 Hz and another synchronous condenser was tripped on overfrequency. The operators were restoring load to bring the island frequency down, but as they approached 61 Hz, another AC fault occurred near the HVDC rectifier terminal, resulting in another temporary block of the HVDC, and another round of underfrequency load shedding. Finally, the operators were able to restore frequency to near nominal and resynchronize Vancouver Island to the mainland.

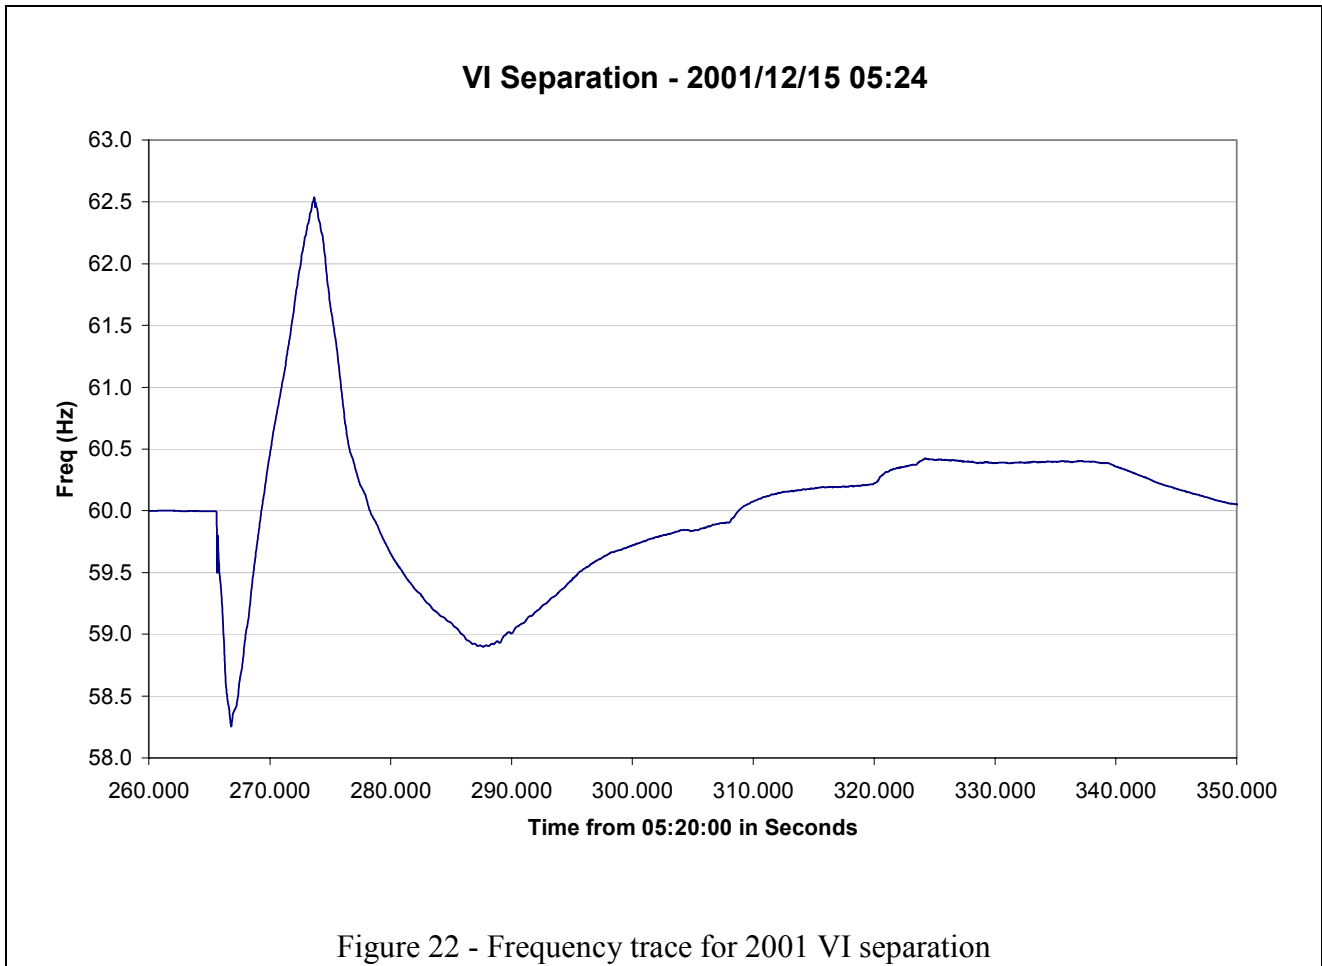
Figure 22 - Frequency trace for 2001 VI separation

On Dec 15, 2001, another storm system rolled across the southern part of the mainland of British Columbia. At 1:06 AM, insulator flashovers on one of the HVDC circuits resulted in that part of the HVDC being taken out of service. At 3:43 AM, one of the 500 kV circuits tripped out due to icing on the insulators and was returned to service 18 minutes later. Three minutes later, the line tripped out again, and remained out of service for the next 8 ½ hours. Eighty minutes later, the second 500 kV line tripped out (again due to insulator icing), severing the synchronous tie between Vancouver Island and the mainland. Because of the higher fault impedance of the insulator icing, the remaining HVDC link did not block, and the frequency declined at approx 1.4 Hz/sec. Underfrequency load shedding operated, but again overshot, and the frequency rose to 62.5 Hz, at which point the thermal generating plant on the island tripped on overfrequency, which triggered another round of underfrequency load shedding. After this, the frequency was reasonably well behaved until the operators could resynchronize with the mainland.

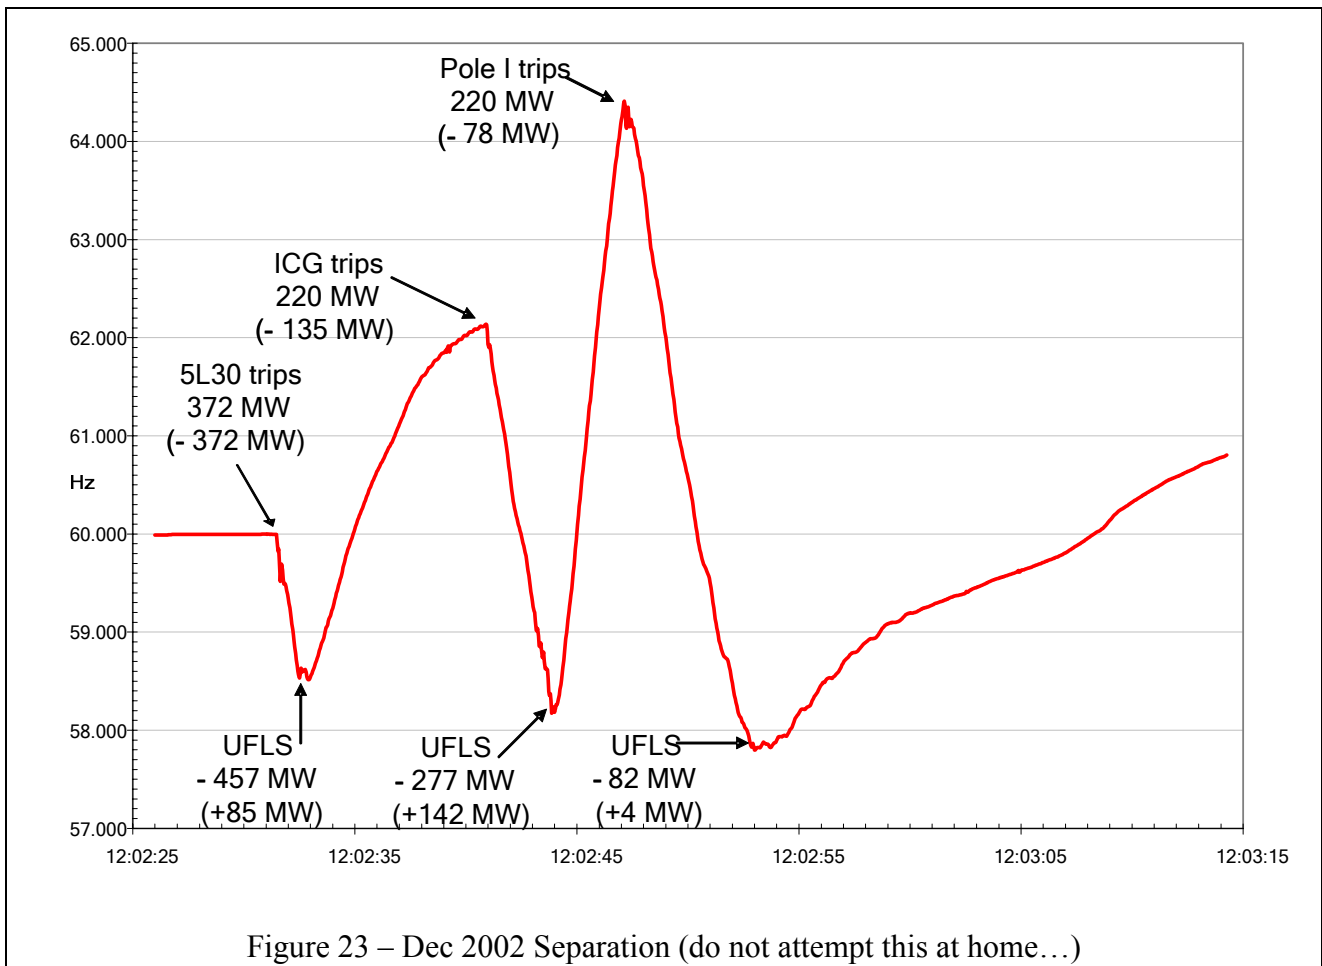
The Dec 26, 2002 Vancouver Island separation was perhaps the most spectacular in terms of frequency deviations. At the time of the event, 5L32 was out of service, due to a mudslide which had damaged six towers two weeks before the event. At 12:02 PST, circuit 5L30 tripped as a result

of a flashover to a tree. The lack of clearance was caused by an extreme increase of conductor sag between towers due to an unequal ice loading on the conductors in adjacent spans. At the time 5L30 tripped out, the island load was 1567 MW, of which 372 MW was being fed via 5L30. The loss of import power resulted in the frequency dropping to 58.5 Hz before UFLS could drop enough load to arrest the frequency decline. By this point, 457 MW of load had been shed, so the frequency rose to 62.1 Hz, at which point ICG tripped on overfrequency. ICG output at this time was 220 MW. The frequency then dropped to 58.2 Hz before 277 MW of load was tripped via UFLS. With the largest source of rotational inertia on the island now offline, the frequency rose quickly to 64.5 Hz, at which point half of the HVDC was tripped on overfrequency. This resulted in the loss of 220 MW of import. One more round of UFLS (82 MW) ensued before the island frequency could stabilize at a point above any unoperated UFLS and below any unoperated overfrequency tripping.

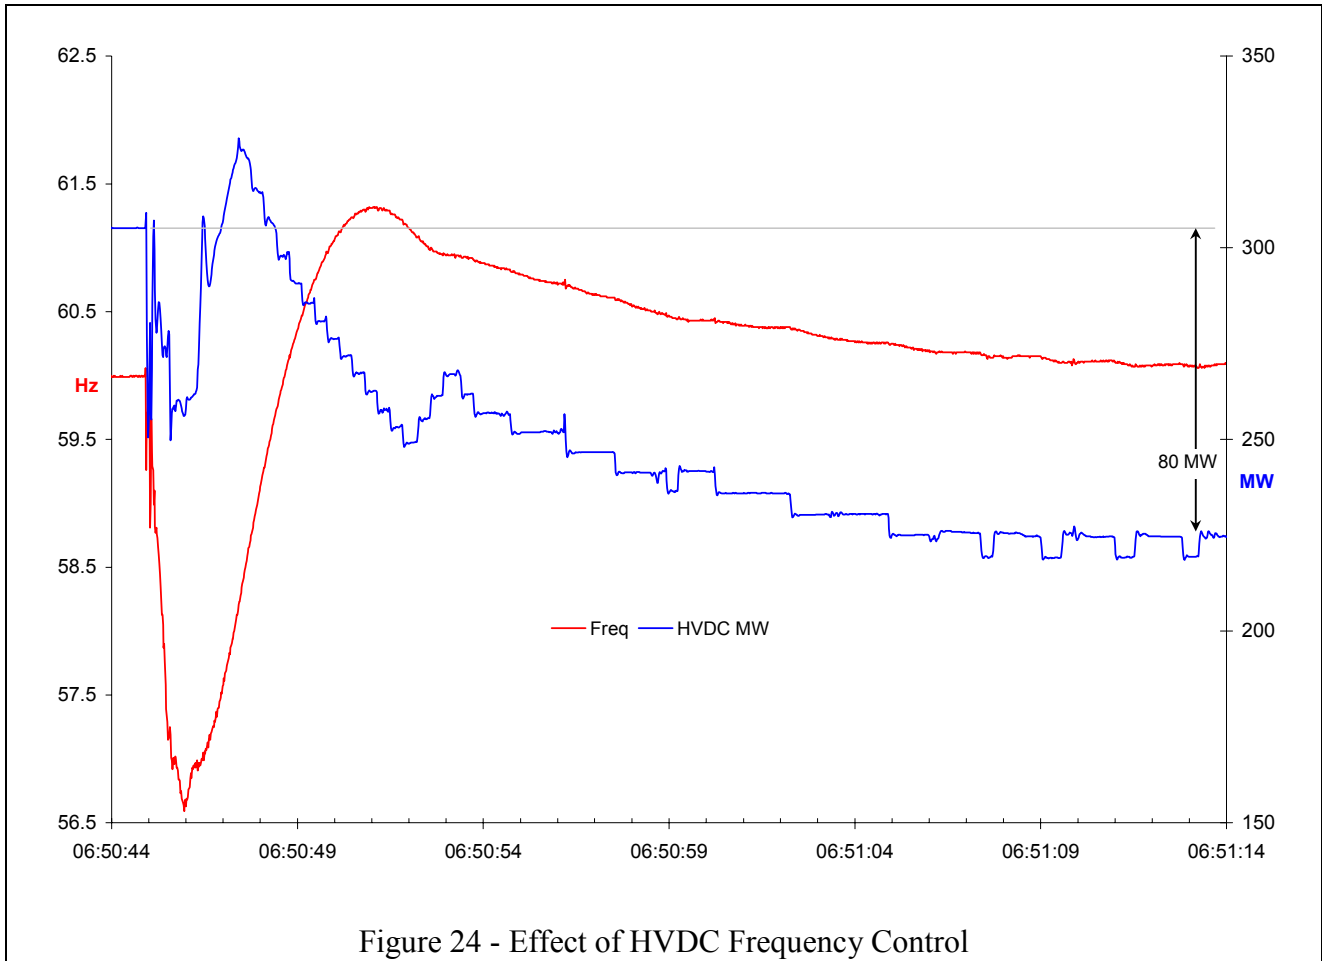
Figure 24 - Effect of HVDC Frequency Control

When 5L30 and 5L32 tripped, the frequency on VI began dropping at an average rate of 5 Hz/sec. Underfrequency load shedding operated to arrest the frequency decline. The frequency had started to recover at approx 57.2 Hz, but just after the frequency started rising, one radially connected hydro generator (JOR G1) was lost due to its associated line protection tripping on a power swing. Two more stages of underfrequency load shedding then operated before the frequency decline was finally arrested at 56.6 Hz. The HVDC frequency control then dropped 80 MW of import power to relieve the overfrequency
