Forward to the Basics: Selected Topics in Distribution Protection

Lee Underwood and David Costello, *Schweitzer Engineering Laboratories, Inc.*

Abstract—Modern relays provide protection elements that were historically not used due to cost or panel space restrictions. These new elements can provide improved protection for the power system. However, protection engineers may be unfamiliar with the behavior of these elements and may make settings choices that lead to unintended consequences. At the same time, engineers must continue to properly employ good settings practices long established for more traditional elements.

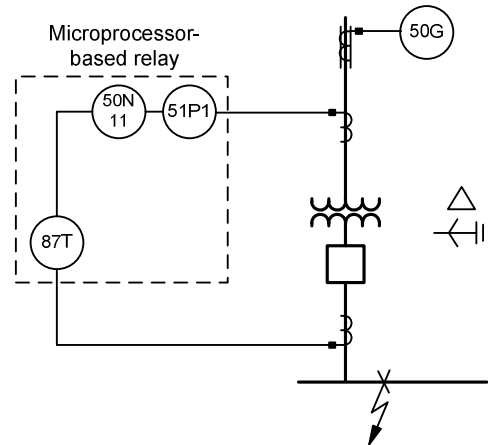
Fig. 1. Ground Overcurrent Protection for Delta-Connected Transformer Winding

In industrial power systems, a sensitive overcurrent relay connected to a zero-sequence CT (50G) is often used for ground fault protection of the feeder conductors and the high-voltage delta winding of a delta-*Wye* transformer (Fig. 1). With increasing use of microprocessor-based transformer differential relays, protection engineers may also apply residual overcurrent protection (50N) as backup. These residual elements provide protection for ground faults within the delta winding and can be fairly sensitive because the delta-

Wye connection obviates the need to coordinate this element with low-voltage ground fault relays. However, care must be taken when selecting pickup and time-delay settings to prevent misoperation due to false residual currents. Because the three separate CTs supplying the 50N relay will not saturate evenly during a fault, false residual currents must be expected, and the 50N relay element cannot usually be set with the same sensitivity and short time delay typical of the 50G. As stated in [1], “instantaneous overcurrent relays may be used, but sensitive settings will probably result in incorrect operations from dissimilar CT saturation and magnetizing inrush. This can be avoided by using a short-time overcurrent relay with a sensitive setting.”

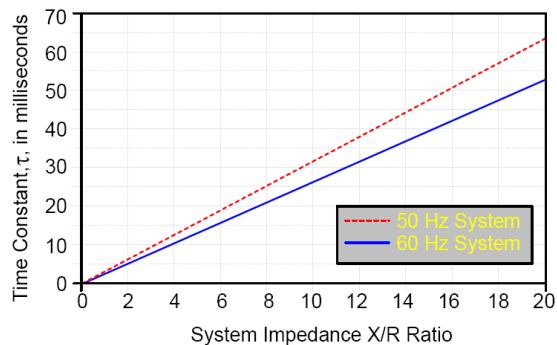
Fig. 3. X/R vs. Time Constant

The time constant that defines the dc current rate of decay is a function of the system X/R ratio, as given by (1) and shown in Fig. 3.

A conservative time delay for the residual element is determined by multiplying the expected decay time of the dc offset (3 to 5 time constants) by 1.5.

For example, if the X/R is 10, the minimum recommended time delay for a 60 Hz system would be 7 to 12 cycles.

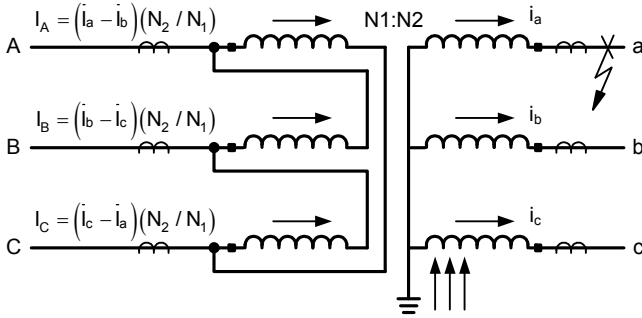
Fig. 7. Zero-Sequence Currents for Phase-to-Ground Fault on Transformer Wye Winding

In an ANSI standard transformer, the currents and voltages on the high-voltage winding will lead those on the low-voltage winding by 30 degrees. The connection that produces this phase shift is shown in Fig. 7 for a transformer with a high-voltage delta winding.

Taking Phase A as an example, the current measured by the CTs in the high-voltage winding I_A is the difference between the low-voltage winding currents I_a and I_b multiplied by the turns ratio N_2/N_1 . As shown in (4), if we express the phase currents I_a and I_b as the sum of the sequence currents I_1 , I_2 , and I_0 , subtracting I_b from I_a causes the zero-sequence components of the two currents to cancel, and there will be no zero-sequence component in I_A . Thus it is often stated that the delta connection filters or traps zero-sequence currents.

Recommendations were made to change the compensation settings to remove zero-sequence current. To test the solution, a COMTRADE file was created using the available event report data and played back to a relay with the correct settings. As shown in Fig. 9, the operate current is low, the restraint current is high, and the relay restrains for the through fault as expected.

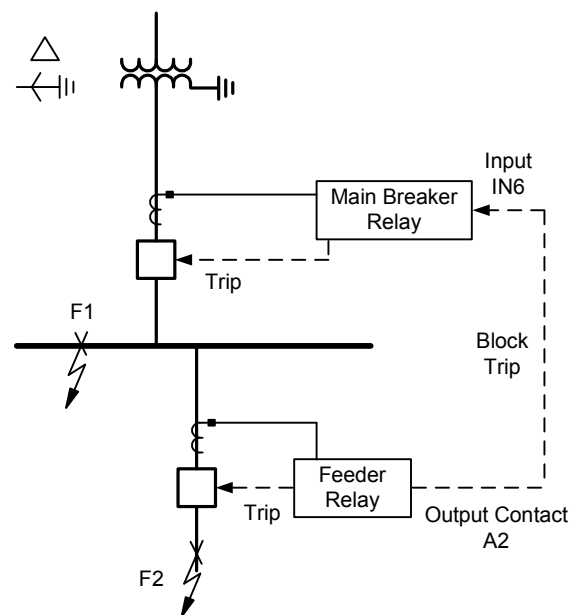
Fig. 10. Fast Bus Trip Scheme

Fig. 10 shows a fast bus trip scheme implemented with an existing main breaker and feeder relay. For a fault at F2 on the feeder, the feeder relay should trip. The feeder relay closes an output contact, which energizes a blocking input on the main breaker relay. The blocking signal prevents the main breaker relay from tripping at high speed. Only one feeder is shown for simplicity; additional feeders would have similar blocking contacts wired in parallel with the feeder shown.

For a fault at F1 on the bus, the feeder relay should not operate (assuming this is a radial system). The main breaker relay is allowed to trip at high speed without the presence of a blocking input. A short coordination delay (3 to 5 cycles) is used to ensure security for feeder faults.

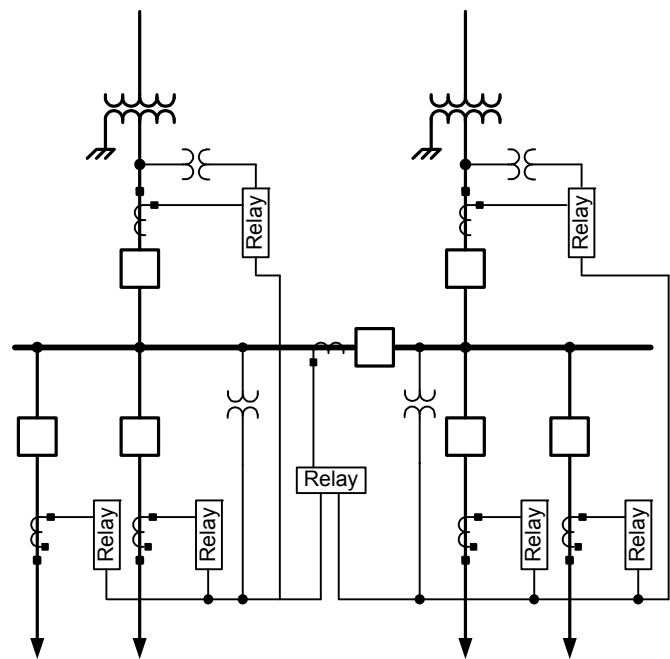
Fig. 16. One-Line Diagram of New Substation

Fig. 16 is a one-line representation of a new substation nearing completion. Commissioning and final checkout testing were underway. The 47 MVA transformer on the right had been energized from the high side (low side open) for several weeks. The job at hand was to energize one of the feeder circuits (shown at the far left), picking up a small amount of load, and perform in-service commissioning tests for the transformer differential relay.

When the feeder breaker was closed, the bus-tie breaker tripped unexpectedly. Nothing else in the substation tripped. The event report data collected from the bus-tie breaker are shown in Fig. 17. The trip was generated by a ground overcurrent element, 50G1, after a four-cycle fast bus trip scheme delay. In this design, the blocking signals for the fast bus trip scheme are received via fiber-optic communications.

It was recommended that the pushbutton be changed to do what was labeled, that is, supervise ground overcurrent trips. This error speaks again to a lack of scheme testing and a lack of documentation of all parts and pieces of standard logic settings.
