# A Bus Cleared and a Hidden Breaker Insulation Failure Revealed

Robert Roman and Kevin Damron, *Avista Utilities*  
Emma Clawson, *Schweitzer Engineering Laboratories, Inc.*

**Abstract**—On June 27th, 2023, lightning struck a transmission line about one mile from a substation. Shortly after the first lightning strike, the high-impedance bus differential relay cleared the bus at the substation even though there was no apparent fault on the bus. About half an hour after these two events, the percentage-restrained bus differential relay attempted to trip the bus again, even though the bus was still de-energized from the initial events.

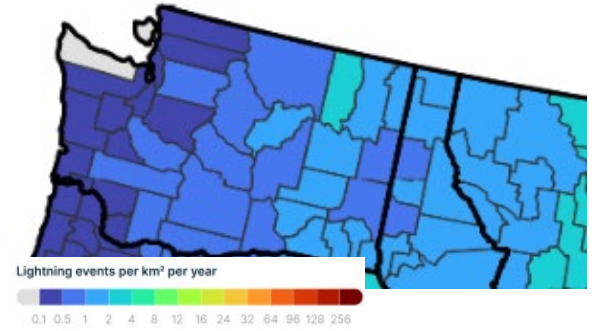
Fig. 7. Total lightning density for the utility’s service territory [4].

Fig. 7 shows the total lightning density across the utility’s service territory for one year (2023). A review of the historical data [4] shows the total lightning density to have been lower than shown in Fig. 7. Shield wires and surge arresters were not included in the original design of the substation based on the low risk of lightning in 1978, when the substation was constructed.

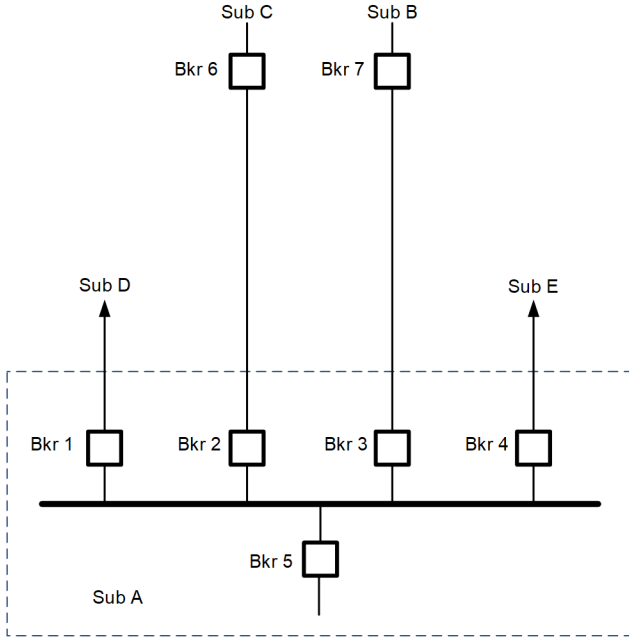
Fig. 8. Sub A configuration.

Sub A is a 230 kV substation with five 230 kV breakers, as shown in Fig. 8. The breakers relevant in the following events are Breaker (Bkr) 2 and Bkr 3. The relays protecting the Sub A–Sub B line on the Sub A end of the line were modern line relays, and the relays protecting the Sub A–Sub C line at the Sub A end of the line were legacy line relays. The Sub A bus protective relays were a modern high-impedance bus differential relay and a modern percentage-restrained bus differential relay, referred to as 87B1 and 87B2, respectively.

The initial information received from the system operators was that the Sub A–Sub B line (Bkr 3 and Bkr 7) and the Sub A bus (Bkr 1, Bkr 2, Bkr 3, Bkr 4, and Bkr 5) had tripped at the same time. The initial thought was that lightning had struck the Sub A–Sub B line and the Sub A bus at the same time. The technicians arrived at the substation, saw no visible damage

from the fault, and therefore, proceeded to re-energize the Sub A bus and the Sub A–Sub B line. There was no indication or idea that any of the breakers might have been compromised or that a second fault had occurred while the Sub A bus had been open.
