Relay Settings Improvements at Grand Ronde, Boyer, and Tillamook

Why 125% of the protected line can be a good Zone 1
setting.

Abstract:

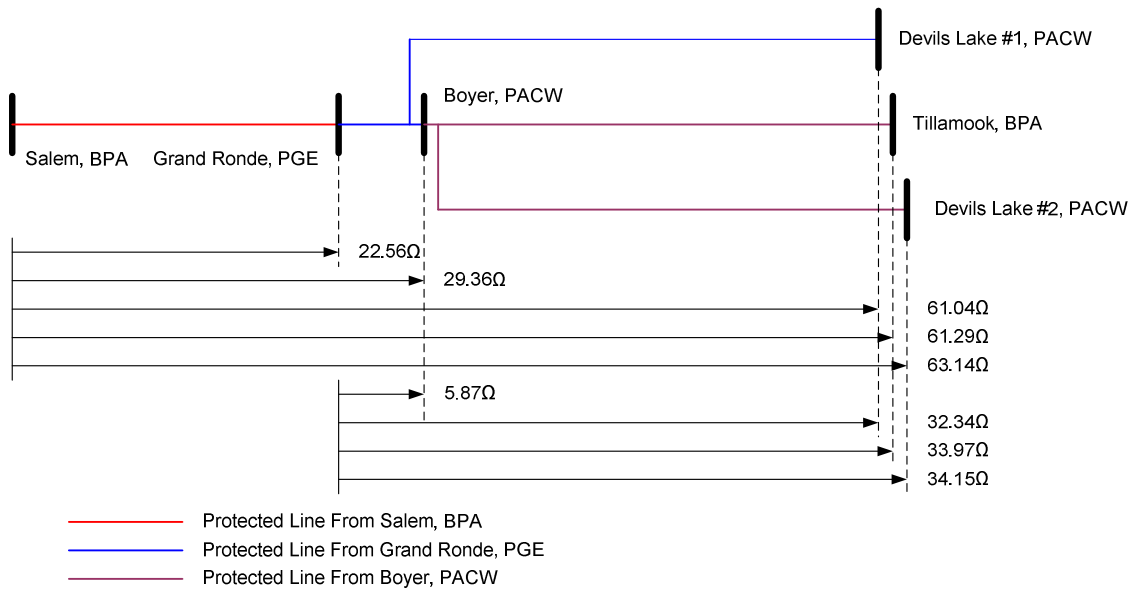
Figure 2: Apparent Impedances Salem to Tillamook

Both figures 2 and 3 show the line lengths proportional to apparent impedance. The impedances looking into Grand Ronde from Tillamook and Salem do not add up to the total circuit impedance end-to-end due to the infeed affects of the 57kV system at Grand Ronde.

Looking at the situation from Tillamook, the problem is even worse. Salem, which is two terminals away, has lower impedance than both Devils Lake lines end, and Devils Lake #1, which is one terminal away, has lower impedance than Devils Lake #2, which is part of the protected line. Figures 2 and 3 provide a graphical representation of the impedances.
