Alarming Experience with Ungrounded Tertiary Bus Ground Detection

Gary L. Kobet, P.E.
Tennessee Valley Authority
Chattanooga, Tennessee, U.S.
glkobet@ieee.org

Abstract—The detection of ground faults on ungrounded tertiary buses is usually provided by three single-phase voltage transformers (VT) connected wye-grounded/broken-delta, with output connected to an overvoltage relay. The overvoltage relay in many cases provides only a control center alarm. This paper will describe ground fault detection on ungrounded buses and will present a case for tripping instead of alarming, or if alarming, for not sending operating personnel into the yard to inspect until after the tertiary bus is deenergized.

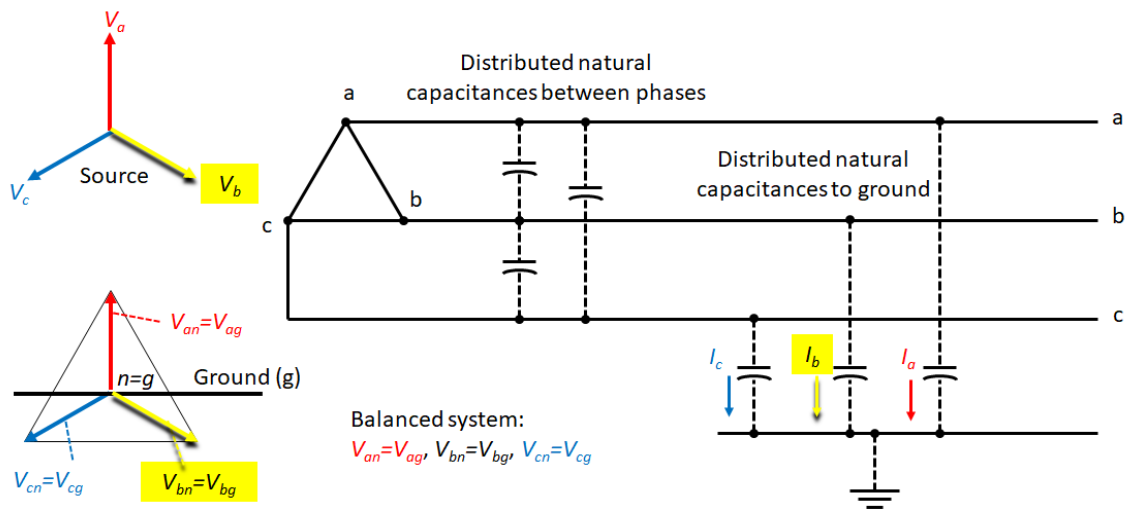
An ungrounded system is one that has no intentional grounding, such as a three-phase delta transformer winding connection. Note the system is still “grounded” through the natural system capacitance to ground as shown in Fig. 1 (albeit via very high capacitive impedance).

Fig. 1. Ungrounded system - unfaulted

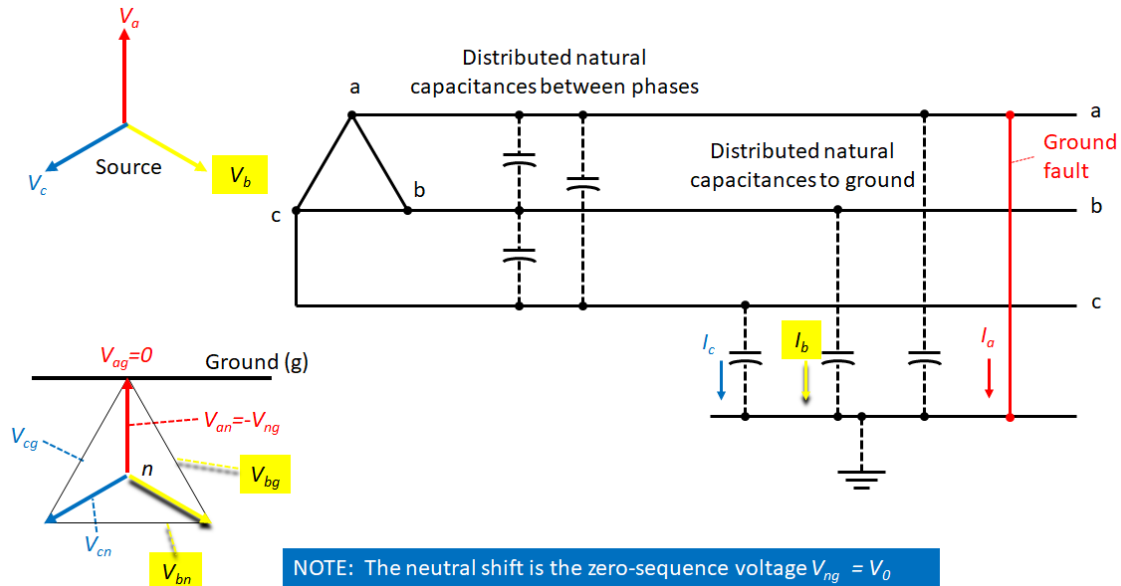
When ground faults occur in such systems, note the following from Fig. 2:

- the faulted phase-to-ground voltage is zero;
- the neutral point shifts so that the neutral-to-ground voltage equals the faulted phase-to-neutral voltage; and
- the unfaulted phase-to-ground voltages rise to full phase-to-phase voltage.

Fig. 2. Ungrounded system - phase-to-ground fault

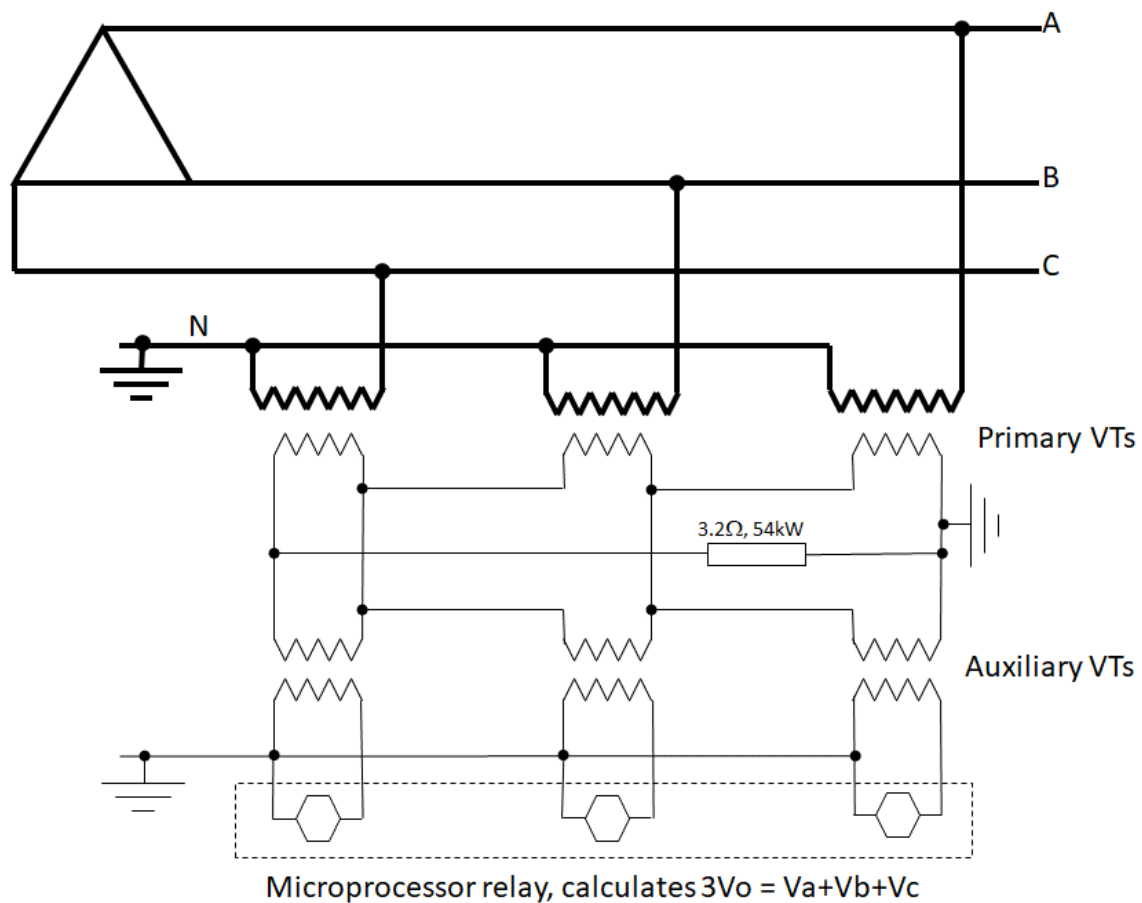
This function could also be implemented in a digital relay which can calculate zero sequence voltage from the three-phase voltages (Fig. 5).

Fig. 5. Ungrounded Tertiary Bus Ground Detection - microprocessor relay calculating $3V_o$ from auxiliary VTs

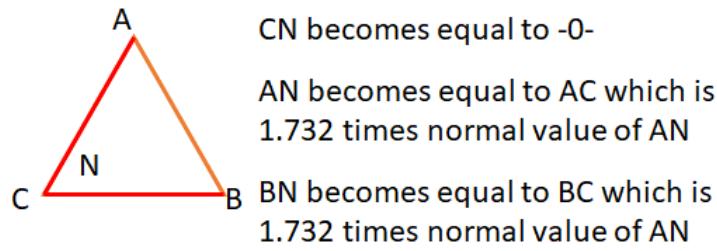
However, for a single-line-to-ground fault, the faulted phase-to-ground voltage is obviously zero for a bolted fault, while the unfaulted phase-to-ground voltages rise to full phase-to-phase voltage (Fig. 7). The resulting relay voltage is 3 times nominal phase-to-neutral voltage.

Abnormal Condition - Ground on C-phase (tie C & N together)

VX-VY becomes **3** times normal value of AN, BN, or CN

Fig. 7. Ungrounded Tertiary Bus Ground Detection

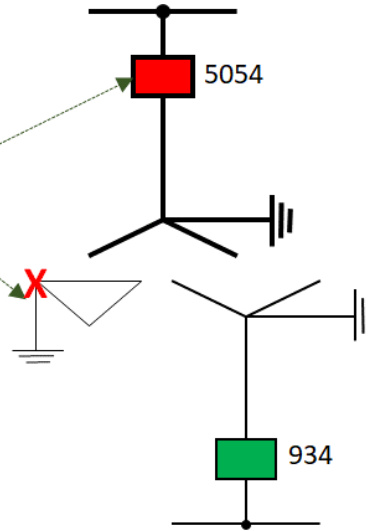
A 500/161/13kV transformer bank was energized; 15 minutes later A-phase transformer failed catastrophically due to a phase-phase fault (174kA) and subsequent fire. Root cause was determined to be failed 13kV tertiary bushings. It is suspected at some point after energization the insulation of one tertiary bushing faulted to ground, causing a single-phase-to-ground fault when the bank was energized (Fig. 9). The bank had no tertiary ground fault detection scheme installed, and the fault evolved to double-phase-to-ground when 23 minutes later insulation of a second tertiary bushing also faulted to ground (Fig. 10), producing the double-phase-to-ground tertiary fault. The insulation on one of the tertiary bushings was destroyed (Fig. 11, Fig. 12).

One bushing fails to ground

NOTE: No tertiary ground detection scheme!

Fig. 9. 9/22/2010, Location 1: Tertiary bushing failure

This was one of seven EHV transformers across six locations with tertiary buses having no ground fault detection scheme. But if there had been a scheme that alarmed only, any personnel sent to the yard to investigate would have been exposed to the 174kA phase-to-phase fault and fire.

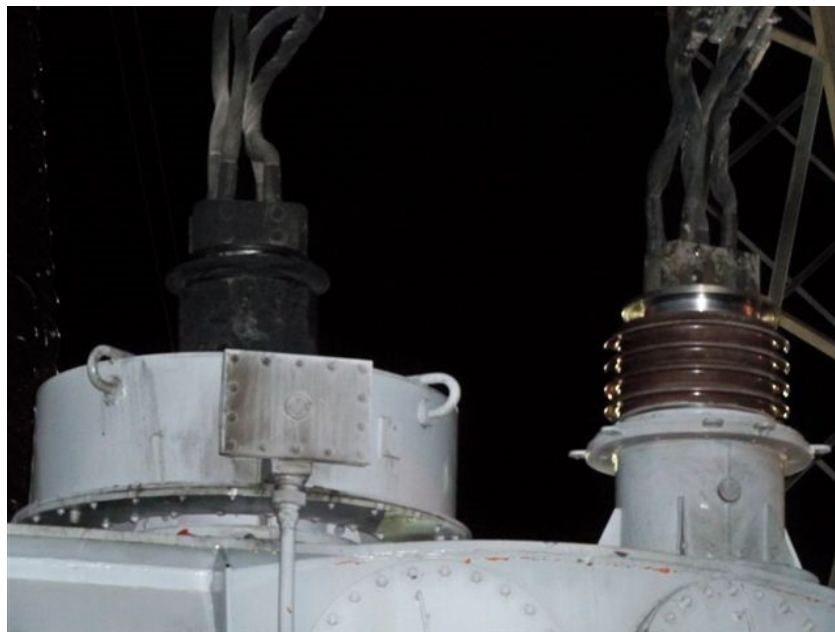
Fig. 12. 9/22/2010, Location 1: Tertiary bushing failure

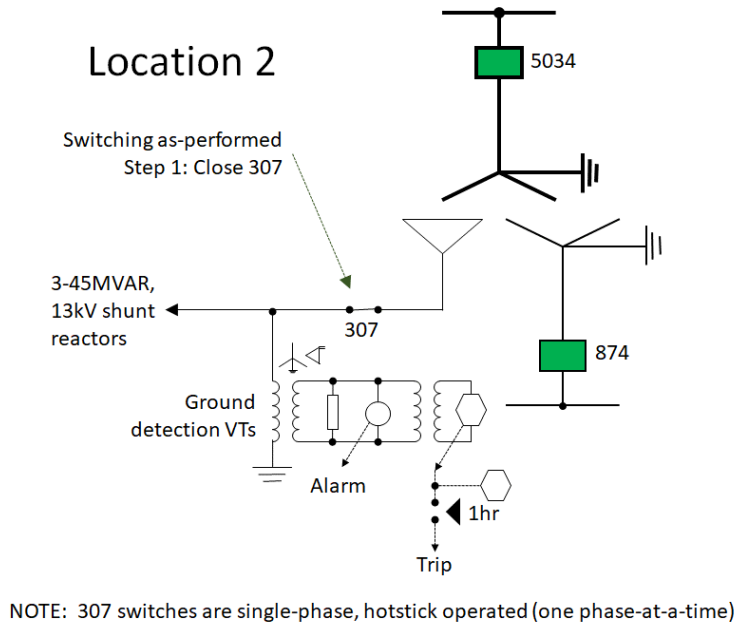
At a different location, another 500/161/13kV transformer bank was energized; two seconds later tertiary ground alarms asserted and locked in after another second; 23 seconds after energization, a three-phase tertiary bus fault occurred (57kA), resulting in a fireball that destroyed the tertiary bus VTs. Root cause was one of the VTs had faulted to ground causing the initial alarm; the other two faulted 23 seconds later. The sequence and resulting damage are illustrated in Fig. 13 through Fig. 18.

Fig. 13. *6/15/2015, Location 2: Switching as performed, step 1*

The disturbing thing about this event was that the switching was written initially to energize the 500/161/13kV transformer bank, and then send an operator in the yard to energize the tertiary bus VTs by closing the 307 switches with a hot-stick, one phase at a time. If this had been done, the operator may very well have been engulfed in the fireball that destroyed the VTs. However the switching was rewritten before it was performed to be in accordance with present TVA practice to close the 307 switches before the bank and 13kV yard were energized.

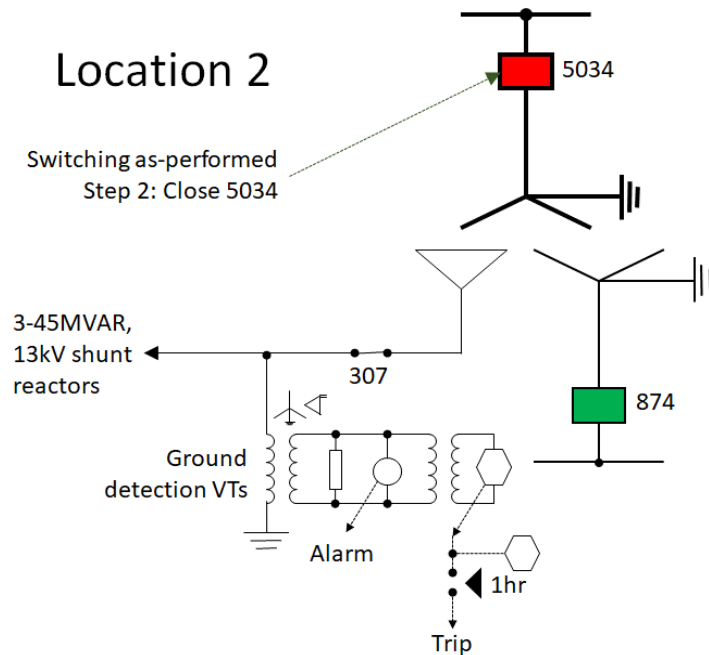
Fig. 14. *6/15/2015, Location 2: Switching as performed, step 2*

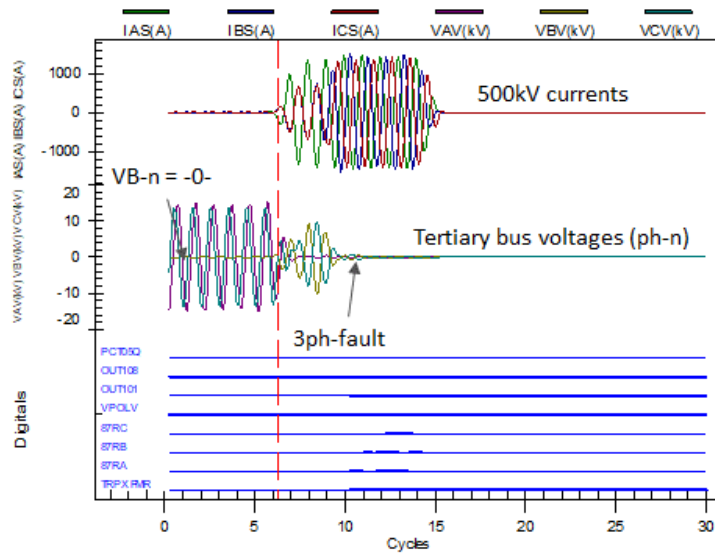
Fig. 15. 6/15/2015, Location 2: Relay event record

In this case, the tertiary ground detection scheme alarmed and also started a one hour timer. There was not enough time to send anyone in the yard to investigate, but if there had been, they also could have been in the yard investigating, and been exposed to the 57kA three-phase fault & fireball.

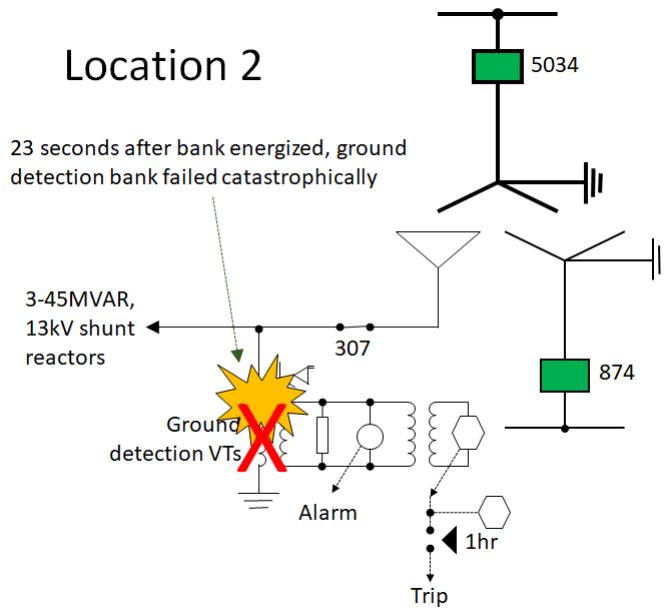
Fig. 16. 6/15/2015, Location 2: 57kA three-phase fault

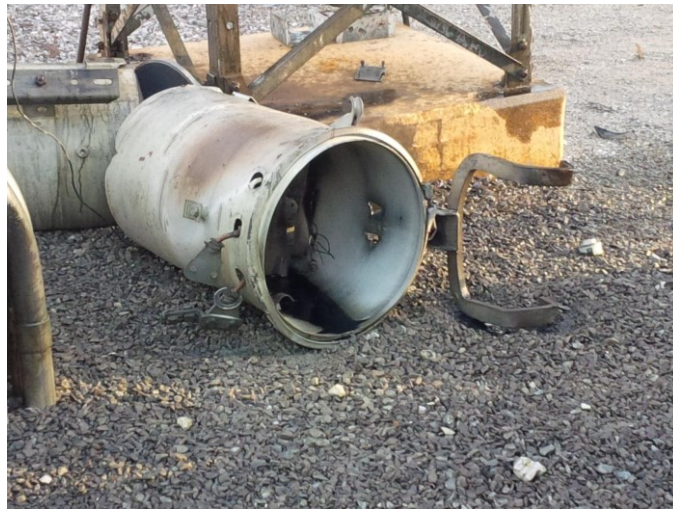
Fig. 17. *Location 2 6/15/2015 - Tertiary VT failure*

Note the VT that failed was the original equipment installed in the 1960s. The most recent test results indicated severely compromised insulation, but the paper records were misplaced immediately after testing and not reviewed until after the failure.

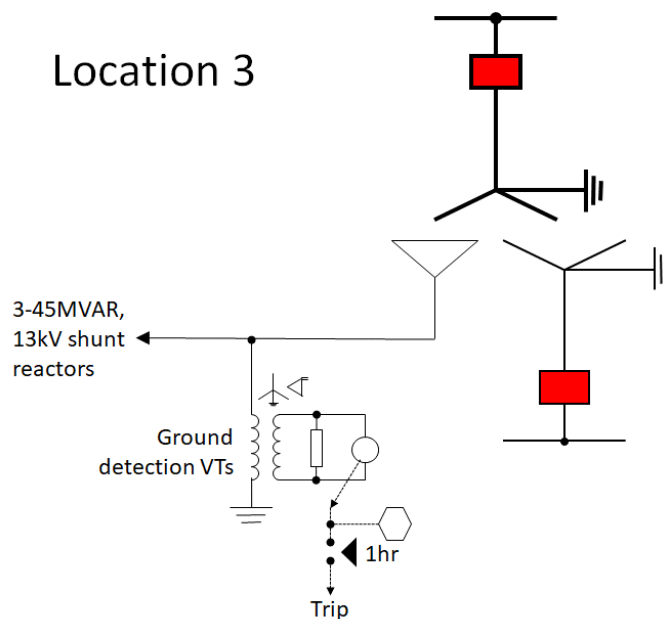
At a third location (Fig. 19), another 500/161/13kV transformer bank experienced a ground fault on the 13kV tertiary bus. The fault resulted in chattering ground detector alarms for over two hours, some alarms lasting almost four minutes, but the trip timer was set for one hour. No testing was performed but the trip timer was reduced to 15 cycles after this event.

Fig. 19. 2/28/2018 and 8/18/2018, Location 3 (no trouble found)

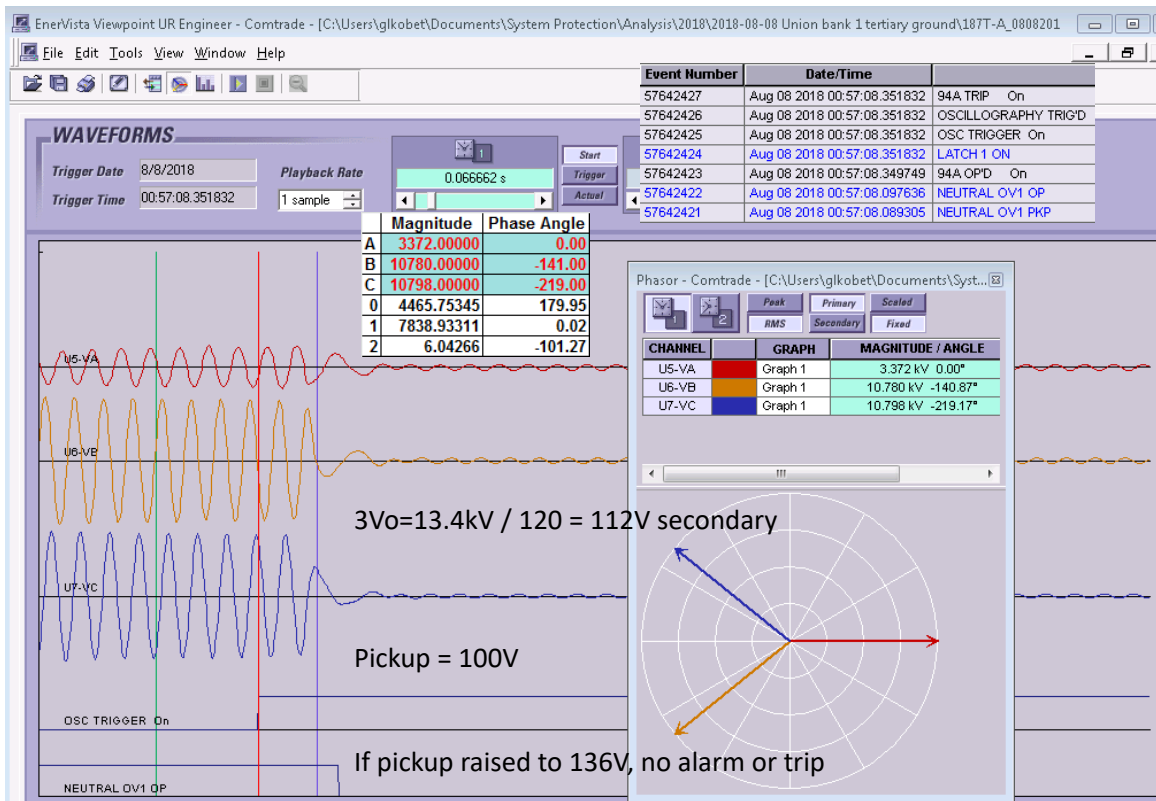
At that same location, another ground fault occurred on the same tertiary bus of the same transformer bank, this time lasting longer than the 15 cycle trip timer. The bank tripped and was subsequently cleared (Fig. 20). All tertiary equipment was tested, including tertiary bus work, transformer tertiary windings and bushings, station service transformers, and the ground detector transformers themselves. Nothing was found. It is suspected in both cases that the faults were probably caused by debris blowing through the station during severe storms.

It should also be noted that the pickup of the overvoltage element was set on 100V, which is just over 50% of the voltage for a bolted phase-to-ground fault. This is a highly sensitive setting relative to that for most installations (see VI.A).

Fig. 20. 2/28/2018 Location 3 - Relay event record

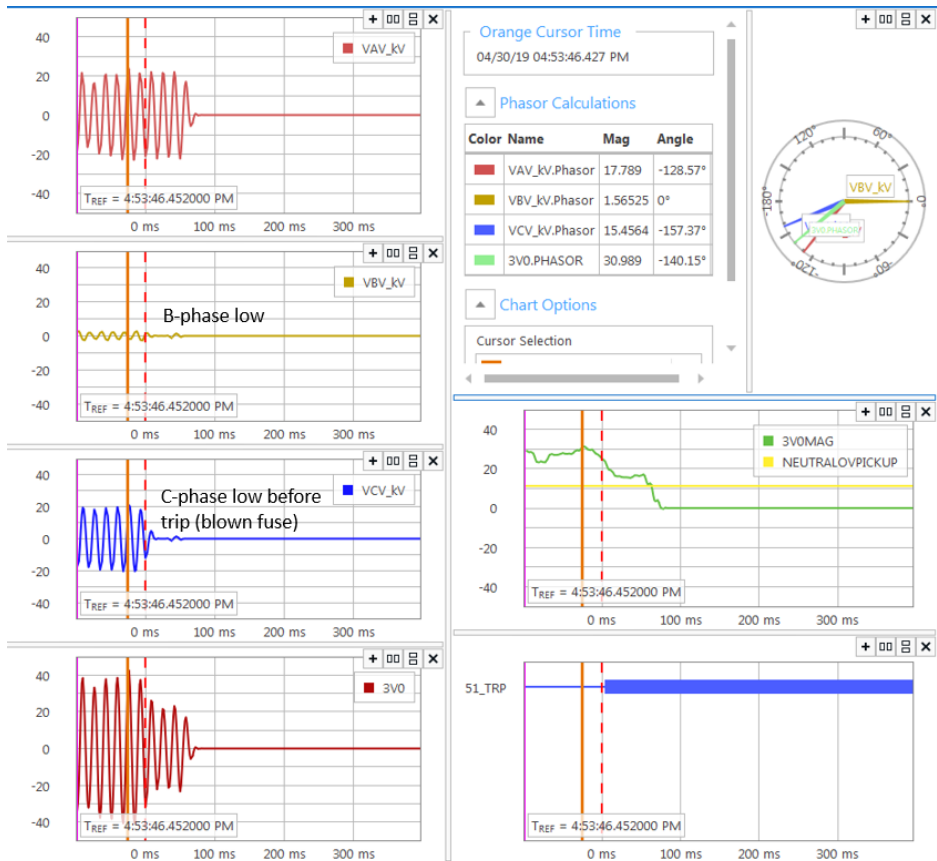
At a fourth location, a 500/161/13kV transformer bank tripped for a ground fault on the 13kV tertiary bus (Fig. 21, Fig. 22). The bank had been energized and loaded for about one month following spring outage work.

Fig. 22. 4/30/2019 Location 4 - Relay event record

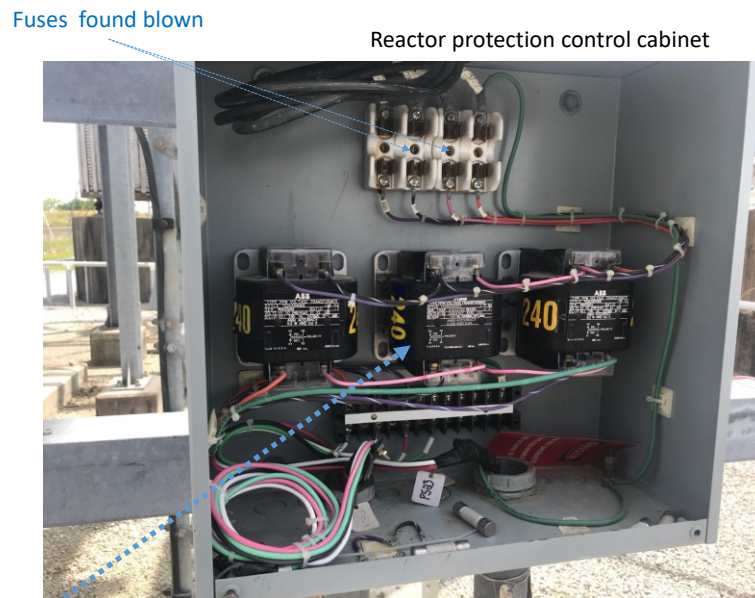
- A-phase VT had shorted primary-to-secondary-to-ground;
- B-phase auxiliary VT shorted primary-to-secondary;
- Three fuses had also blown in the ground detector secondary circuit: B- and C-phase fuses on the primary of the 240/120 auxiliary VTs, as well as the fuse ahead of the electromechanical 59N alarm relay (Fig. 23).
- Analog input to the A-set bank protective relay for B-phase tertiary voltage was damaged

B-phase aux VT shorted primary-to-secondary

Fig. 23. 4/30/2019 Location 4 - Auxiliary VTs and fuses

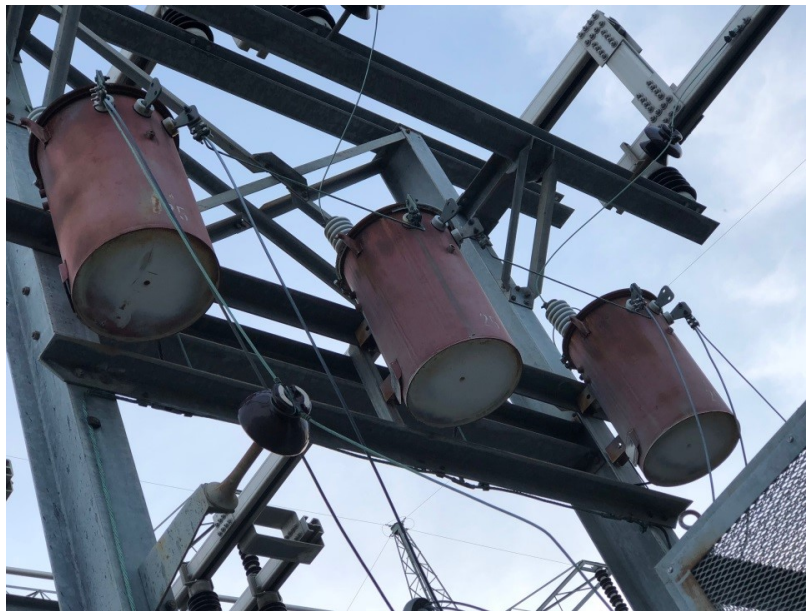
The conclusion was the A-phase VT failed primary-to-secondary which damaged secondary equipment. These were the original VTs (installed mid 1960s), shown in Fig. 24.

Fig. 24. 4/30/2019 Location 4 - Tertiary bus voltage transformers
