# STEADY-STATE PROTECTION STUDY FOR THE APPLICATION OF SERIES CAPACITORS IN THE EMPANGENI 400 KV NETWORK

Graeme Topham  
Eskom Enterprises  
Technology Services International, RSA

Edmund Stokes-Waller  
Schweitzer Engineering Laboratories, Inc. RSA

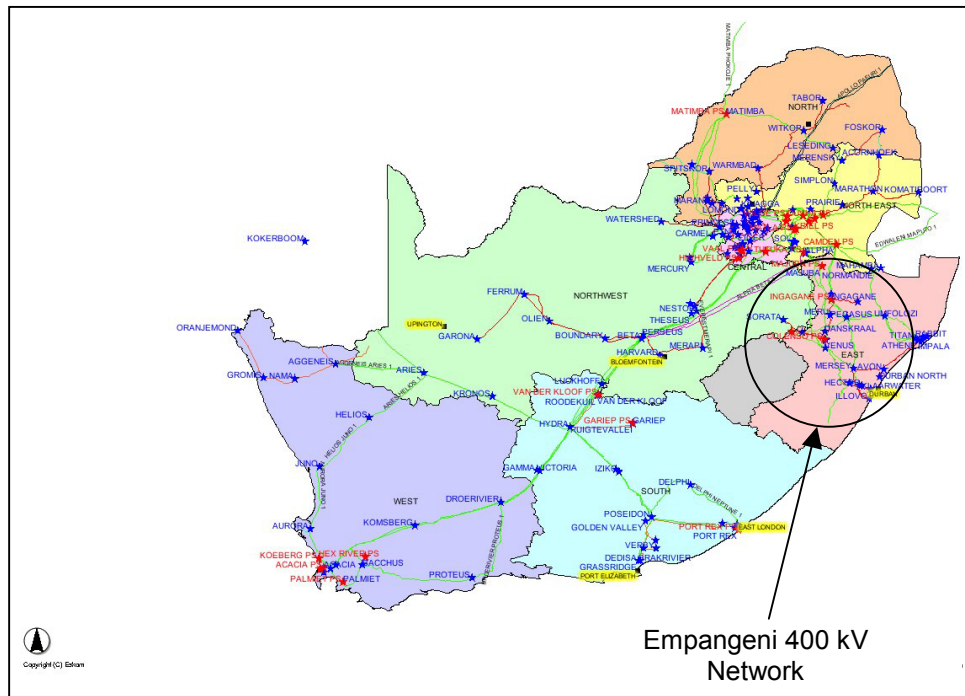
**Figure 1** Network diagram 1—Eskom transmission network single-line diagram

Eskom is the electricity utility of South Africa. The utility has been in existence for over 81 years. The currently installed generation capacity is 42 GW, which includes 6 GW of reserve (mothballed) generation, consisting mainly of coal-fired power stations concentrated in the northeastern part of the country. There is also a 1,800 MW nuclear plant in the southwestern tip of the country. A 765 kV, 400 kV, and 275 kV transmission network spans the country, providing the transmission backbone. The relevant portion of the network, to which this paper refers, is in the South African Kwazulu Natal region in the southeastern part of the country.

Most of the study focused on fault-throwing exercises on the proposed series-compensated feeders (refer to Figure 1):

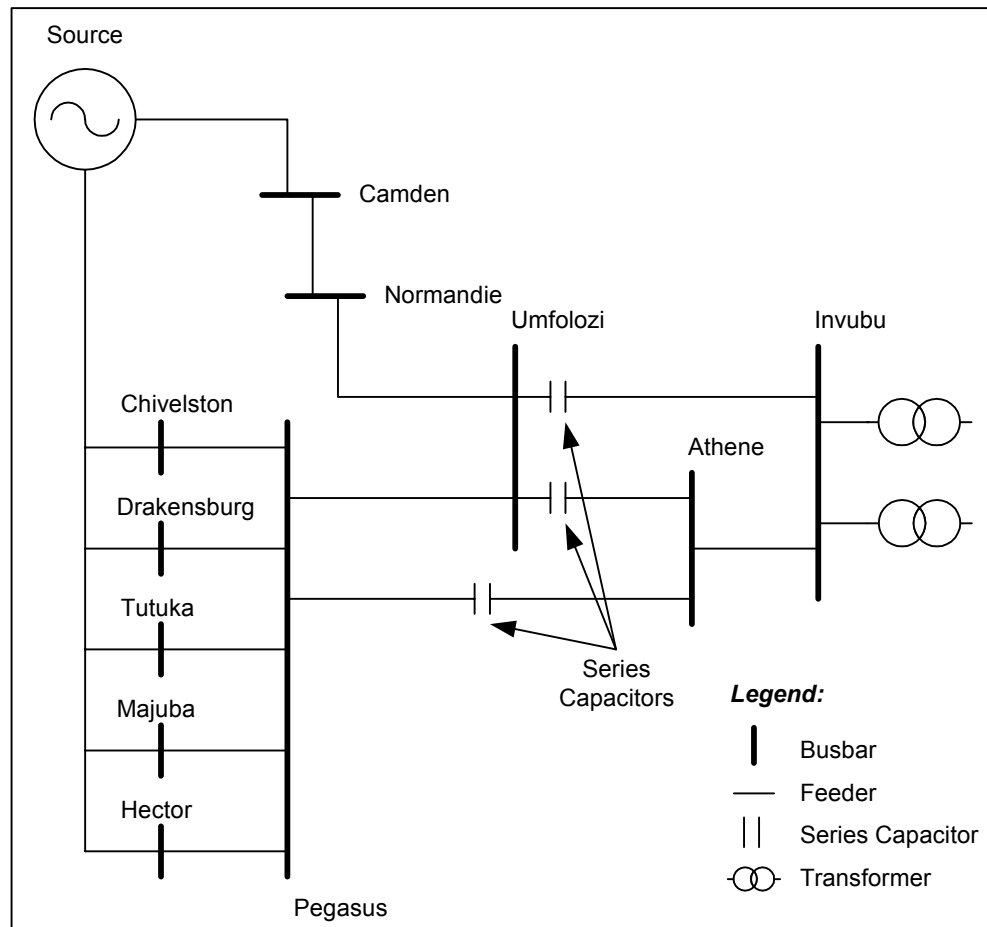
**Figure 2** Network diagram 2—Empangeni 400 kV network single-line diagram

The protection study was divided into two main groups: steady-state and transient protection performance analysis. The protection performance of feeders (indicated in Figure 2) as analyzed under steady-state conditions is represented in this paper. The aim of this paper is to share information about the steady-state protection study; e.g., theoretical background, method, results, and recommendations.

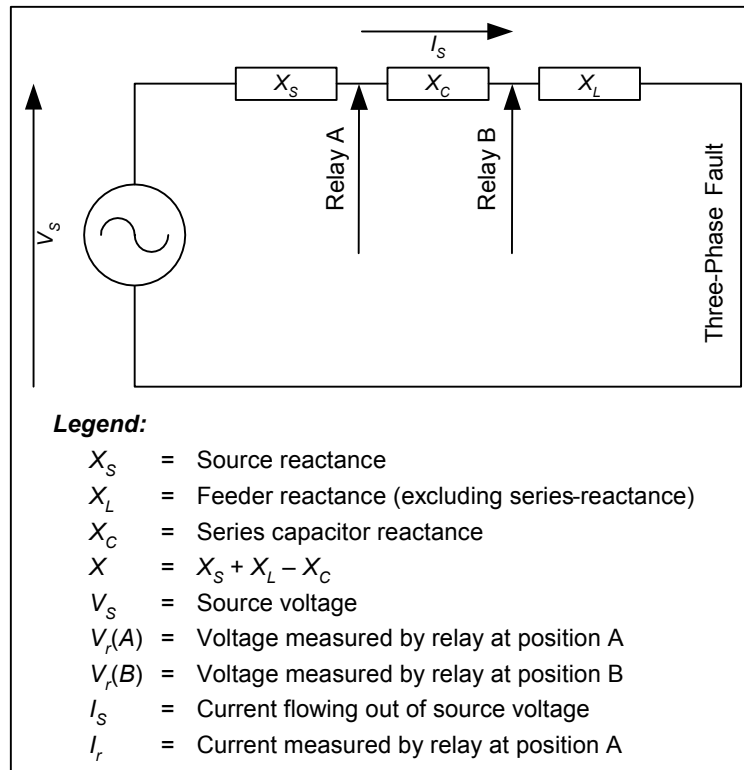
**Figure 3** Single-line diagram of series-compensated network

Figure 3 illustrates a typical single-line diagram of a network with series compensation and a fault applied at the end of the feeder. Distance impedance relays are situated at positions A and B.

For simplicity, assume  $X_S$  and  $X_L$  represent a series-inductive reactance value, and thus for the above circuit, where  $X$  is the total network reactance, we have:

$$I_S = \frac{V_S}{j(X_S + X_L - X_C)} = \frac{V_S}{jX} \quad (1)$$

In Figure 3, the current  $I_S$  lags or leads the voltage by 90 degrees, depending on the sign of  $X$ , because  $X$  is a pure reactance value.

For the protective relay at position A,  $I_r = I_s$ , where  $I_r$  is the fault current. The current  $I_s$  will reverse direction when  $(X_C > X_S + X_L)$ . Both the relays at positions A and B will experience current reversal should this occur.

$$\begin{aligned} V_r(A) &= jI_s - (X_C + X_L) = j \left( \frac{V_S}{jX} \right) (-X_C + X_L) \\ &= V_S \left( \frac{-X_C + X_L}{X} \right) \end{aligned}$$

The voltage measured by the relay  $V_r(A)$ , will reverse its sign when  $(X_C > X_L)$  and  $(X > 0)$  and  $(X_C < X_S + X_L)$ .

Voltage reversal is not possible under the same criteria as for position A, because  $V_r(B) = jI_s X_L$ . However, voltage reversal can occur as a consequence of current reversal.

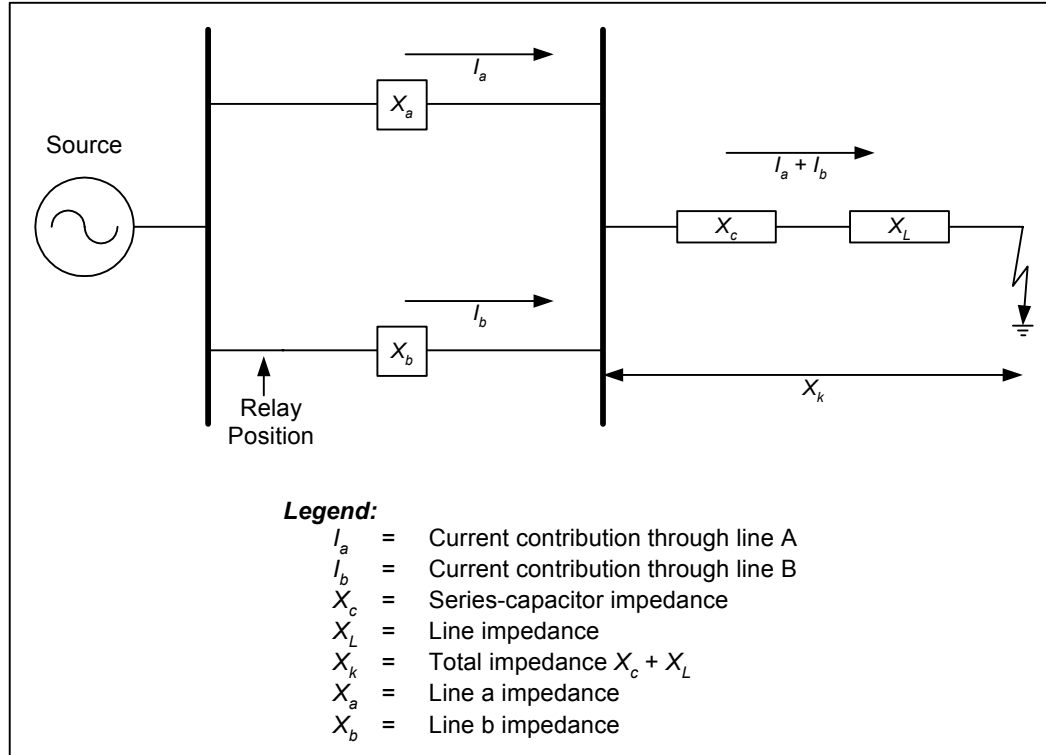
**Figure 4** Effect of remote busbar infeeds on distance relays

The effect of remote busbar infeeds, as illustrated in Figure 4, may result in apparent impedance problems for distance impedance relays.

The actual impedance to the fault is equal to  $(X_b + X_k)$ . The relay is presented with an impedance equal to  $(X_b + \left(\frac{I_b + I_a}{I_b}\right) \cdot x \cdot X_k)$ , where  $x$  is the error factor and is equal to  $\frac{I_b}{(I_b + I_a)}$ .

Therefore, the effective reach for the impedance relay is equal to  $(X_b + \left(\frac{I_b}{I_b + I_a}\right) X_k)$ .

Under normal network conditions, the effective relay reactive reach is smaller than the actual impedance to the fault namely  $(X_b + X_k)$ . The effect is reversed when  $(X_c > X_L)$ .

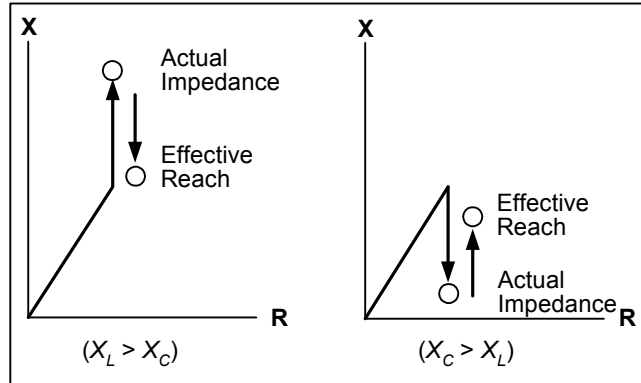
**Figure 5** Effect of remote busbar infeeds on impedance measurement

Care should be taken when coordinating backup protection to ensure that the relays will see the fault but will not operate for load conditions.

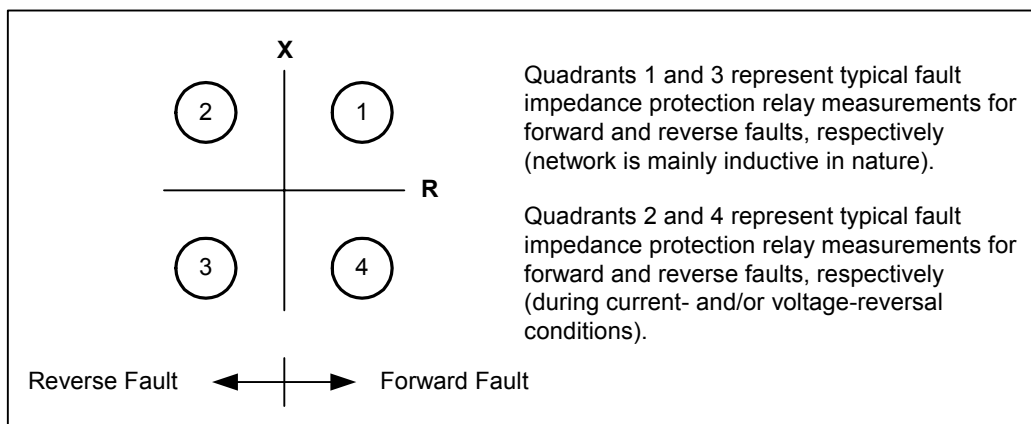
**Figure 6** Typical positive-sequence impedance measured by impedance relays under different network conditions

For network conditions with  $(X_L > X_C)$ , faults in front of the relay would typically be measured to fall within the first quadrant of the positive-sequence impedance plain. Similarly, faults behind the relay would typically be measured in the third quadrant.

During voltage and/or current reversal conditions (with no series capacitor bypassing), the measured steady-state impedance may also fall within the second or fourth quadrants of the positive-sequence impedance plain, depending on the exact network impedance parameters and conditions.

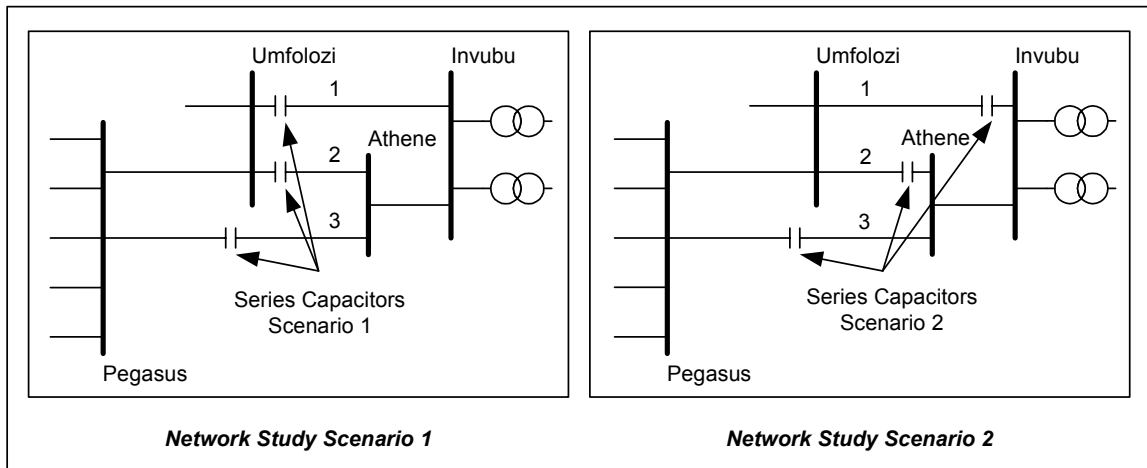
**Figure 7** Network study scenario diagrams

The proposed and studied series capacitor compensation locations are indicated in the following two diagrams, where Network Study Scenario 1 illustrates the series compensation situated at the source end of the proposed feeders and Network Study Scenario 2 illustrates the series compensation situated at the load end.

The only difference between the two scenarios studied is the location of the series capacitors on each feeder. Table 2 is a summary of the series capacitor locations for each scenario.

The descriptive numbers 1 or 2 (or 3) as indicated in Figure 7, are used in Figure 9, Figure 10, Figure 13, Figure 14, and Figure 15 (refer to legends) to reference the series-compensated feeder numbers as follows:

- 1 = Umfolozi-Invubu feeder
- 2 = Umfolozi-Athene feeder
- 3 = Pegasus-Athene feeder

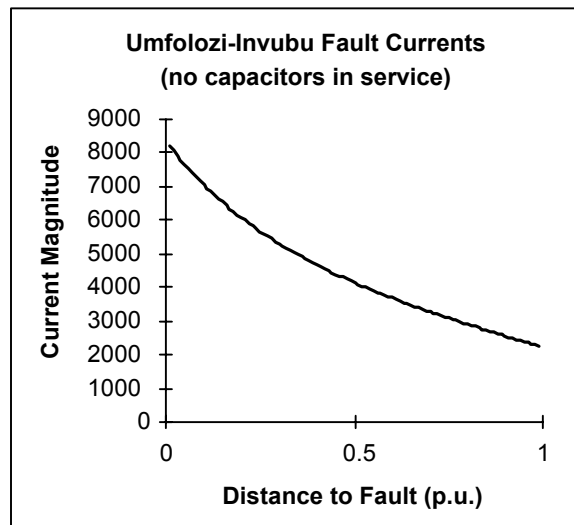
**Figure 8** Maximum fault current through Umfolozi-Invubu 400 kV CT prior to the addition of series compensation

As an example of typical relay measurement behavior, Figure 8 illustrates the maximum fault currents flowing through the Umfolozi-Invubu 400 kV current transformer (CT) for faults at different locations on the same feeder.

The distance to fault value indicated on the X axis relates to the per unit (p.u.) value of the position of the fault location with respect to the feeder length and referenced to the local end (Umfolozi or Pegasus). The same applies to Figure 9, Figure 10, Figure 11, and Figure 12.

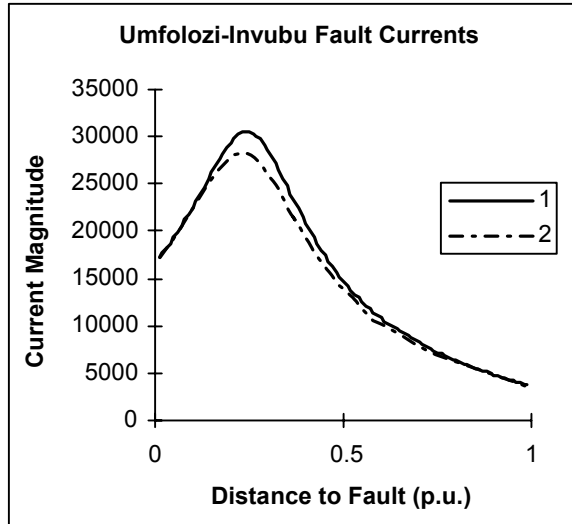
**Figure 9** Maximum fault current through Umfolozi-Invubu 400 kV CT, after the addition of series compensation

The maximum fault current through the series-compensated Umfolozi-Invubu 400 kV CT changes drastically, from 8 kA to 30 kA, as shown in Figure 9.

The maximum fault current is reached for faults at a distance of approximately 25% of the feeder length from Umfolozi. At this point, the value of  $X_c$  is almost equal to the sum of  $X_s$  and  $X_L$  and the equivalent network impedance is almost completely resistive. This is obviously slightly different from our basic theory discussions earlier (where we only focused on reactance and excluded resistance), because resistance is included in the network under consideration.

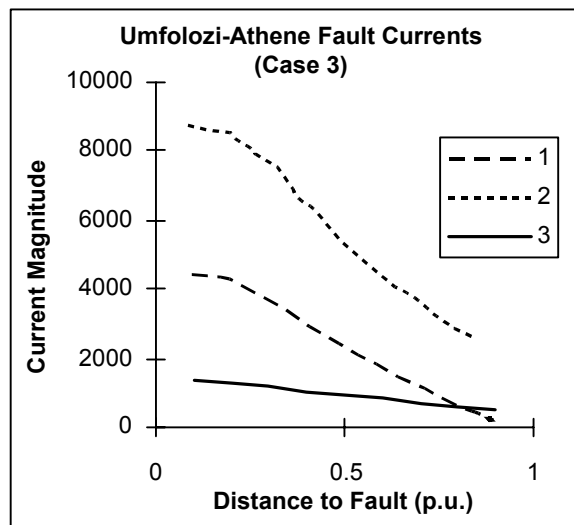
**Figure 10** Minimum fault current (case 3) through Umfolozi-Athene 400 kV CT, with series compensation

Four different network scenarios were studied to analyze the protection performance during minimum fault conditions (see Figure 10 as an example). These were:

- Half of generation in area out of service
- Half of generation and Pegasus-Umfolozi 400 kV feeder out of service
- Half of generation and Umfolozi-Normandie 400 kV feeder out of service
- Half of generation and Umfolozi busbar split so that Pegasus and Normandie infeeds are not linked

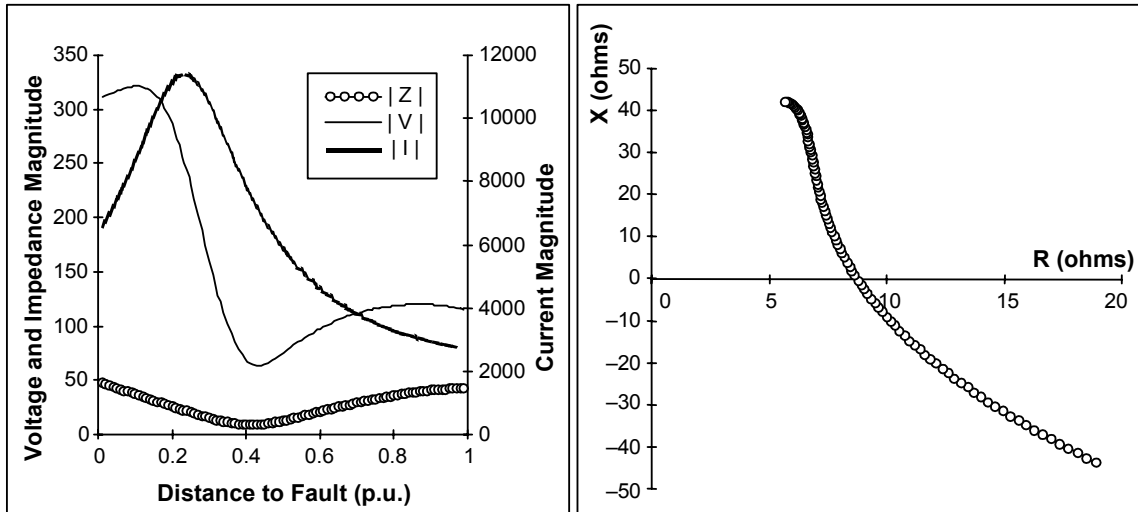
**Figure 11** Measurement values by Pegasus-Umfoloji impedance relay for faults, at various distances, on the Umfoloji-Athene 400 kV feeder during maximum fault conditions

The relays with directionality toward the fault tend to see the apparent impedance in quadrant 1 or quadrant 4 on the positive-sequence impedance plain, depending on whether or not the current reversal occurs (see Figure 11).

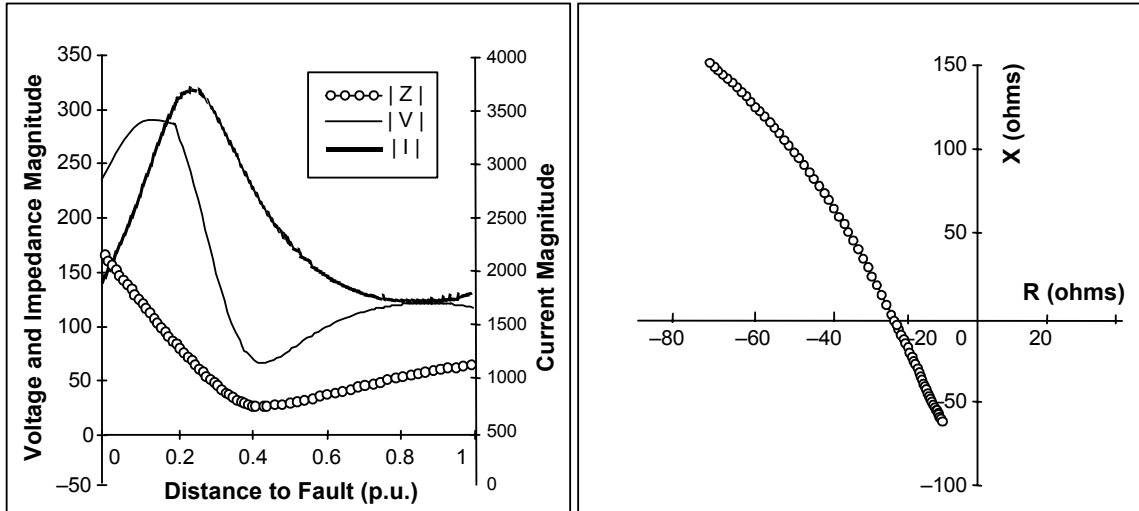
**Figure 12** Measurement values by Pegasus-Chivelston impedance relay for faults at various distances on the Umfolozi-Athene 400 kV feeder during maximum fault conditions

Similarly, relays with directionality away from the fault tend to see the fault in quadrant 2 or quadrant 3 on the impedance plain, as indicated in Figure 12.

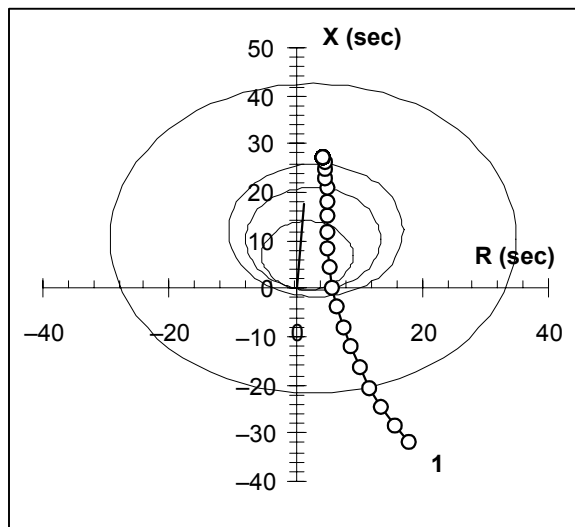
**Figure 13** Incorrect Zone 1 measurement

#### ***Area 1—Incorrect tripping in Zone 1 for faults on series-compensated feeders***

As the fault distance on series-compensated feeder number 1 moves from Umfolozi to Invubu, the measured positive-sequence impedance by the protection relays not located on this same feeder changes. This movement of impedance measurement is illustrated in Figure 13 and referenced by the number 1. Figure 13 indicates not one but multiple impedance measurements

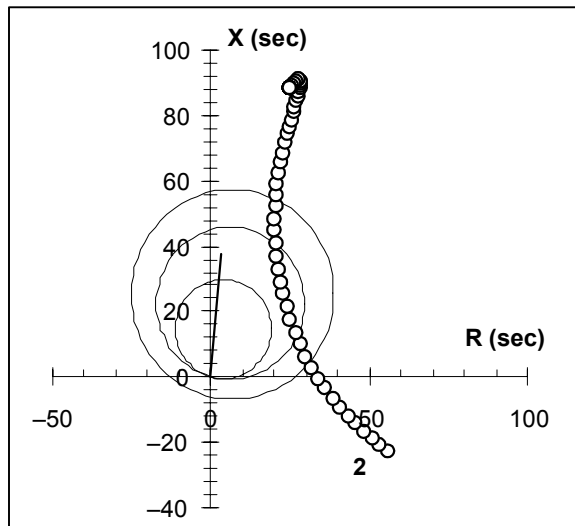
**Figure 14** Incorrect operation due to extended resistive coverage of relay characteristics

Polarized impedance protection relays can extend the resistive impedance coverage under different fault conditions. This has the advantage of greater coverage for high-resistance faults and results in faster protection operation. This additional fault resistance coverage, under these network conditions, creates problems for the relays concerned, due to the fact that both reactance and resistance criteria are incorrectly satisfied and may result in tripping.

Problems may also be experienced, should some relays be replaced by relays with quadrilateral impedance characteristics.

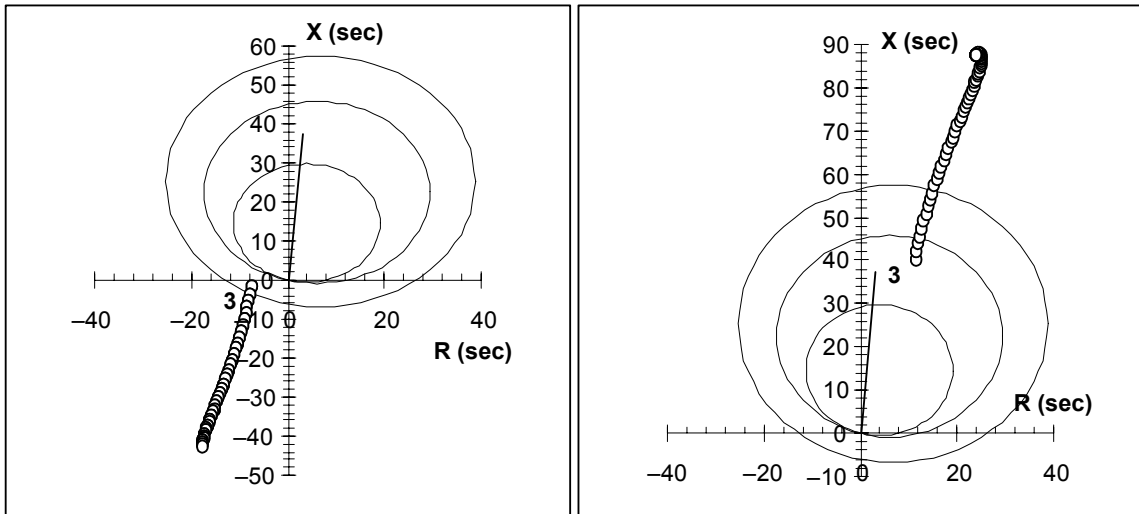
Figure 15 Incorrect permissive tripping

### Area 3—Incorrect permissive tripping

Incorrect operation of the protection starter elements may occur and cause protection carrier signals to be transmitted, depending on the particular protection settings. This may result in incorrect permissive tripping protection operations.
