# Correlating Lightning Data With Traveling Waves on Power Lines Aids Patrol Crews in Locating Faults

Eric Rosenberger, *PPL Electric Utilities Corporation*

Martin J. Murphy, *Vaisala, Inc.*

Mangapathirao V. Mynam, *Schweitzer Engineering Laboratories, Inc.*

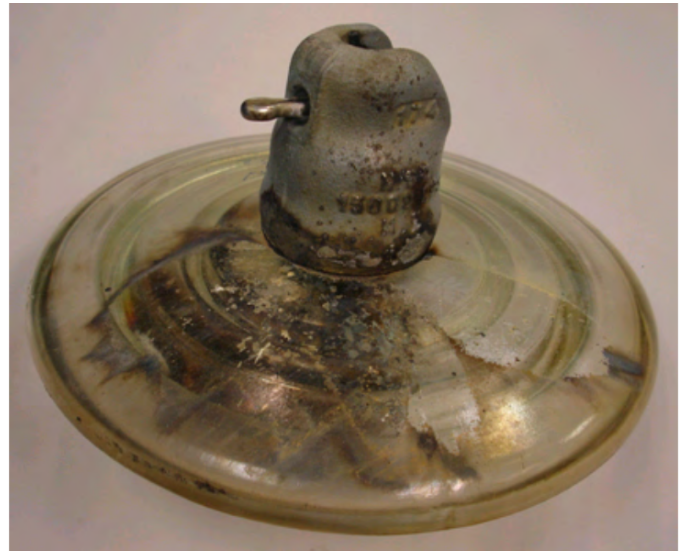
Fig. 1. A flashed insulator bell identified by a patrol crew: UB of Bonneville Power Administration [3].

Traveling-wave (TW) signals are used by line protective relays to accurately locate faults and to provide ultra-high-speed tripping on power lines [1] [2]. References [3], [4], [5], [6], and [7] document the performance of these devices. Accuracy of TW-based fault locating is on the order of one to two tower spans. Fig. 1 shows the insulator damage identified by a patrol crew at 38.15 mi on a 40 mi transmission line. The fault locator reported the distance at 37.97 mi using the double-ended TW-based fault-locating method. Fig. 2 shows the currents and voltages recorded at the terminals of a 345 kV, 40 mi transmission line for an internal Phase-C-to-ground fault. The TW-based current differential scheme operated in less than 1 ms, clearing the fault in 1.5 cycles.

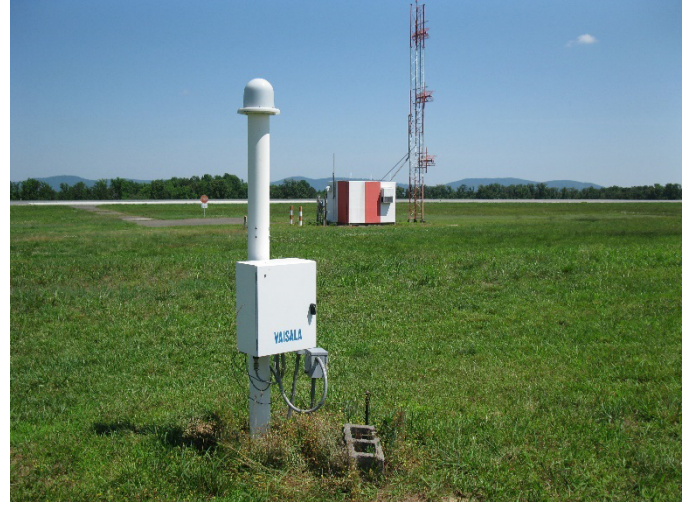
Fig. 5. Lightning sensors measure RF pulses generated by lightning activity.

The U.S. NLDN consists of more than 100 sensors distributed throughout the continental United States with typical sensor separations (i.e. “sensor baselines”) of 300–350 km. Each sensor (see Fig. 5) measures the time and angle of arrival (i.e., the direction of the signal detected by the sensor using geographic north as the reference) of radio-frequency (RF) pulses generated by lightning activity over a frequency range covering 0.5 kHz to 500 kHz.

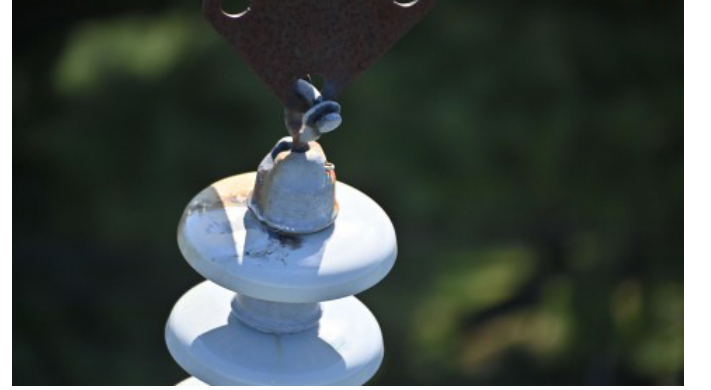
The built-in TW-based fault locator reported the location at 5.1 mi. Fig. 8 shows the flashed insulators identified by the aerial patrol crew at the location reported by the relay.

Fig. 8. A flashed insulator identified by the aerial patrol crew.

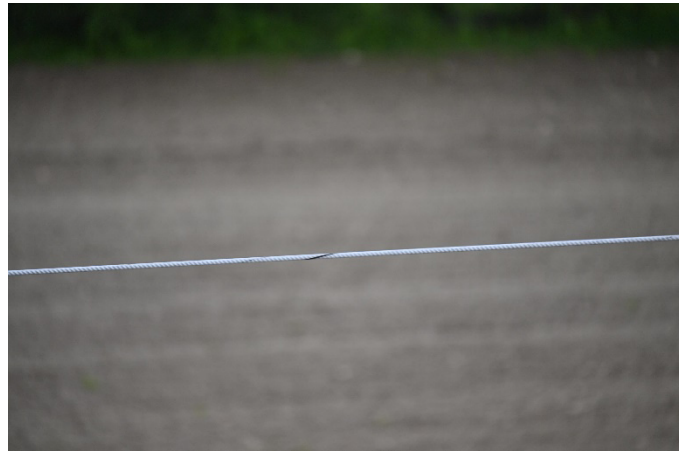
The ratio of the aerial to ground mode magnitudes in this event is 0.4. In this case, lightning did not cause a back flashover resulting in a fault on the power line. Fig. 14 shows a burn mark on the shield wire at the reported location.

Fig. 14. A burn mark identified by the aerial patrol crew on the shield wire at the reported location.

The event data collection and correlation processes performed by the PPL Electric relay event system helped identify and categorize low-energy events caused by lightning strikes in the vicinity of their lines. This information helps with pinpointing and prioritizing exact locations to patrol and inspect for lightning disturbances. Fig. 14 shows an example of very minor lightning strike damage to a 230 kV line shield wire that went undiscovered after a helicopter patrol of a line. After correlating the NLDN data with low-energy event TW measurements, PPL Electric sent a drone to specifically patrol the shield wire in the mid-span line section and quickly discovered the damage caused by the lightning strike to the shield wire.

Without this extraordinary depth of event data, finding a very small burn mark caused by lightning on an overhead transmission line shield wire would be much more difficult and cost prohibitive.
